Reported tailings dam failures A review of the European incidents in the worldwide context

M. Rico^{a,*}, G. Benito^b, A.R. Salgueiro^c, A. Díez-Herrero^d, H.G. Pereira^c

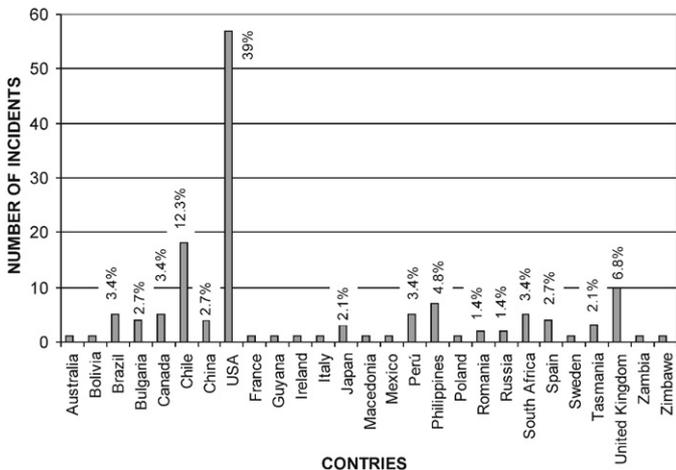
This lack of information affects strongly the representativeness of the database, since the major part of the compiled cases is taken from a few countries. In Fig. 1, the distribution of tailings dam incidents by country indicates that 74% of the cases come from a small number of countries: USA (39%), Europe (18%), Chile (12%) and Philippines (5%). In Europe, out of the 26 cases compiled, 38% occurred in the UK and 56% are distributed between 9 other countries (Bulgaria, France, Ireland, Italy, Republic of Macedonia, Poland, Romania, Spain and Sweden). The geographical distribution of the collected cases reflects the lack/abundance of information from individual countries and the uneven distribution of mine exploitations and corresponding tailings dams.

Fig. 1. Distribution by country of the tailing dam incidents recorded in the database.

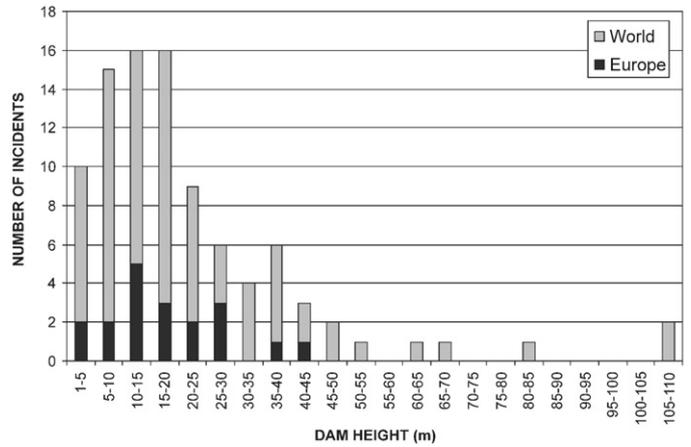
The analyses of the distribution of the world's tailings dam failures with regard to dam height (Fig. 2) show that 55.9% of the cases occurred in dams over 15 m in height and only 22.6% of incidents in dams higher than 30 m. The distribution is similar when considering only Europe, even though some differences are noticed (Fig. 2). 47.4% of European incidents occurred in dams over 15 m in height, while this figure is 43.2% for events elsewhere in the world. By contrast, there is a greater percentage of failures in dams of 15–30 m in Europe (42.1%) than in the rest

Fig. 2. Distribution of the number of incidents related to dam height.

of the world (31.1%). Furthermore, all European dam failures occurred in dams less than 45 m in height.

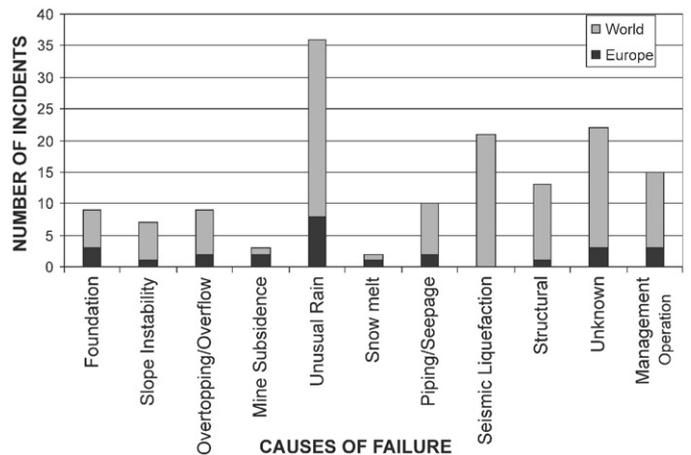
In this database, 15 different failure causes have been spotted. In many cases (39%), the dam breaks resulted from a combination of different factors. For example, failures attributed to meteorological causes (intense rainfall, hurricanes, rapid snowmelt, ice accumulation in the tailings dam, etc.) may also be associated with overflow/overtopping, seepage, foundation failure or bad impoundment management. In this analysis, 11 “cause of failure” categories were differentiated (see Fig. 3), and each incident was assigned to a single category, which contributed the most to the dam break according to the dam failure description. The major fraction of incidents relates to meteorological causes (e.g. unusual rainfall events/periods and snow), accounting for 25% of worldwide cases and 35% in Europe.

The second most important cause in Europe is related to poor management and inadequate human activities at the tailings dam sites. Deficient management practice accounted for 10% of worldwide incidents and 12% of European cases. This

Fig. 3. Distribution of the number of incidents according to cause in the world and in Europe.

category includes the following specific causes: poor beach management, faulty maintenance of the dam drainage structures, inappropriate dam procedures (e.g. rapid dam growth, presence of heavy machinery in unstable dams). It is likely that the correct application of basic safety regulations would have prevented the accidents.

The following most common cause of dam break in Europe is related to failures of the dam foundations and, in most of the reported cases, this was due to a poor choice of dam placement and dam construction, accounting for 12% of European cases and 6% of all cases registered globally. Other causes that correspond to a greater number of events in Europe than in the rest of the world are seepage/piping, overtopping and mine subsidence accounting for, respectively, 8, 8 and 8% in Europe, against 7, 6 and 2% globally. The higher frequency of these types of failures in Europe, along with meteorological causes and poor management, is a relevant finding as compared with the worldwide situation. It is also worth noting the lack of incidents caused by earthquakes (seismic liquefaction) in Europe. This cause, for the rest of the world, accounts for 14% of total cases.

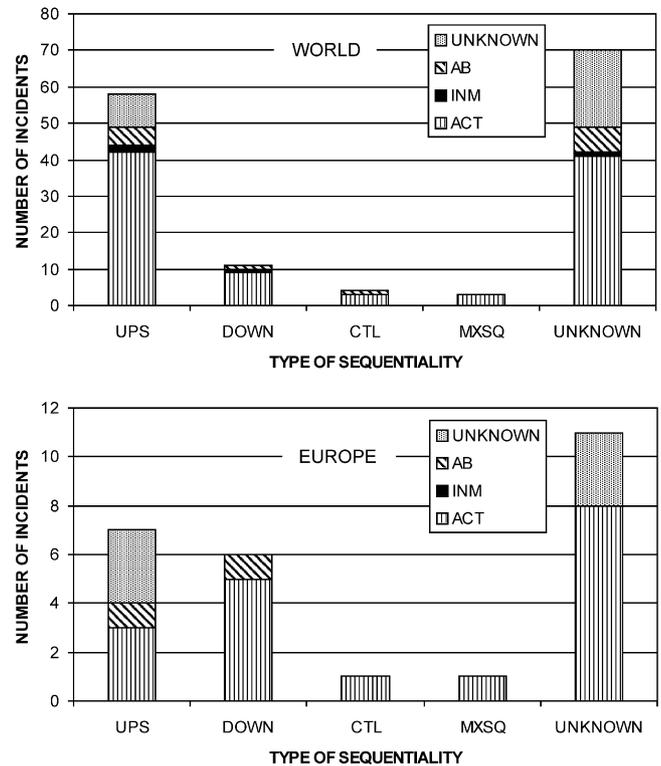
Tailings dams are usually constructed in phases as the impoundment fills. New parts of the embankment are built on top of the previous structure with the new dam crest thus moving upstream, downstream or following a centerline (see ref. [32] for detail explanation). The method of dam construction that accounts for the highest number of incidents is associated with the upstream raised method (UPS), representing 76% of the cases in the world and 47% of failures in Europe (% referred to reported cases where available data on dam construction method exists). Downstream (DOWN) and centerline (CTL) raised tailings dams represent 15 and 5% of global cases, respectively,

Fig. 4. Distribution of the number of incidents according to type of dam construction and state of activity in the world (above) and in Europe (below). (UPS, upstream; DOWN, downstream; CTL, centerline; MXSQ, mixed construction; ACT, dam active at the moment failure happened; INM and AB, dam inactive at the moment failure occurred, abandoned (AB) or inactive but maintained (INM).

whereas in Europe they correspond to 40 and 6.5% of known cases.

Dam constructed using more than one method was included under the category of mixed construction (MXSQ), which represents a 4% of global cases and 6.5% in Europe. In Fig. 4, the different construction types are presented alongside the state of activity at the dam. The figure shows that the greatest number of incidents worldwide occurred in active dams of upstream growth type. In Europe, a similar percentage of dam incidents occurred in dams with upstream and downstream raised methods (47 and 40%, respectively). There is a two-fold explanation for this feature: (1) downstream growth in Europe is more commonly used that elsewhere in the world, and (2) there is a lack of incidents related to seismic liquefaction which are known to affect especially dams with part of its structure lying on the tailings deposits. It is estimated that roughly half of the dam breaks could have been avoided with correct tailings dam construction (e.g. adequate site selection, correct dimensions, etc.) and appropriate management during its period of activity.

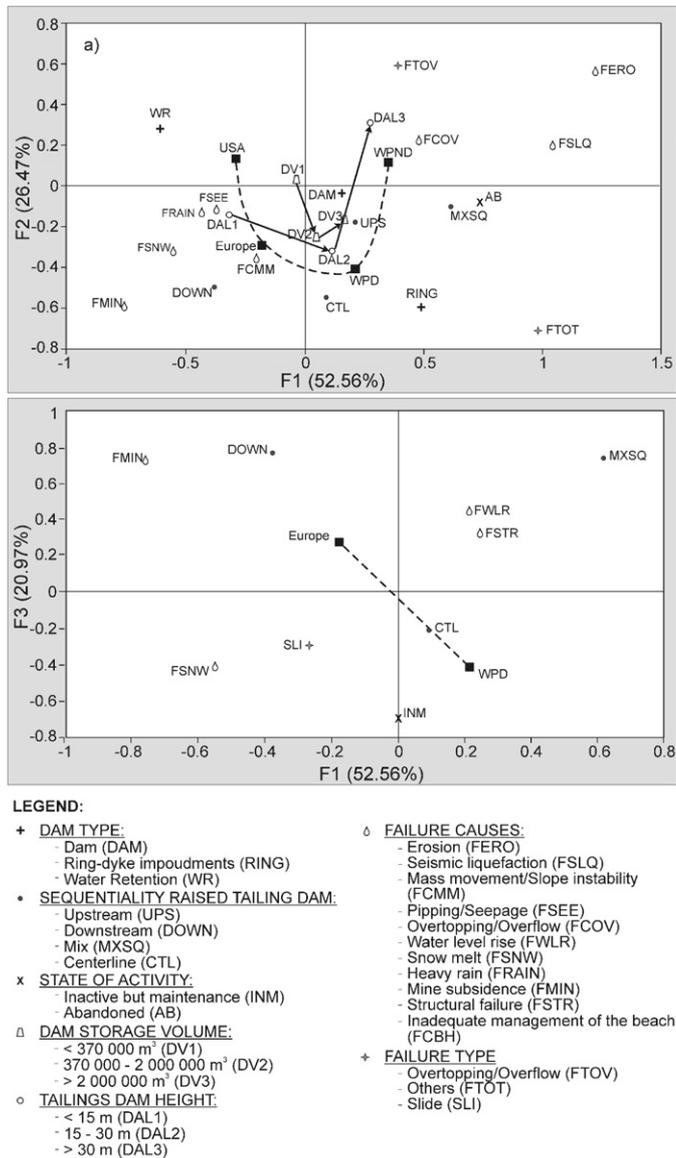
A correspondence analysis was applied to the set of seven contingency tables, of which results are summarised in Fig. 5, accounting for 100% of the available information.

Fig. 5. Projection of attributes and groups of countries onto the first and second plane of correspondence analysis.

- Along axis 1 (from the negative to the positive side) are sequenced the groups of countries according to their “development level” in what environmental regulations are concerned (USA, Europe, WPD and WNPD).

- Regarding ordinal attributes, variables dam storage volume (DV) and dam height (DAL) follow the same sequence (from small to big impoundments), indicating that the more “developed” is a country, the smaller is the dam that breaks.

- Regarding nominal attributes, the modalities that contribute significantly to (USA + Europe) group, according to the above given (Section 2.2) “absolute contribution” criterion, are the following: water retention dam type (WR), downstream sequentially raised dam (DOWN) and failure causes, mine subsidence (FMIN), snow melt (FSNW), unusual rainfall event/period (FRAIN), seepage/piping (FSEE) and slope instability (FCMM). Conversely, for the (WPNP + WPD) group, contribute the following modalities: ring-dyke

impoundments (RING), dam-type impoundments (DAM), upstream sequentially raised dam (UPS), mix sequentially raised dam (MXSQ), abandoned impoundment (AB), seismic liquefaction failure cause (FSLQ), other failure types (FTOT), overtopping/overflow failure cause (FCOV) and overtopping/overflow failure type (FTOV).

- Axis 2 is not relevant for the interpretation of the cross-tabulation countries versus dam and failure attributes since it opposes the two extremes (USA + WPNP) to “intermediate” conditions (Europe + WPD) and no significant attribute modality is assigned to the opposition disclosed by this axis.
- In what concerns plane 1, 3 (Fig. 5(b)) gives a fair insight about the opposition Europe versus WPD, when projection onto axis 3 is interpreted in terms of nominal attribute modalities that contribute significantly to it. In fact, Europe is associated with downstream (DOWN) and mix (MXSQ) raised dams, and with the following failure causes: FMIN, FWLR (water level rise) and FSTR (structural failure); on the other hand, WPD is associated with centerline (CTL) inactive but maintained dams (INM), slide failure cause (SLI) and with the snow melt failure cause, FSNW.
