Field Inspection of the Pebble Copper/Gold Project

July 26-27, 2007

Part I

Bill Cole

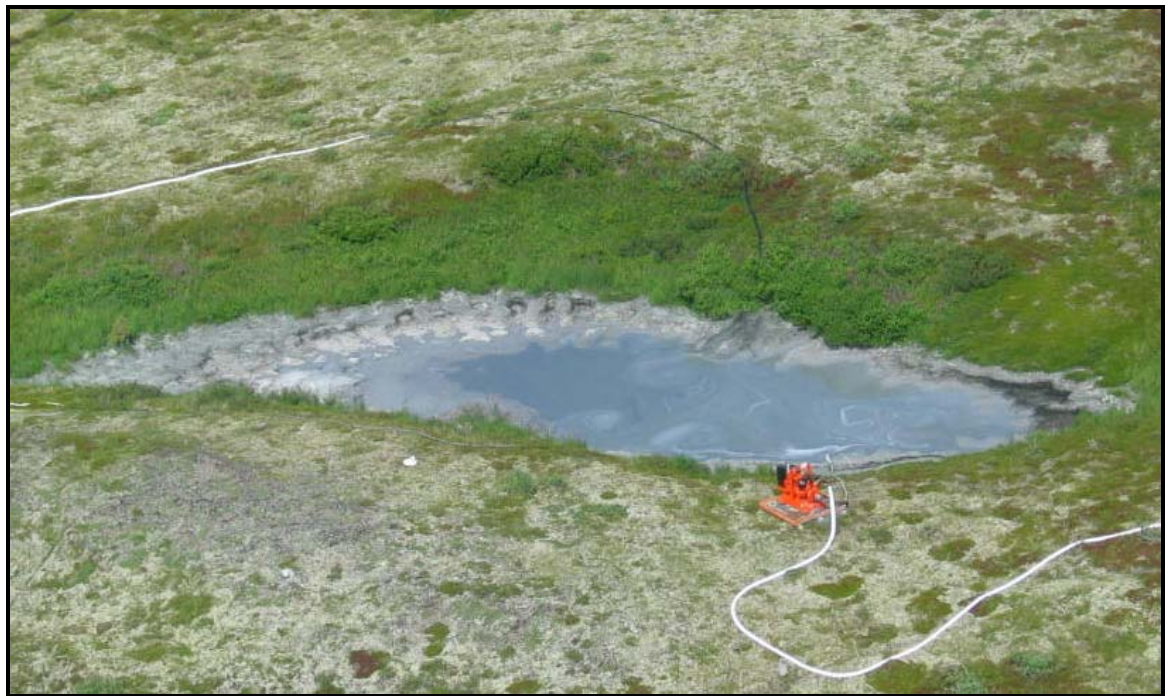
There is some concern in places where multiple wells are being discharged into topographic depressions. This practice can result in considerable amounts of clay material being deposited in the depression. (See photo #14.) It might be better to discharge the water over a larger area. However, by depositing the clays and cuttings

Photo #14. Clay deposited in a dry depression by discharged drilling fluids.

in only a few depressions, there will be less area to reclaim after drilling. Alternately, Northern Dynasty might use a flocculant in their sumps, precipitating the clays in the pits, for later burial. Another alternative is to recirculate the drilling fluids. We are talking to Northern Dynasty personnel about the possibilities.

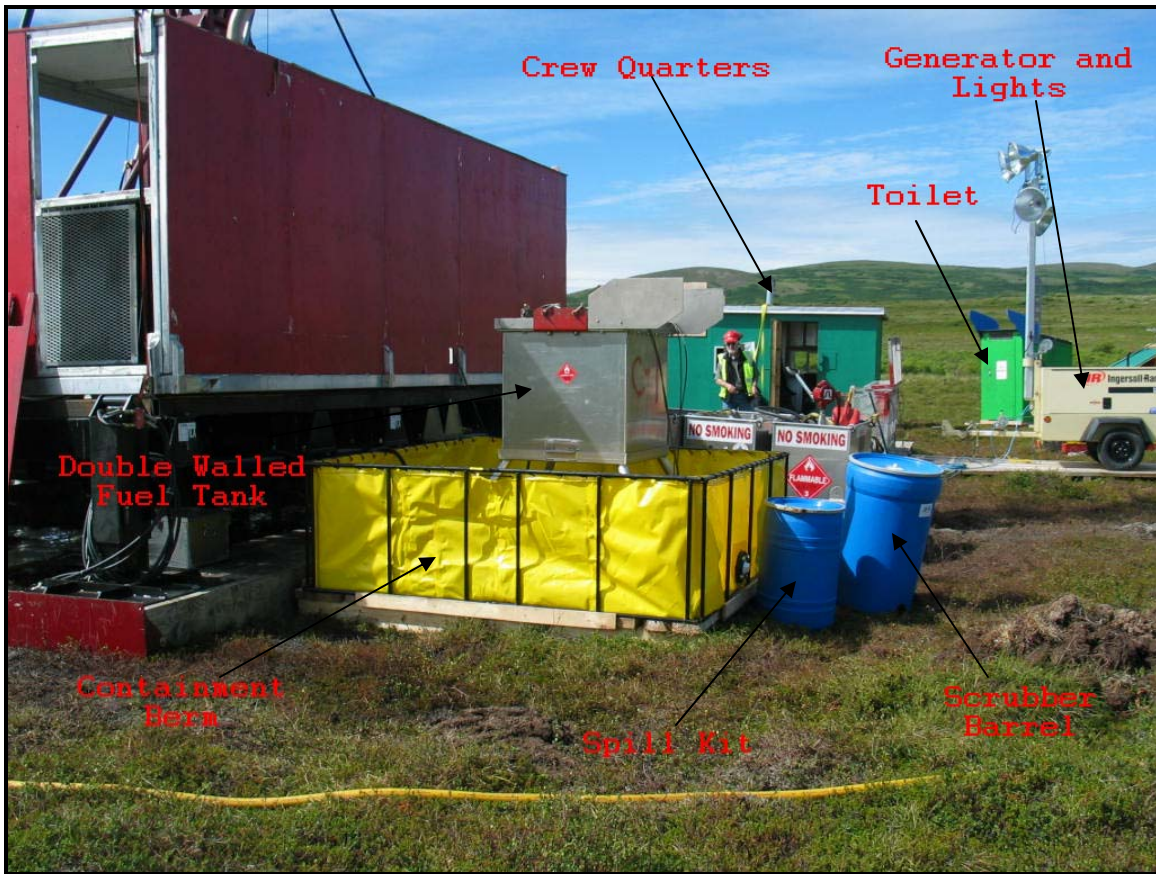
- Crew quarters, for shelter and safety in the event that weather prevents the helicopters from changing worker shifts. The crews have sufficient food and heating fuel for several days. (Photo #16)
- Storage structure – usually a Quonset hut. (Photo #15, Tan colored structure)
- Tundra matting – discussed above.

- Fuel storage. All fuel tanks on the project are double walled aluminum tanks. All are placed in a lining with at least 120% capacity. Many have more than 120% capacity. (Photo #16)

- Spill kit and scrubber barrel. The spill kit contains absorbent materials for cleaning up spills. The scrubber barrel is filled with a material that separates petroleum products from water. Any accidental mixture of petroleum and water is poured in the top. Hydrocarbons are trapped by the material, and water flows out of a hole at the base of the barrel. (Photos #16 and 18)

- Toilet facility with a burner for disposal of wastes. (Photo #16)
- Sump for settling drill cuttings out of the drill return. (Photo #19)
- Trash container (Photo #20)

Photo #16. Drill #6 and facilities.

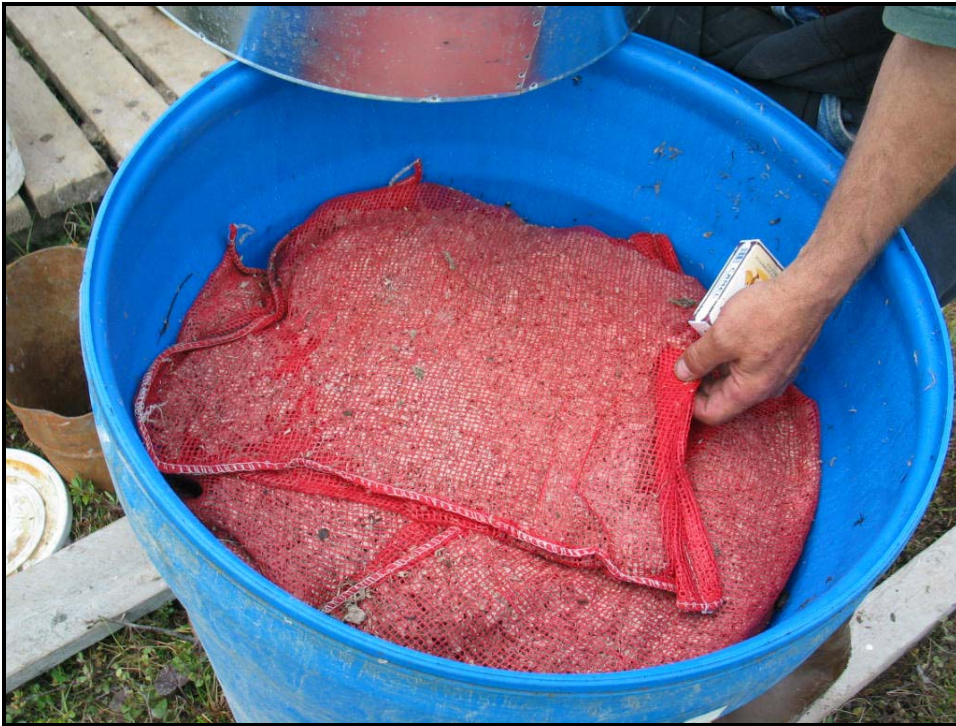
Photo #18. Petroleum absorbent material in a scrubber barrel.

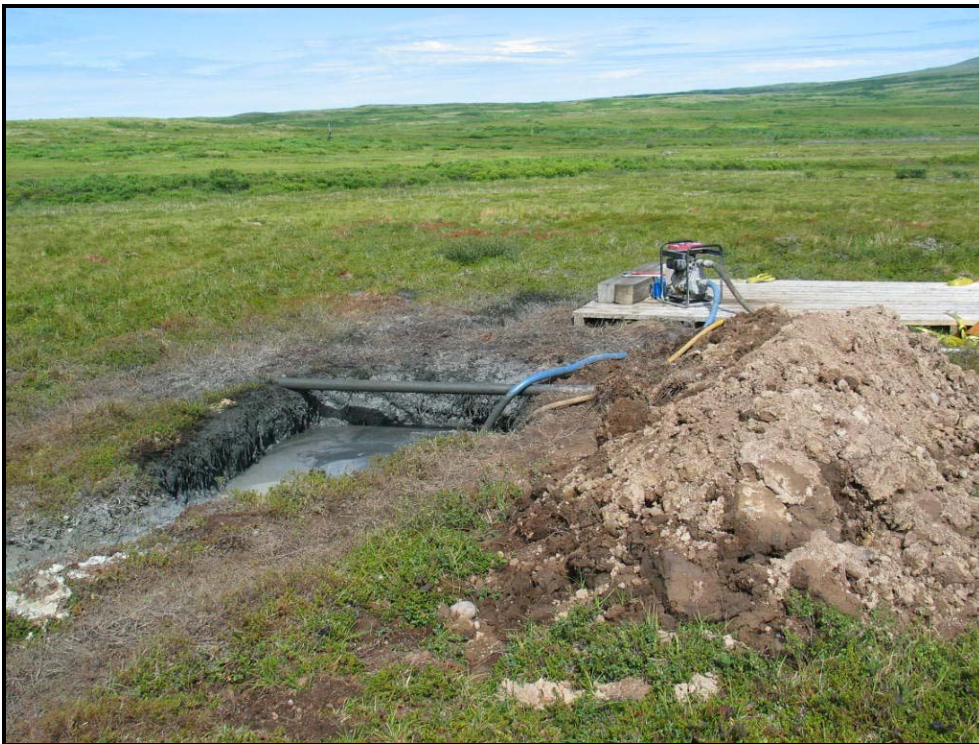
Photo #19. Sump at drill #6.

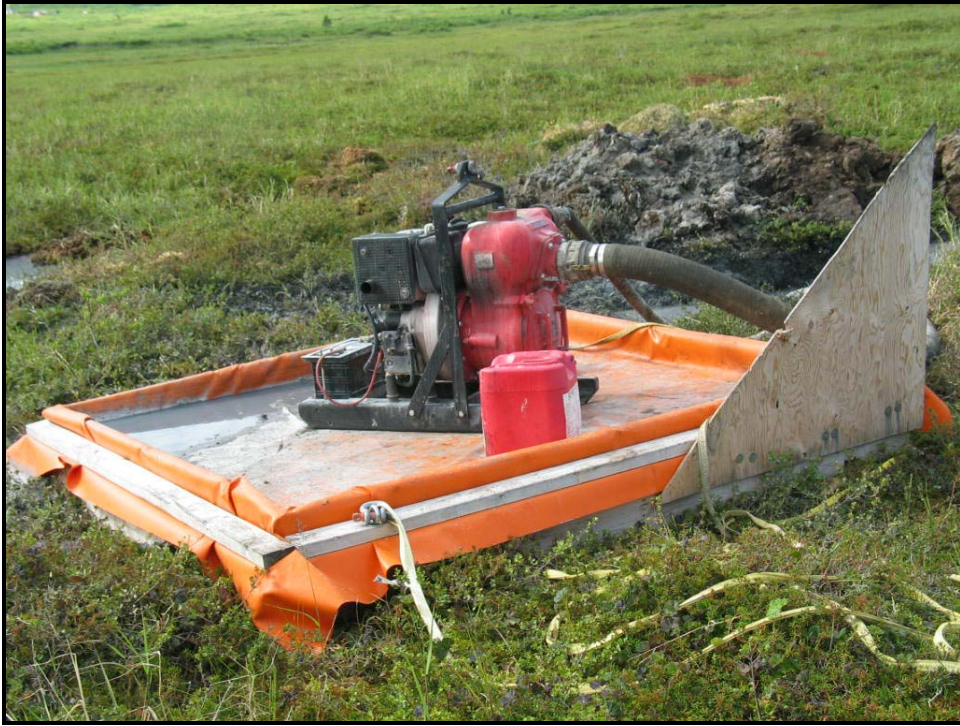
Photo #23. Sump pump at drill #7. Pump is in a containment structure due to proximity to wetland.

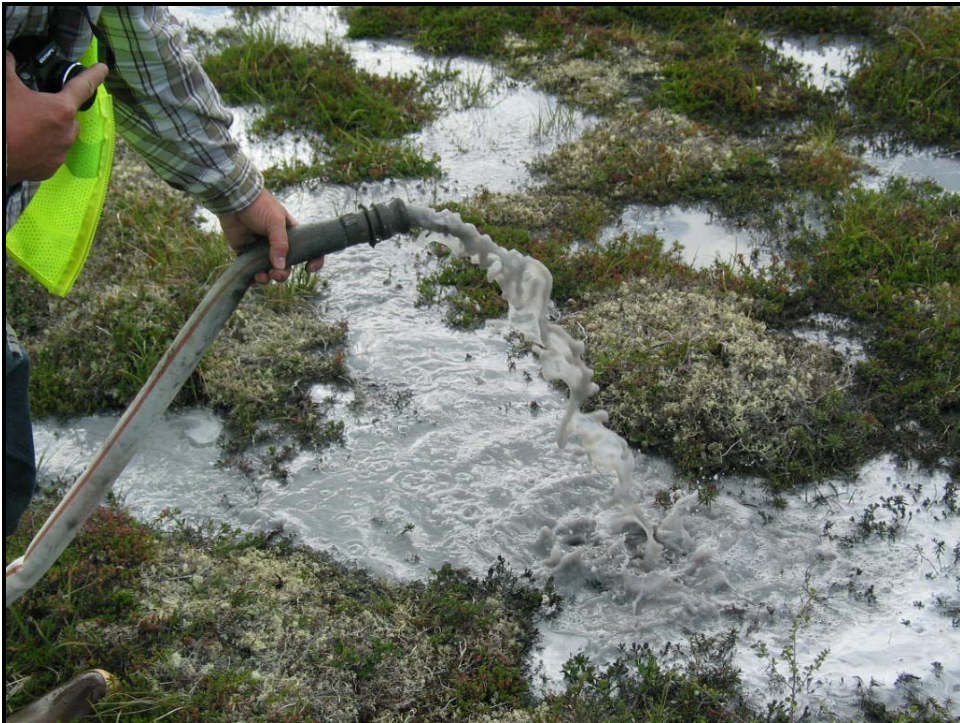
Drill #7 (See photo #21) was operating in a lowland about 300 yards south of Upper Talarik Creek, close to a wetlands. The drilling return was being pumped about 150 yards up hill away from the wetland. The water seeps into the ground over a short distance. (See photos #24-26.)

Photo #24. Drill #7 discharge onto tundra.

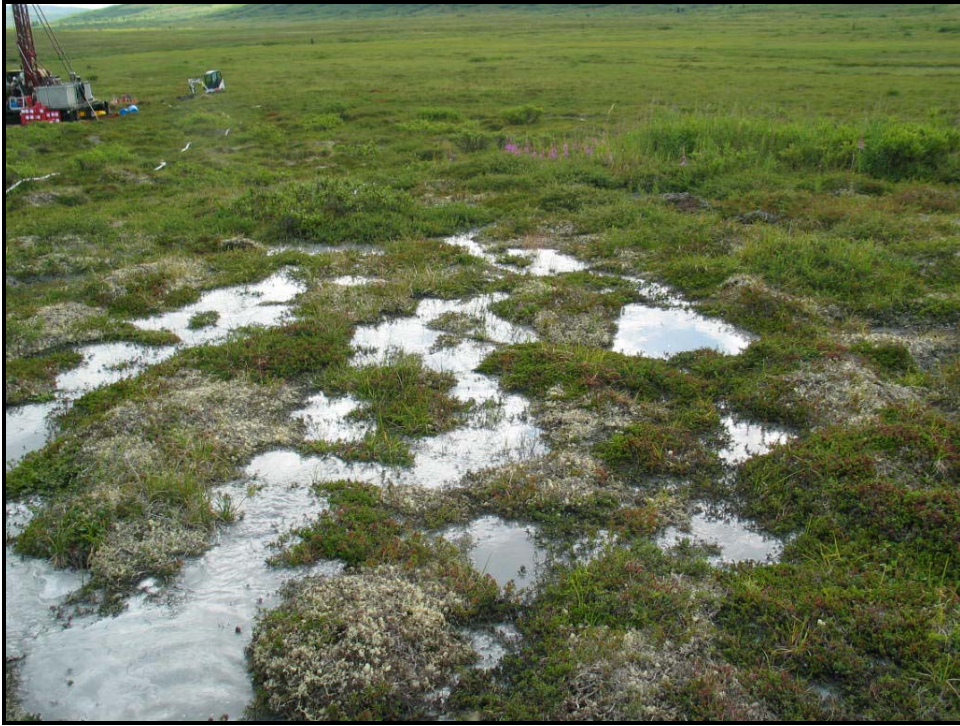
Photo #25. Drill #7 discharge onto tundra. Water seeps into the ground over a short distance.

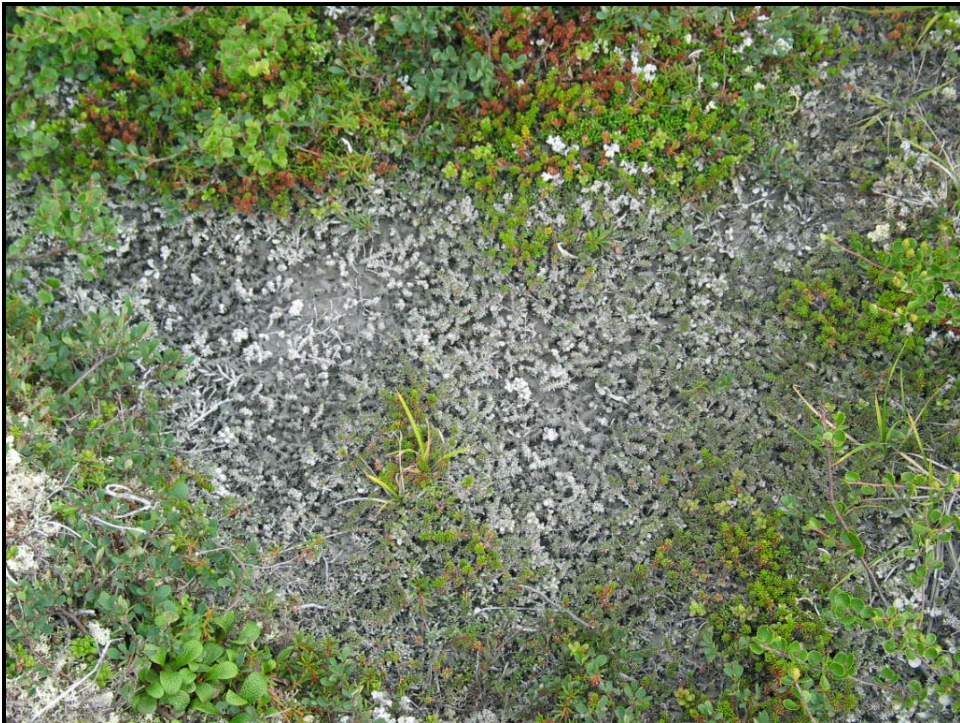
Photo #25. Clay residue left on tundra from drilling discharge.

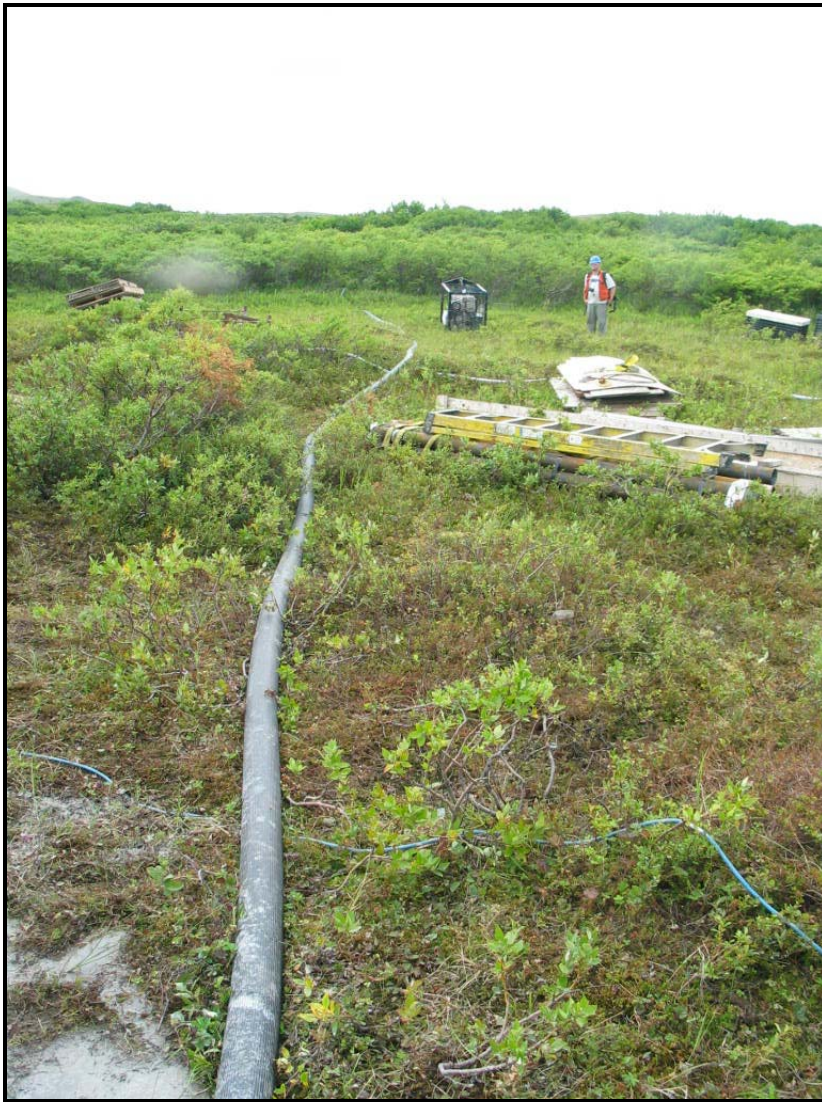
We also inspected drill #1 on the second day. According to the driller's estimate, the hole was making 15-20 gallons of water per minute into the hole, but there was no artesian flow to the surface. There have been no artesian flows from any wells drilled to date in 2007. This hole is located near the 2006 hole that produced a strong artesian flow. (See Southwest Alaska Mine Inspection Tour, 6/14/06-6/16/06 report, by Bill Cole.) Drilling fluids are being pumped approximately 3/8 mile up hill and discharged into a previously dry depression. (See photos #27 and 28.) No drill water is being discharged into any existing water body.

Photo #27. Hose carrying drilling fluids uphill to a topographic depression.

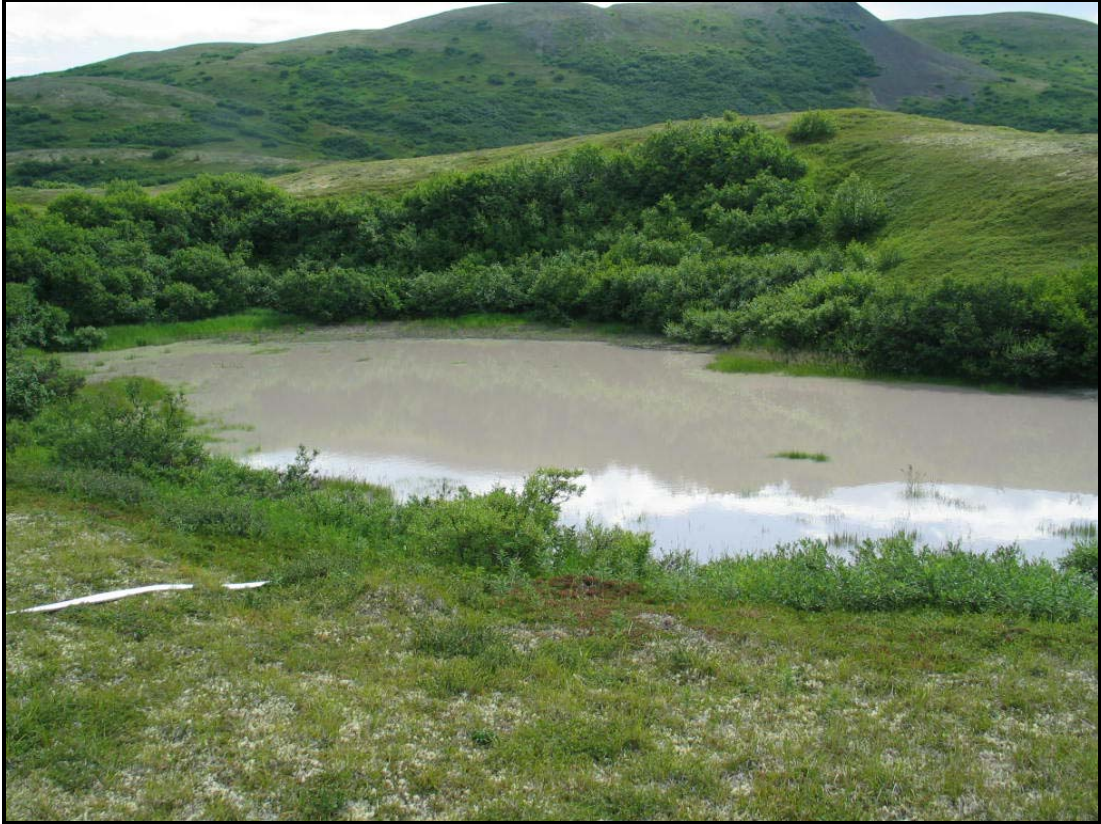
Photo #28. Topographic depression with discharged drilling fluid.

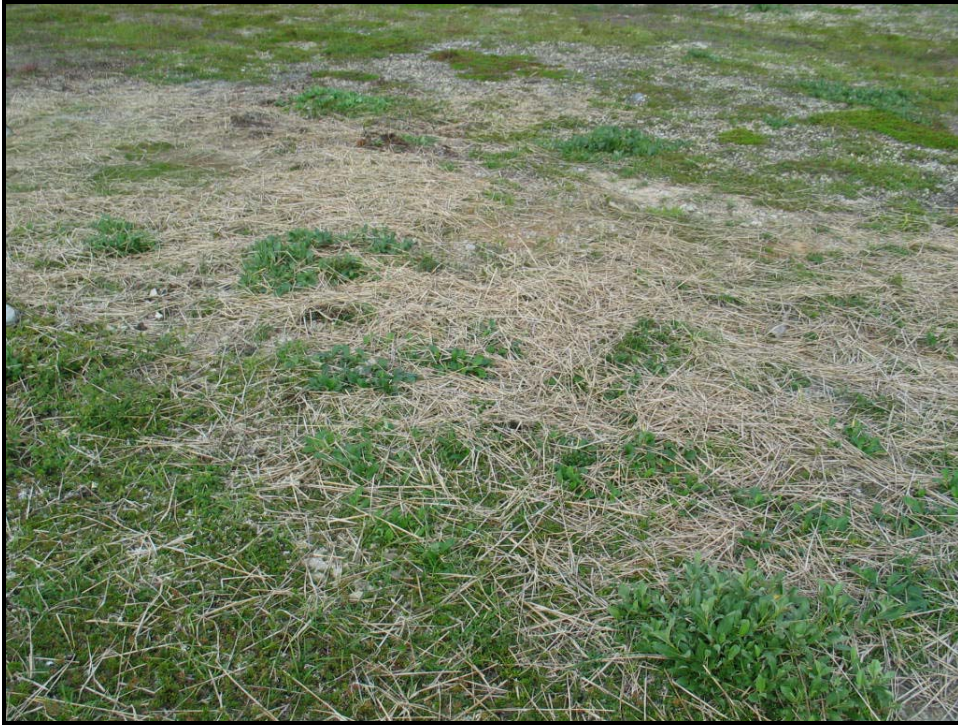
Photo #39. Reclamation at DDH 7364. Site has been treated with straw to prevent erosion, and seeded with grass. Note new vegetation.

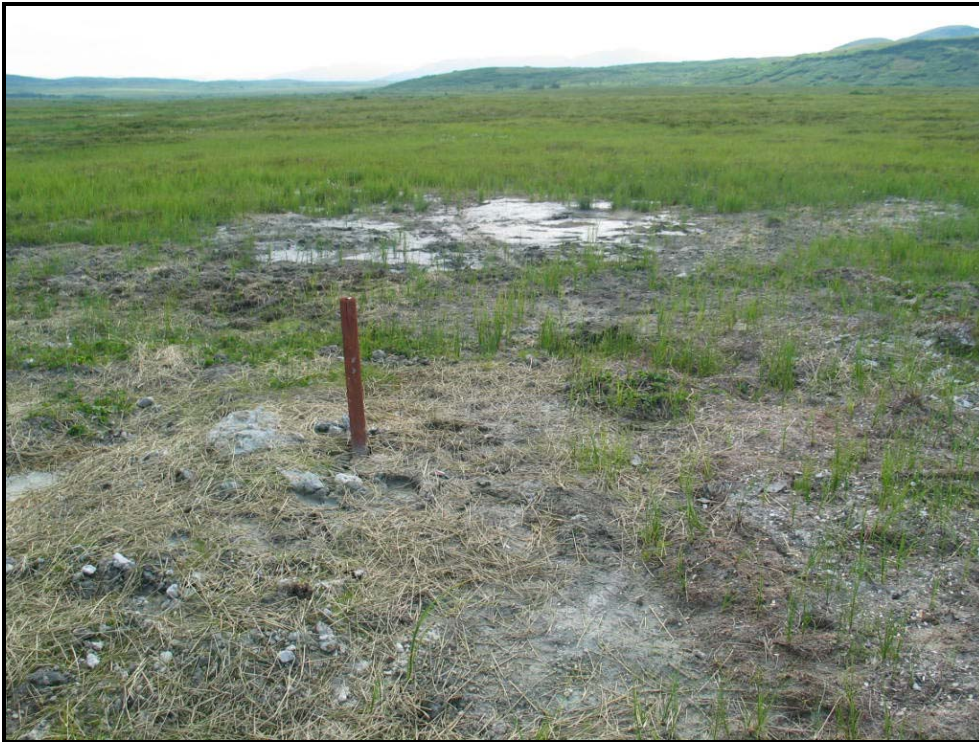
Sumps could not be dug for some of the holes drilled this past winter and spring (fewer than 10) because the ground was frozen. (See photos 46 and 47 in Part II of this report.) Cuttings and drilling fluids from these holes were discharged directly onto the ground. This is a customary practice, and is generally allowed. However, Lena Brommeland, of Northern Dynasty, has informed me that they are currently working to identify drill locations for the coming winter and dig appropriate sumps in advance. This should result in few, if any holes having their cuttings deposited directly onto the tundra.

Photo #46. DDH 7358. This is one of the holes drilled during the spring without a sump.

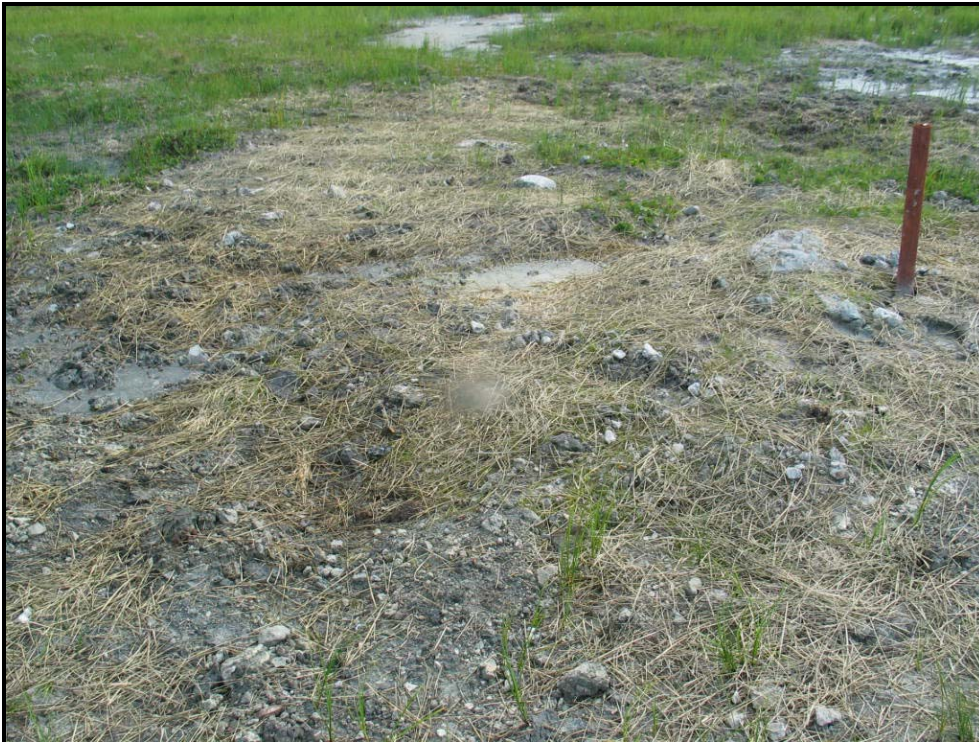
Photo #47. Reclamation at DDH 7358

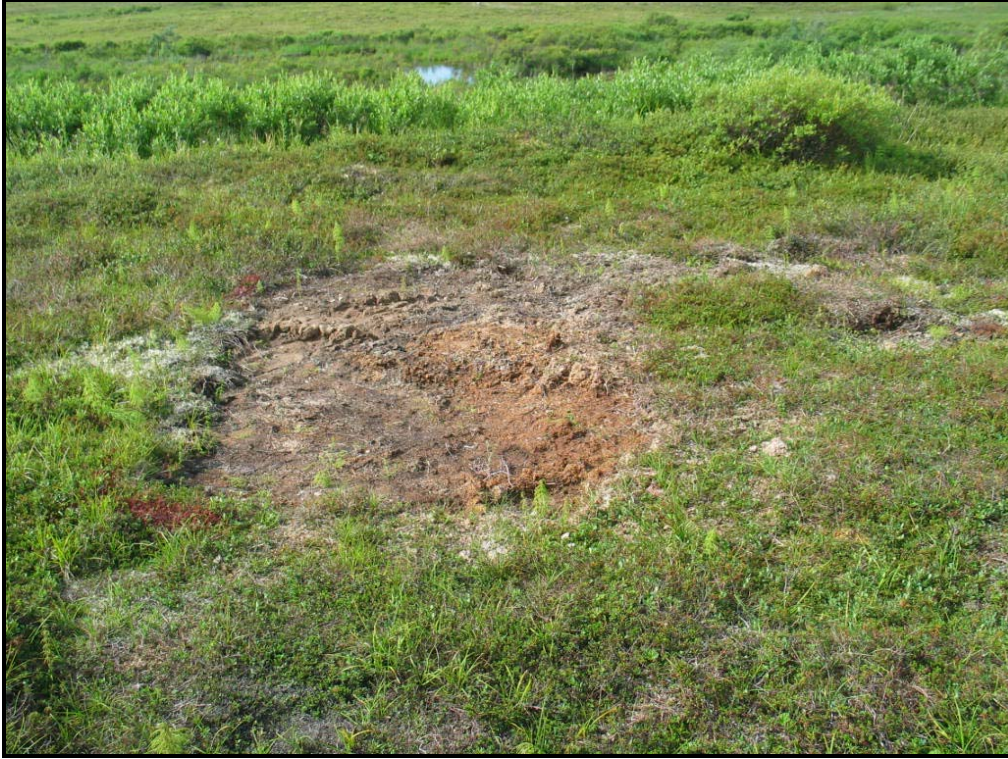
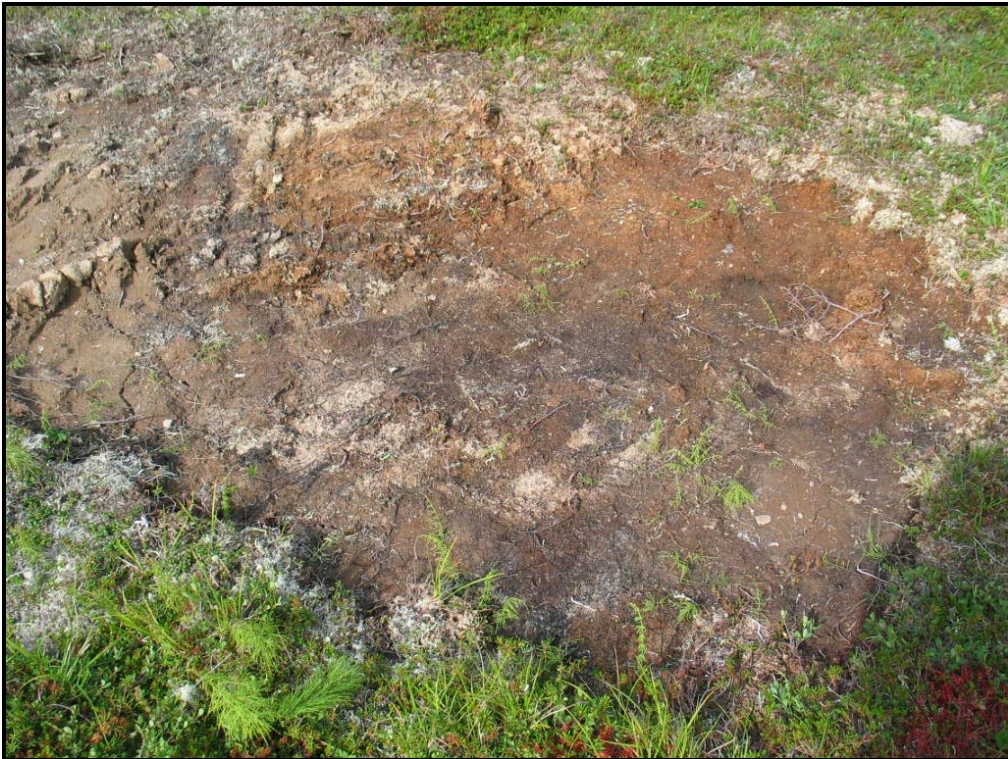
On May 9, 2007 Northern Dynasty had a small spill of 2-5 gallons of diesel fuel while slinging a fuel tank away from DDH 7366. The tank nozzle caught on the containment wall and broke, spilling the diesel. The diesel spilled onto the tundra approximately 200 yards east southeast of the hole. At the time, the tundra was frozen, so the spill only penetrated a few inches. The light backhoe was used to scoop up the contaminated soil. An area of tundra approximately 7'x10' was removed and taken to Oregon for disposal. The spill was properly reported at the time. We inspected the spill site on July 27th. The soil had a very faint smell of diesel when we held it to our noses, but the site appears to have been cleaned more than adequately. (See photos #57 and 58.)

Photo #57. May 9, 2007 diesel spill site.

Photo #58. May 9, 2007 diesel spill site.

Northern Dynasty has made several design changes to minimize the chances of this type of spill occurring in the future. Among these changes is the redesign and purchase of top loading double walled tanks, such that the nozzles cannot catch on the containment wall.

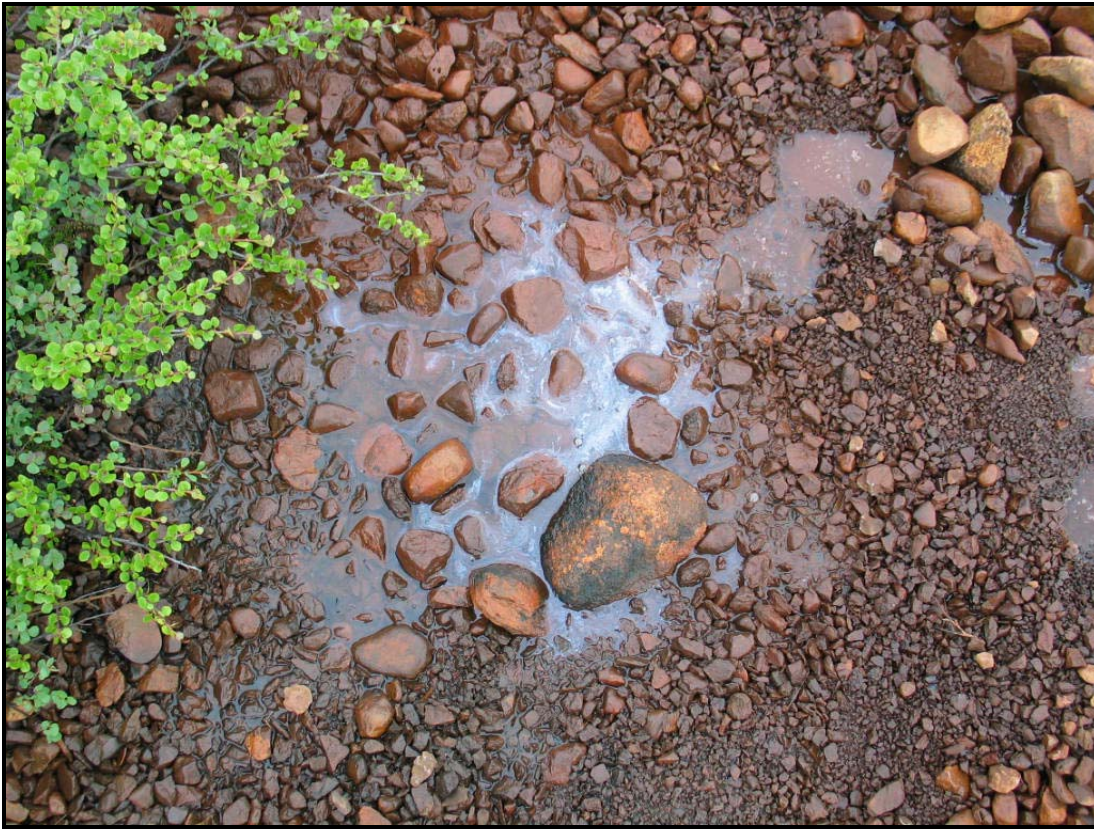
In places we noted oily looking bacterial films in the wetland water. These develop due to bacteria metabolizing the iron and manganese. The films can be distinguished from oil because when broken up, they stay broken apart and do not flow back together. (See photo #67.) (Ref: <http://pubs.usgs.gov/gip/microbes/intro.html>)

Photo #67. Bacterial film due to metabolism of metal oxides.
