## Field Inspection Report -Pebble Copper/Gold Exploration Project-

Personnel: Patricia Bettis (ADNR/MLW) and  
David Johnson (DEC)  
APMA No.: A076118

Inspection Date: October 4, 2007

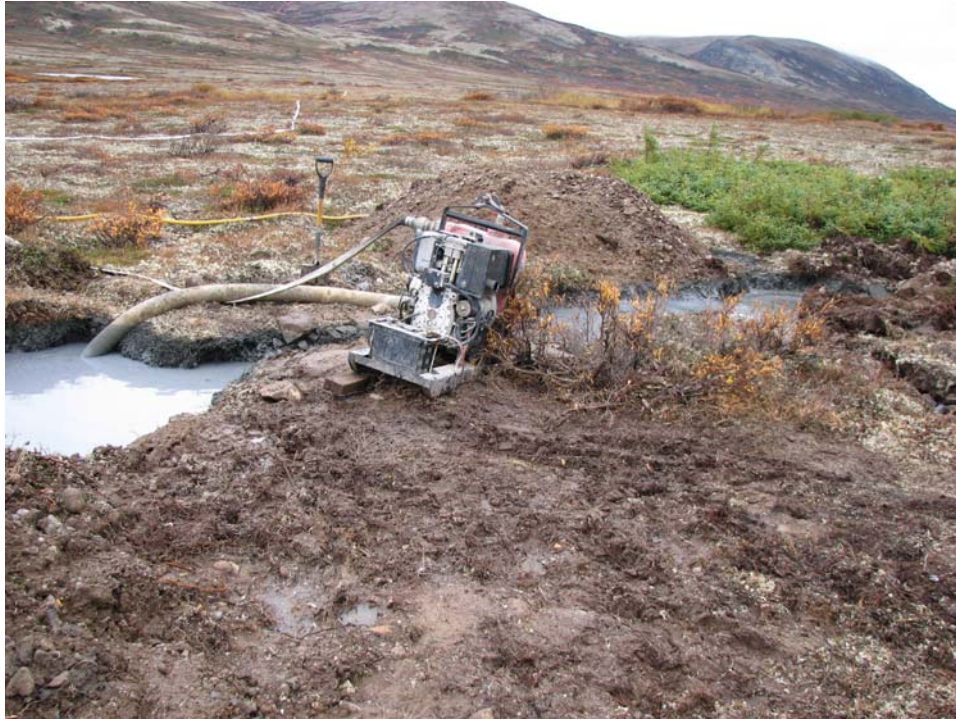
- Distance from water body: **125 ft.**
- Location of fuel storage: **On pad.**
- Sorbent Pads Present or Not: **Yes.**
- Tundra Mat: **Yes.**
- Pipe off Tundra: **Yes.**
- Litter: **None.**
- Spill Indications: **None observed.**
- Activity: **Drilling.**
- Trash Containment: **Yes.**
- Sanitary Facilities: **Yes.**
- Any spills or staining, or 'none' for that matter: **None.**
- General impression of site: **Clean. No disturbance to tundra other than sump pit and trench.**

- Location: **Next to rig.**
- Discharge trench: **Yes. Approx. 6 inches deep and 10 inches wide.**
- Dimension pit: **Approx. 6 feet in depth, 2 to 5 feet in width.**
- In use: **Yes.**
- Level of water in pit: **High.**

Photograph No. 1: Drill Site No.7384 trench and sump pit.

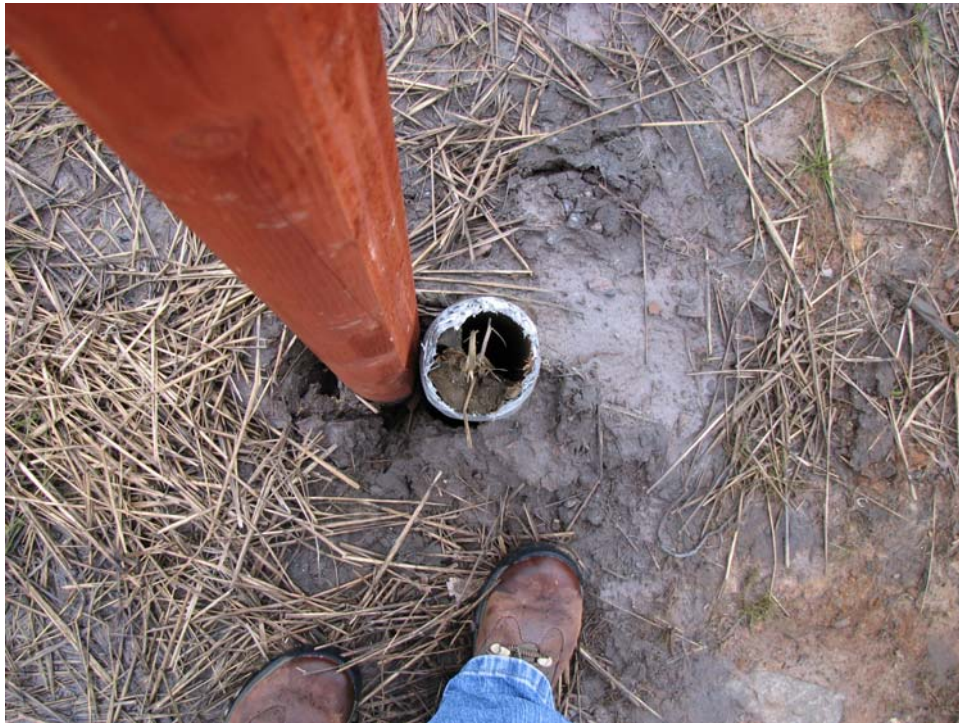
- Abandoned Drill Site No.: **7359**  
Photograph(s) No.: 2
  - Plugged: **Yes.**
  - Cemented:
  - Standing Pipe: **Yes.**
  - Sump Pit Filled In: **Yes.**
  - Site Re-vegetated: **Yes.**
  - Artesian Water Present: **No.**
  - Any spills or staining, or 'none': **None.**

Photograph No. 2: Drill Site 7359 with standing pipe left.

**Action Needed:** Upper three feet of well casing should be removed to eliminate potential hazard threat.

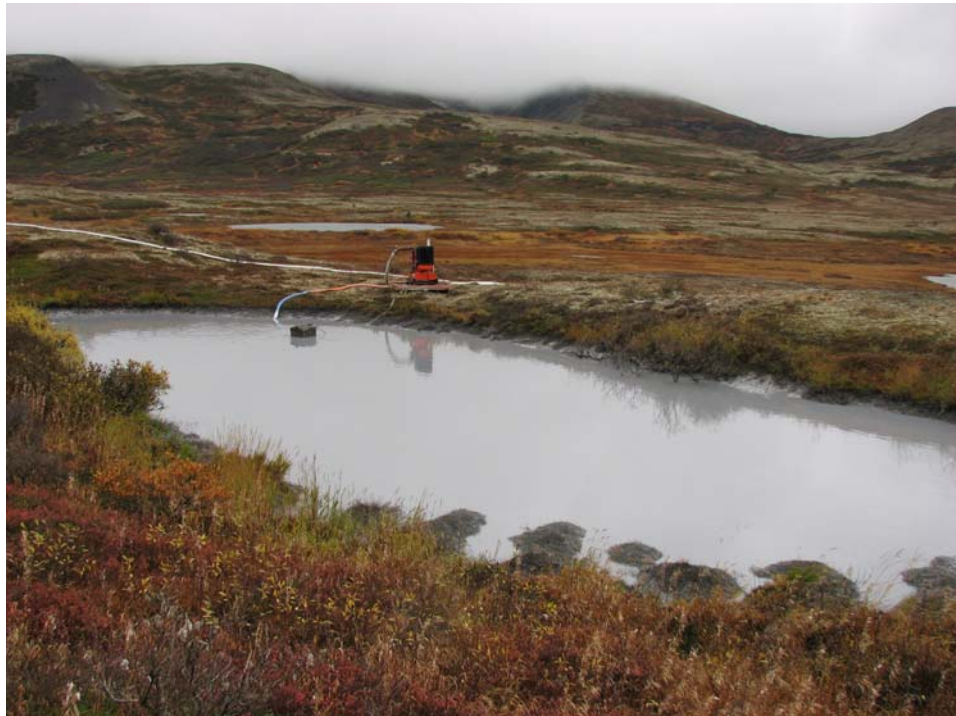
Photograph No. 3: Secondary sump pit (natural hallow) near Drill Site No. 7369.

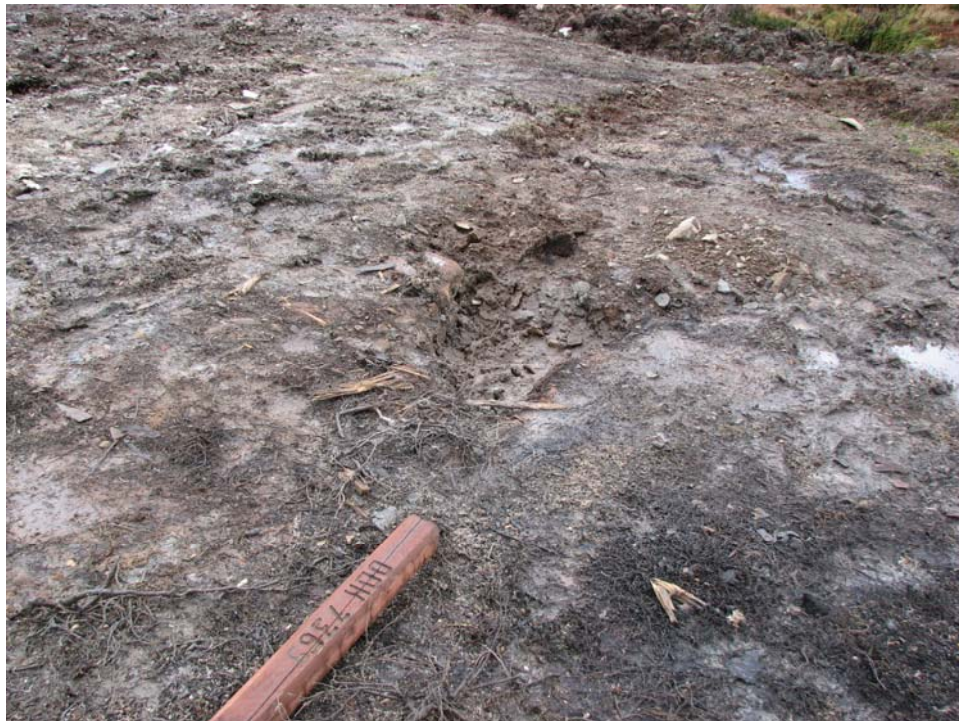
Number and description (depth & length, etc): **Sump pit and trench filled.**

Photograph No. 4: Drill Site No. 7369  
Well casing cut off below ground. Reclamation work started.

**Action Needed:** None. Reclamation of site just started..

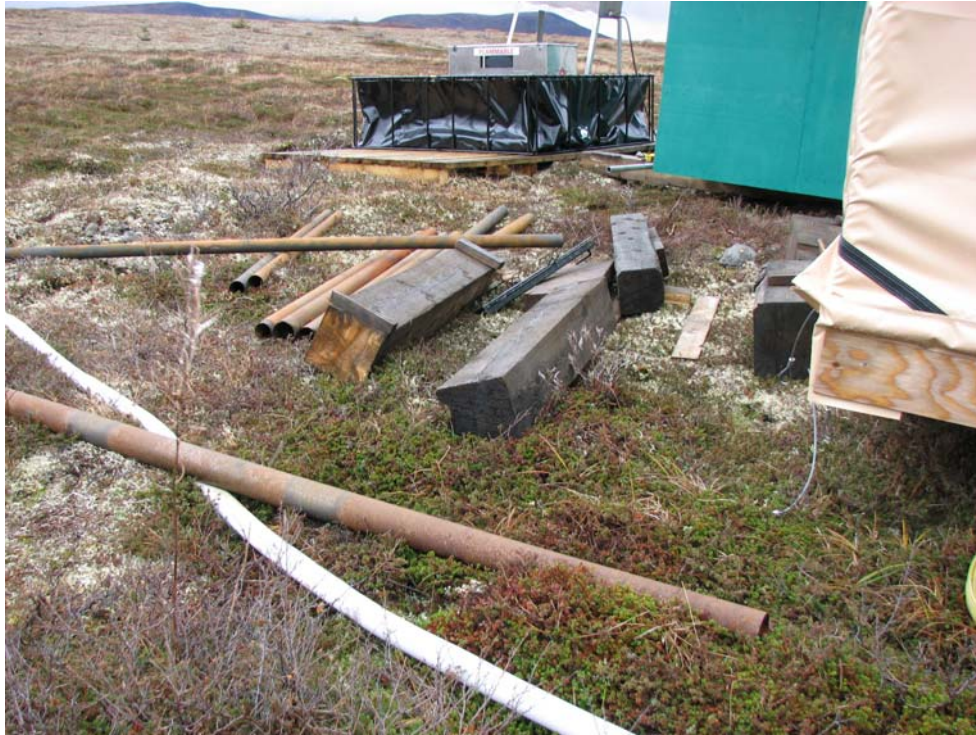
- Distance from water body: **Approx. 230 feet.**
- Location of fuel storage: **On pad.**
- Sorbent Pads Present or Not: **Yes.**
- Tundra Mat: **Yes.**
- Pipe off Tundra: **Discarded pipes on tundra.**
- Litter: **Observed.**
- Spill Indications: **None observed.**
- Activity: **On standby waiting parts.**
- Trash Containment: **Yes.**
- Sanitary Facilities: **Yes.**
- Any spills or staining, or 'none' for that matter: **None.**
- General impression of site: **No disturbance to tundra other than sump pit and trench.**

Photograph No. 5: Drill Site No 7376  
Note pipe and debris on tundra.

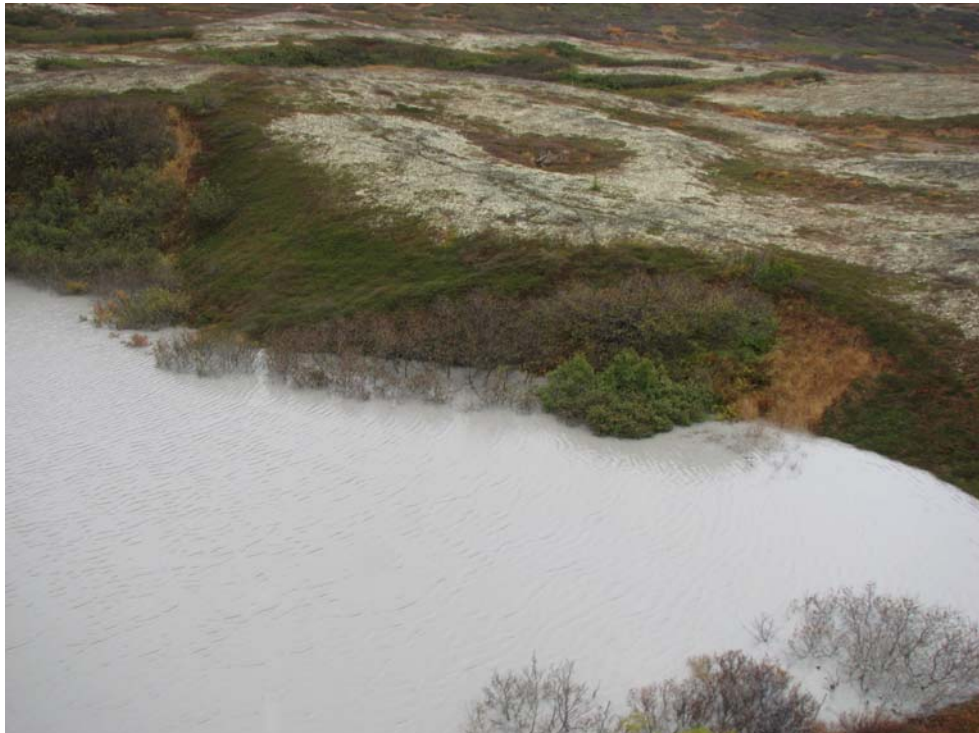
Photograph No. 6: Secondary sump pit (natural hollow) near Drill Site No. 6347  
Note water level relative to vegetation.

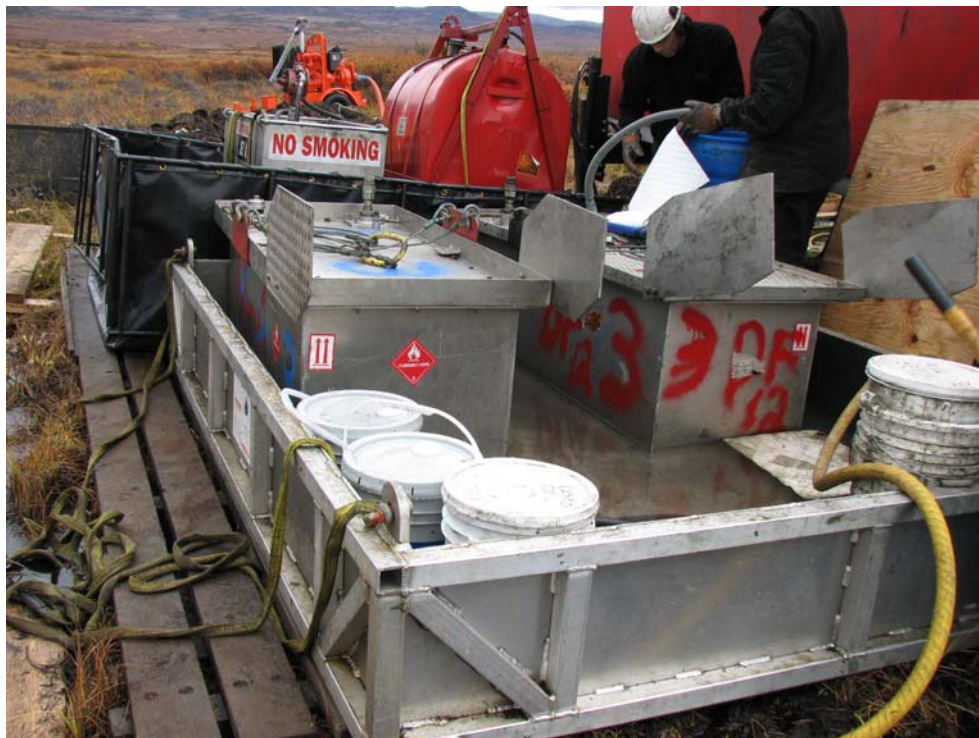
- Distance from water body: **Not measured**
- Location of fuel storage: **On pad.**
- Sorbent Pads Present or Not: **Yes.**
- Tundra Mat: **Yes.**
- Pipe off Tundra: **Pipes observed on tundra.**
- Litter: **None.**
- Spill Indications: **None observed.**
- Activity: **Drilling.**
- Trash Containment: **Yes.**
- Sanitary Facilities: **Yes.**
- Any spills or staining, or 'none' for that matter: **None.**
- General impression of site: **Site is wet, marshy. Not as clean as site no. 7384. Water in fuel containment catch basin.**

Photograph No. 7: Drill Site No 7385  
Note standing water in secondary fuel catchment basin.

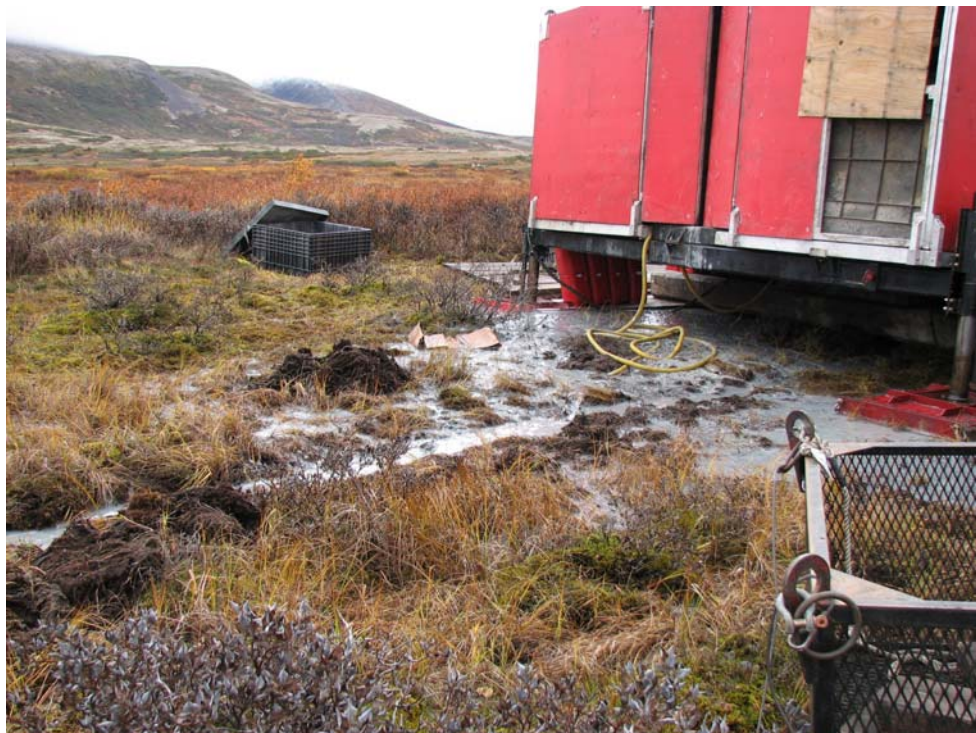
- Location: **Next to rig.**
- Discharge trench: **Yes. Trench was flooded.**
- Dimension pit: **Pit was flooded**
- In use: **Yes.**
- Level of water in pit: **High.**

Photograph No. 8: Drill Site No. 7385  
Trench and sump pit system is inadequate owing to marshy conditions.

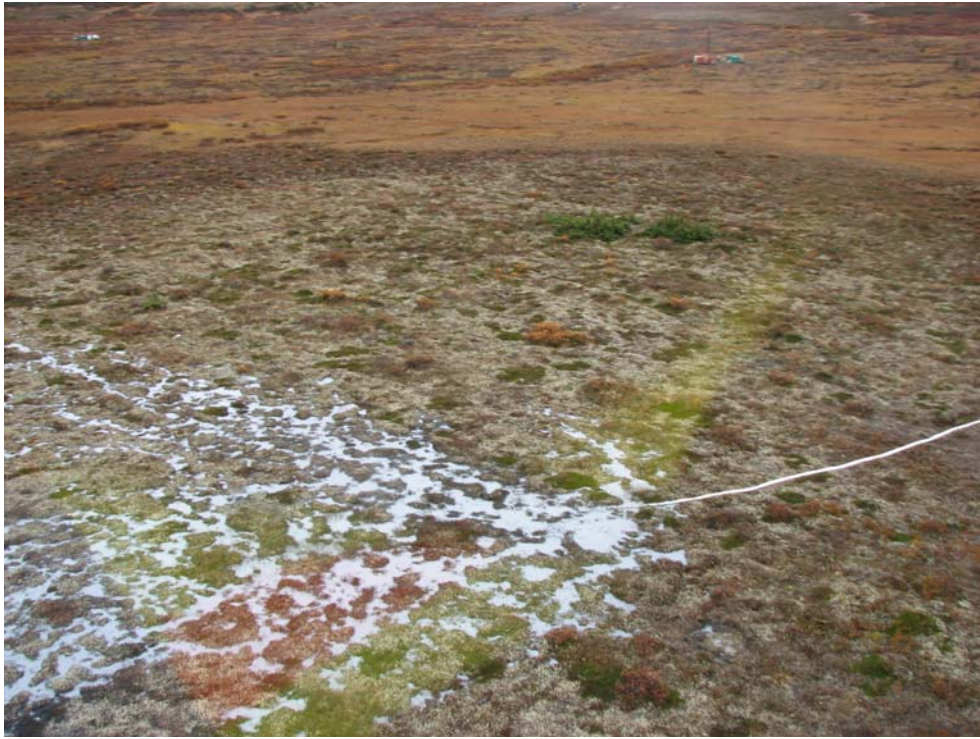
- Topsoil, muck, tundra stockpiled: **Yes.**
- Location and extent of discharged material? **Discharged directly onto the tundra, north of rig, see photograph no. 9.**
- Location of secondary sump pit: **None.**
- Hose color: **White.**

Photograph No. 9: Discharge of drilling water from Drill Site No. 7385 (rig 3) onto tundra.
