Pebble Project – Field Inspection Report

Inspection Date: October 17, 2007

Exploration Project #: A076113

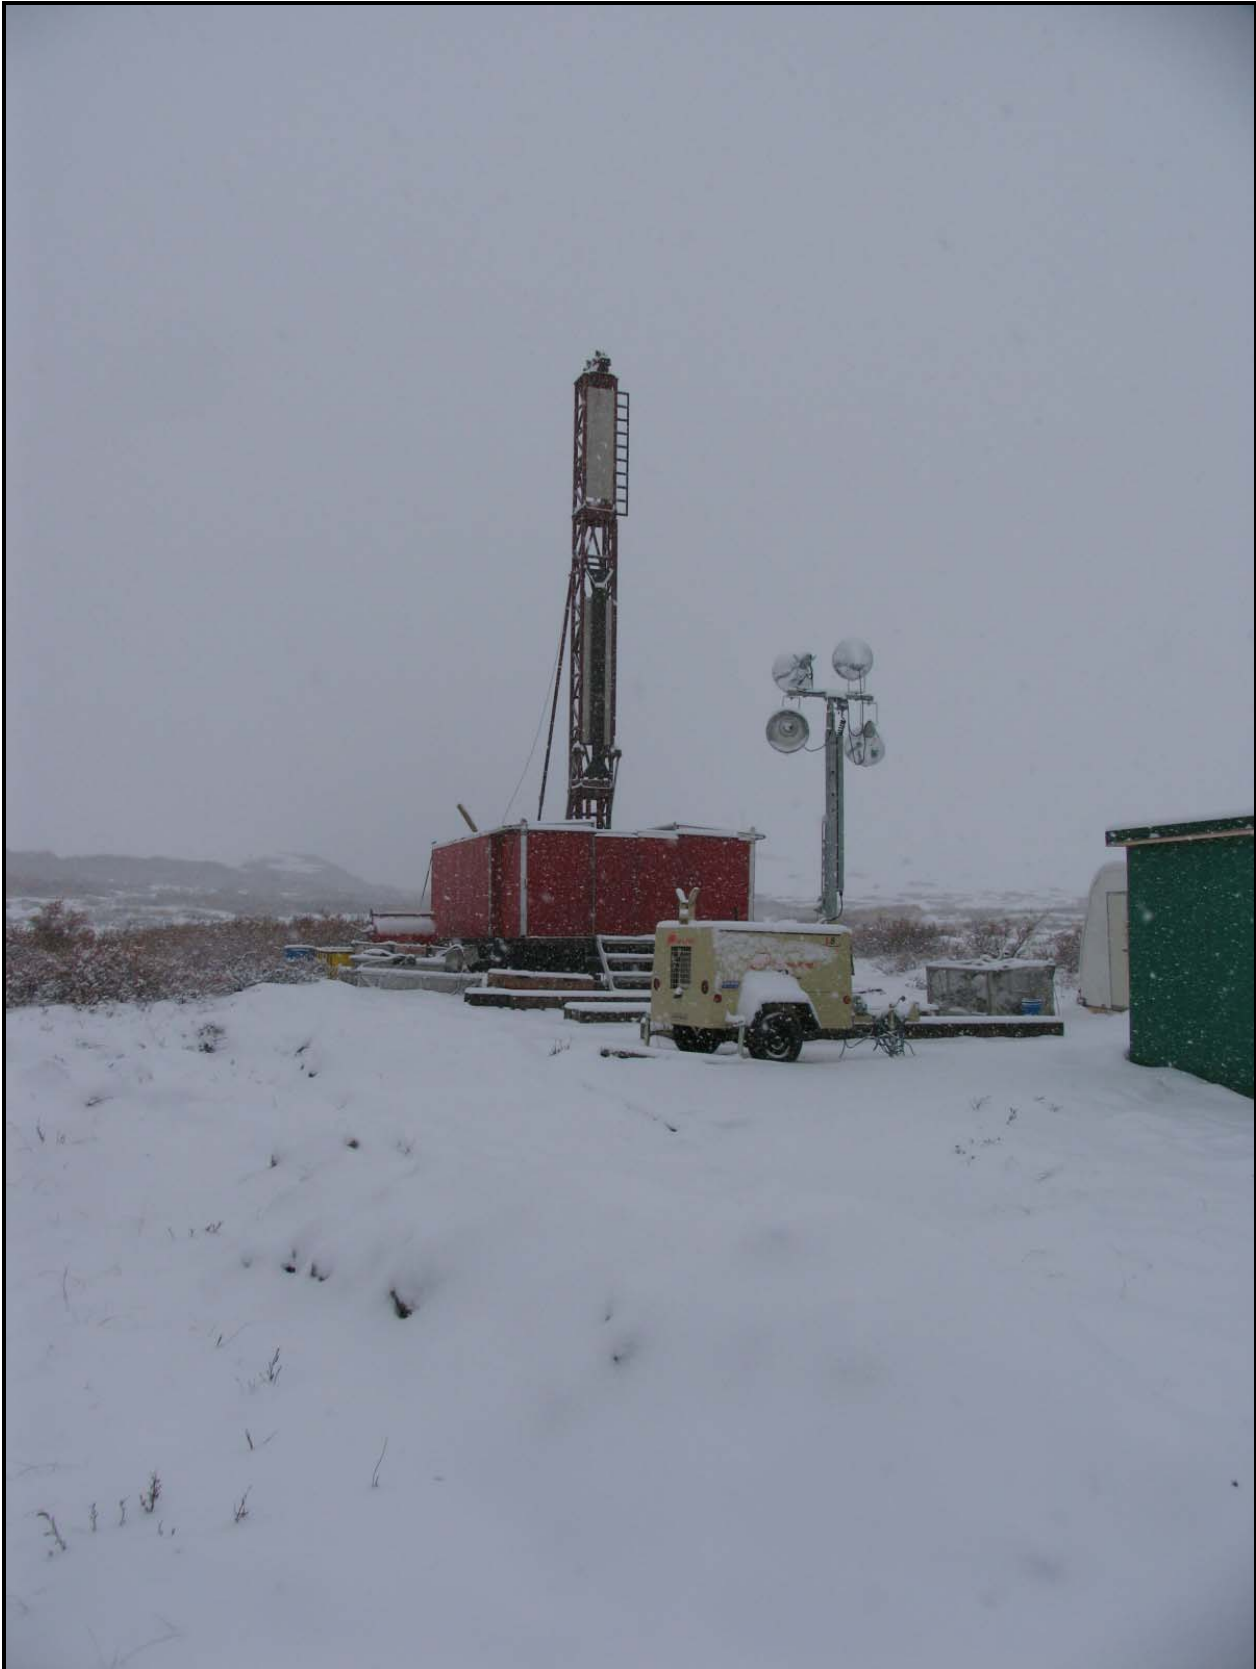
Picture 11 – DDH 7388 (Drill Rig 2)

The seventh site inspected was DDH site 7388 (Drill Rig 2). Quest was the drilling contractor on this hole (see attached map for location). This drill site like the other DDH sites inspected on this trip was in the Pebble East zone. We failed to get a planned depth for this hole, however at the time of our visit the depth was 1,500 feet. The drill was shut down and the plan was to move it to site 8 below. Tundra platforms were in use around the drill site particularly in the areas where there was heavy foot traffic. This drill site was clean and orderly and secondary fuel containment was present for all containerized fuel in case of an accidental spill. Fuel spill clean up kits were present on site. The drill water source for this hole was from a small pond 100 feet away to the southwest. At the time of our visit the drillers were repairing the ‘drill chuck’ so they were temporarily shut down. There was a slight artesian flow of about 4 gallons/minute. Drill water discharge was flowing along a small short trench into a sump which was allowed to overflow into a small depression nearby and spill on to the surrounding tundra. Picture 11 depicts this drill site.

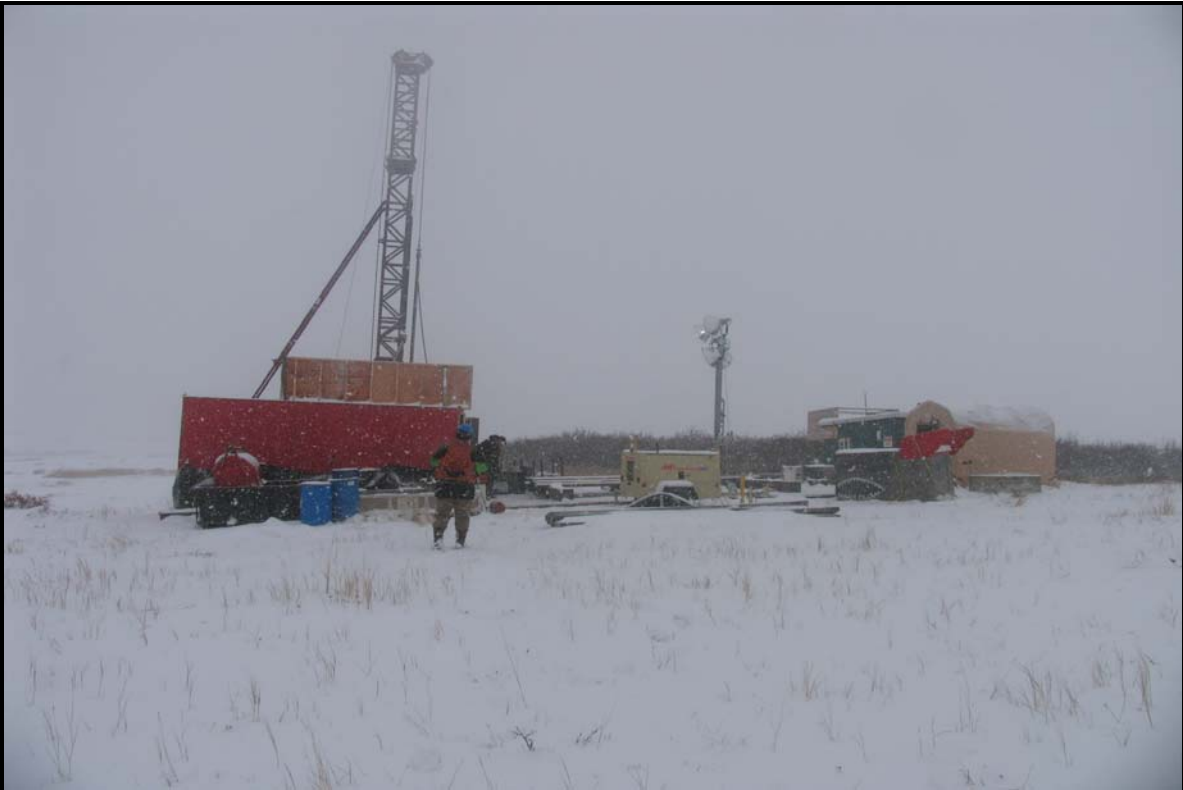
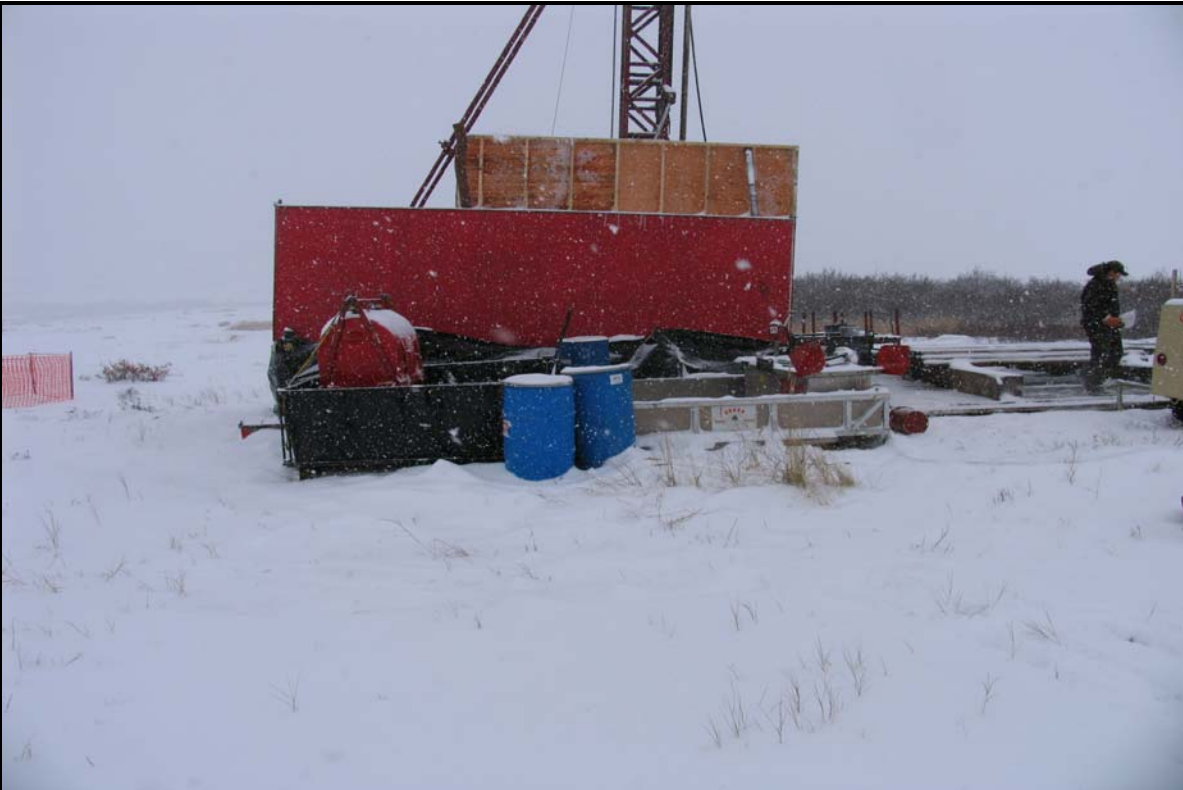
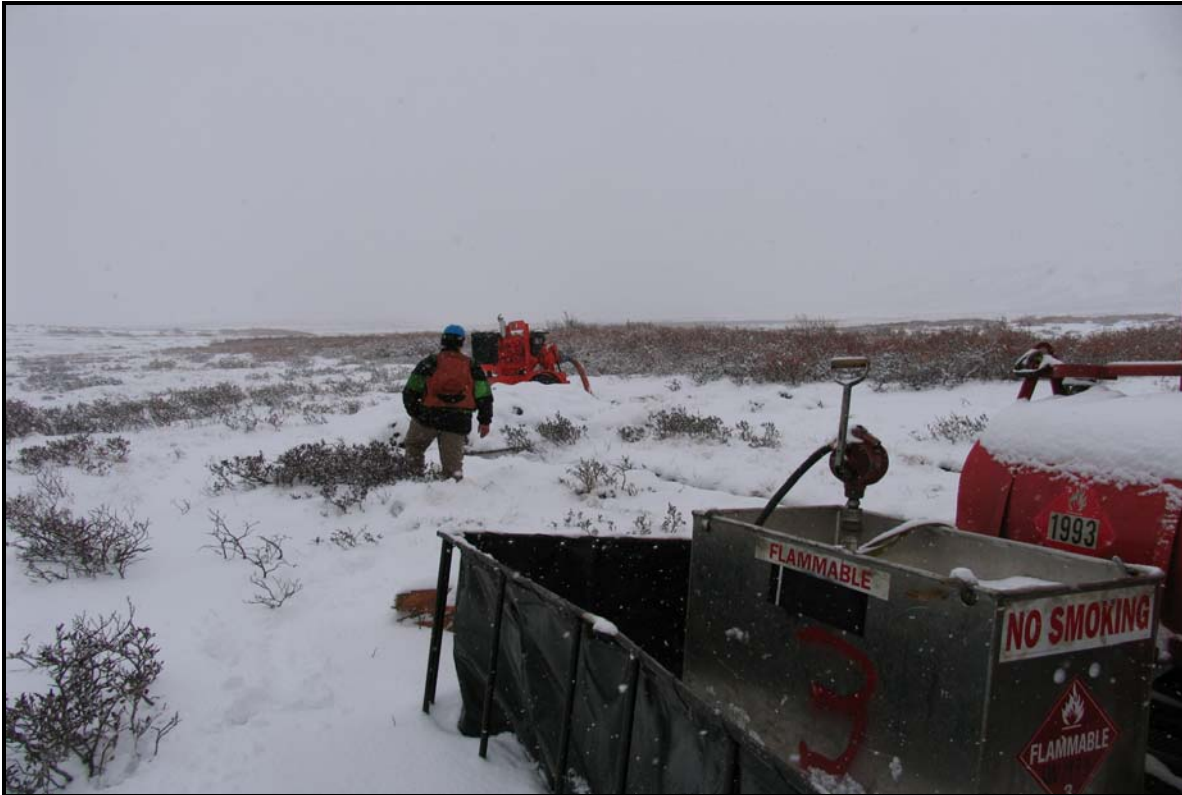
The ninth site inspected was DDH site 7385 (Drill Rig 3). Quest was the drilling contractor on this hole (see attached map for location). This drill site like the other DDH sites inspected on this trip was in the Pebble East zone. The planned depth for this hole was 4,200 feet. At the time of our visit, the rods were stuck at 2,100 feet, so the drillers were cutting them off above this depth so they could drill through to the desired depth. As a result they were pulling rods when we there. Tundra platforms were in use around the drill site particularly in the areas where there was heavy foot traffic. This drill site was clean and orderly and secondary fuel containment was present for all containerized fuel in case of an accidental spill. Fuel spill clean up kits were present on site. Drill water discharge from this site was channeled to a sump behind the drill and then pumped through a hose to a basin area where it was released on the tundra. Pictures 16-18 are of this site.

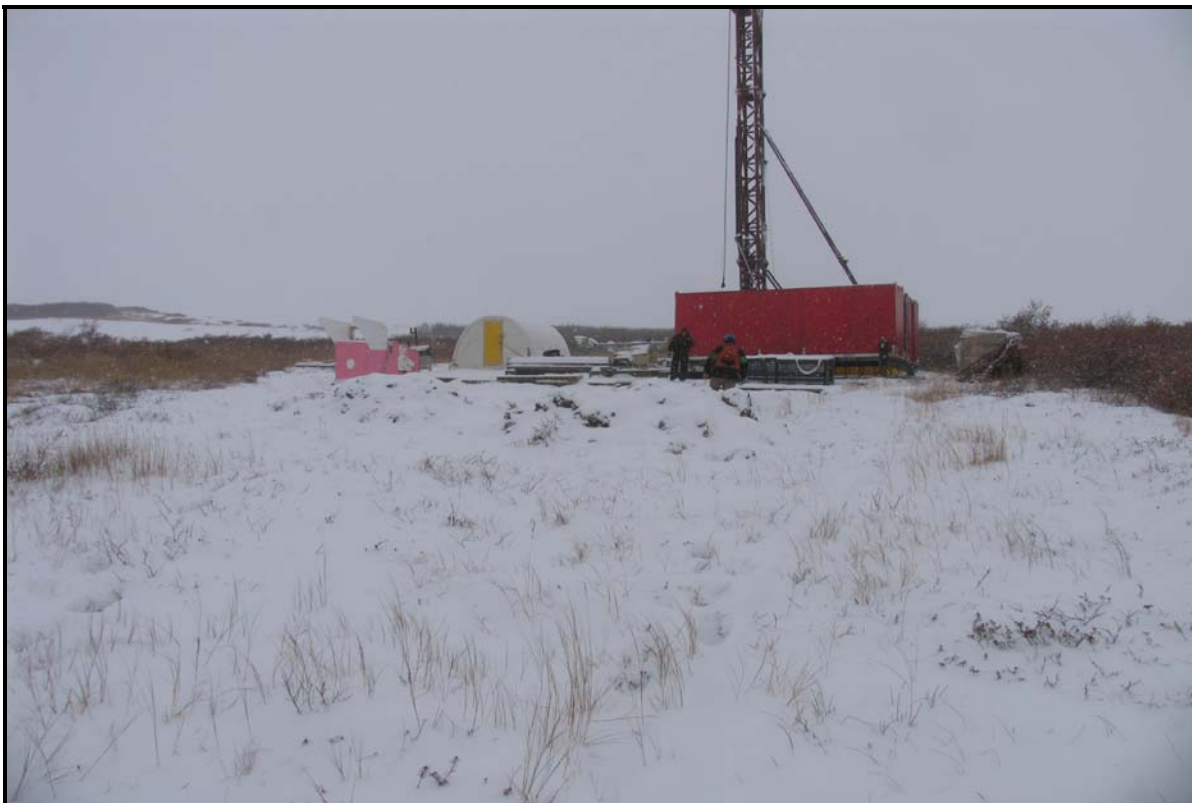
The tenth site inspected was DDH site 4. Quest was the drilling contractor on this hole (see attached map for location). This drill site like the other DDH sites inspected on this trip was in the Pebble East zone. The planned depth for this hole was 4,500 feet. At the time of our visit, they were setting up and had not started drilling yet. Tundra platforms were in place around the drill site, and the site was clean and orderly and secondary fuel containment was present for all containerized fuel in case of an accidental spill. Fuel spill clean up kits were present on site. Pictures 19 and 20 depict this site.
