## Field Inspection Report -Pebble Copper/Gold Exploration Project-

Inspection Date: April 17, 2008

APMA No.: A086118

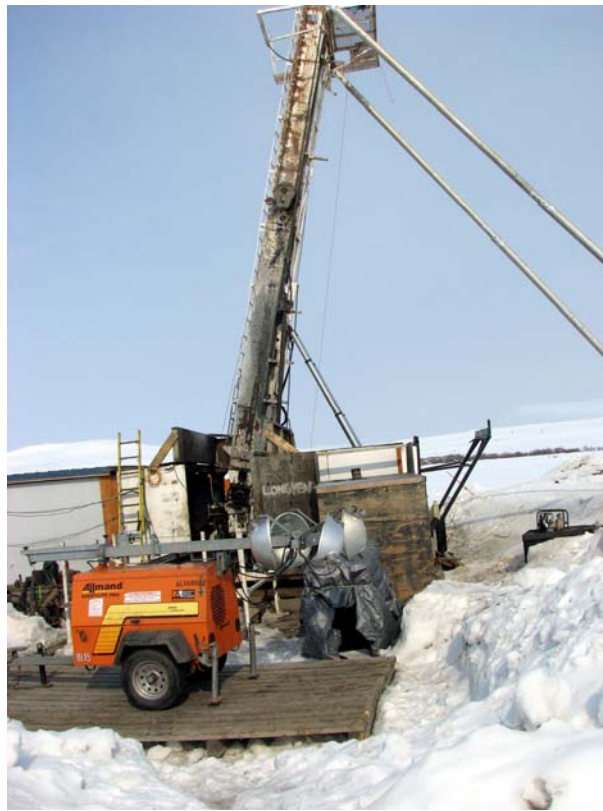
- Distance from water body: **>100 ft.**
- Location of fuel storage: **On pad.**
- Sorbent Pads Present or Not: **Present**
- Tundra Mat: **Yes**
- Pipe off Tundra: **Yes**
- Litter: **None**
- Activity: **Drilling**
- Trash Containment: **Present**
- Sanitary Facilities: **Present**
- Any spills or staining, or 'none' for that matter:  
**None**
- General impression of site: **Clean.**

Figure 1. Rig no. 1 on drill site no.8405. Note tundra pad.

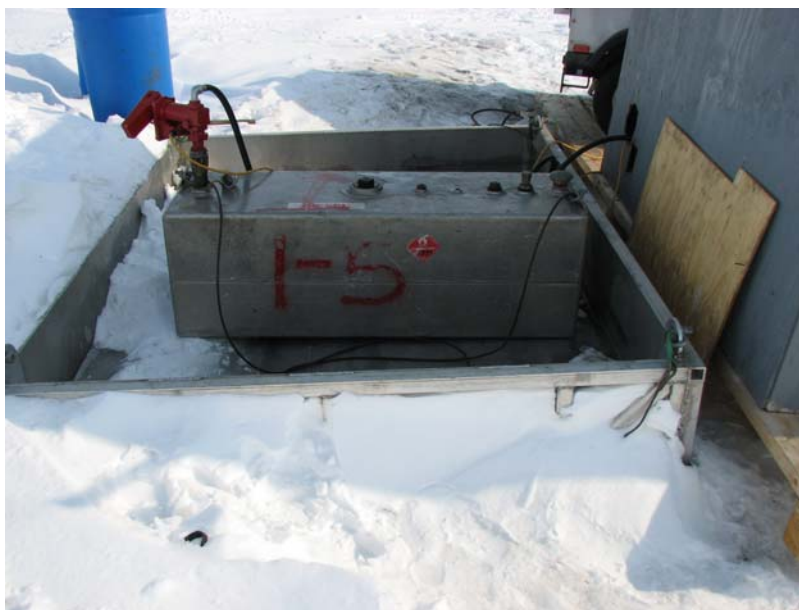
Figure 2. Secondary catch basin for pump fuel tank, rig no. 1 water source.

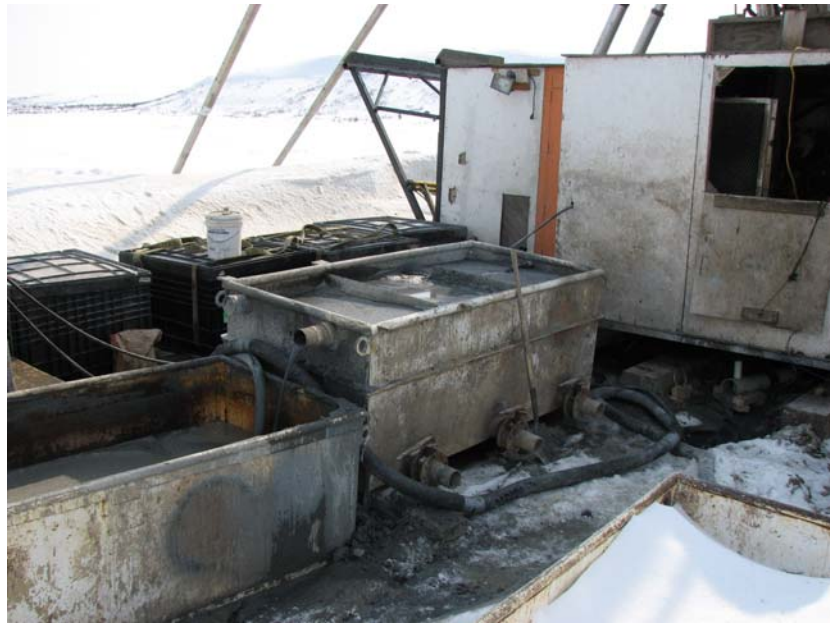
- Drill additives in use (list): **NA**
- Water discharged: **Yes/bypass water discharged to tundra. Water was clear.**
- Drill water recirculation: **Yes. Recirculation system included three tanks used as a settling system for cuttings.**
- Artesian zone encountered: **NA**

Figure 3. Drilling mud recirculation system, rig no. 1.

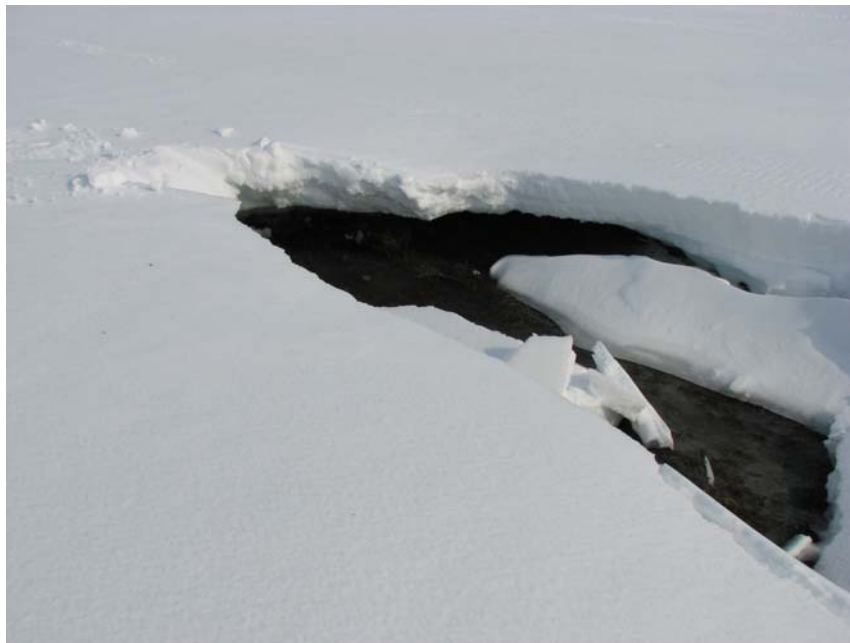
Figure 4. Rig no. 1 bypass water discharged to tundra.

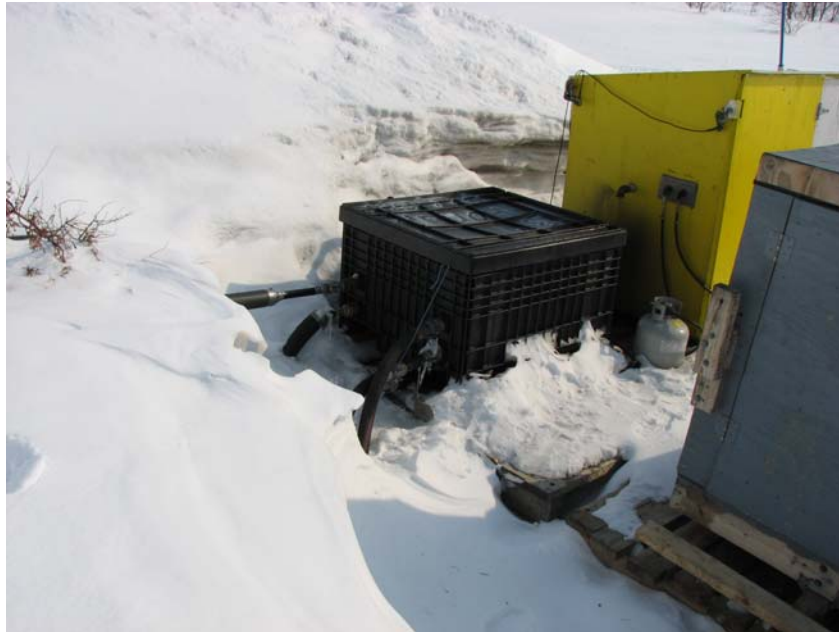
Figure 5. Circulation tank at water source location for rig no. 2
