Field Inspection Report

-Pebble Copper/Gold Exploration Project-

Inspection Date: June 17-18, 2008

APMA No.: A086118

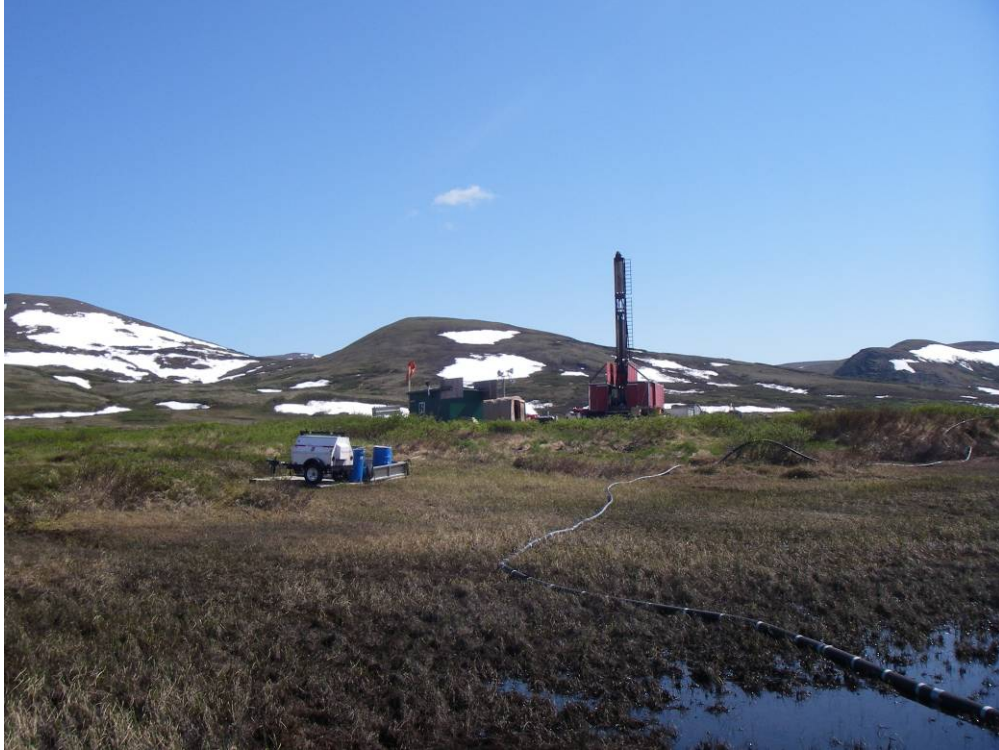
- Condition of Drilling Site**
 - Distance from water body: **> 100 ft.**
 - Location of fuel storage: **On pad (Figure 4).**
 - Sorbent Pads Present or Not: **Yes**
 - Tundra Mat: **Yes**
 - Pipe off Tundra: **Yes**
 - Litter: **None**
 - Activity: **Operational**
 - Trash Containment: **Yes**
 - Sanitary Facilities: **Yes**
 - Any spills or staining, or 'none' for that matter: **None**
 - General impression of site: **Clean, orderly**

Figure 3. Drill rig 8407 (No. 5).

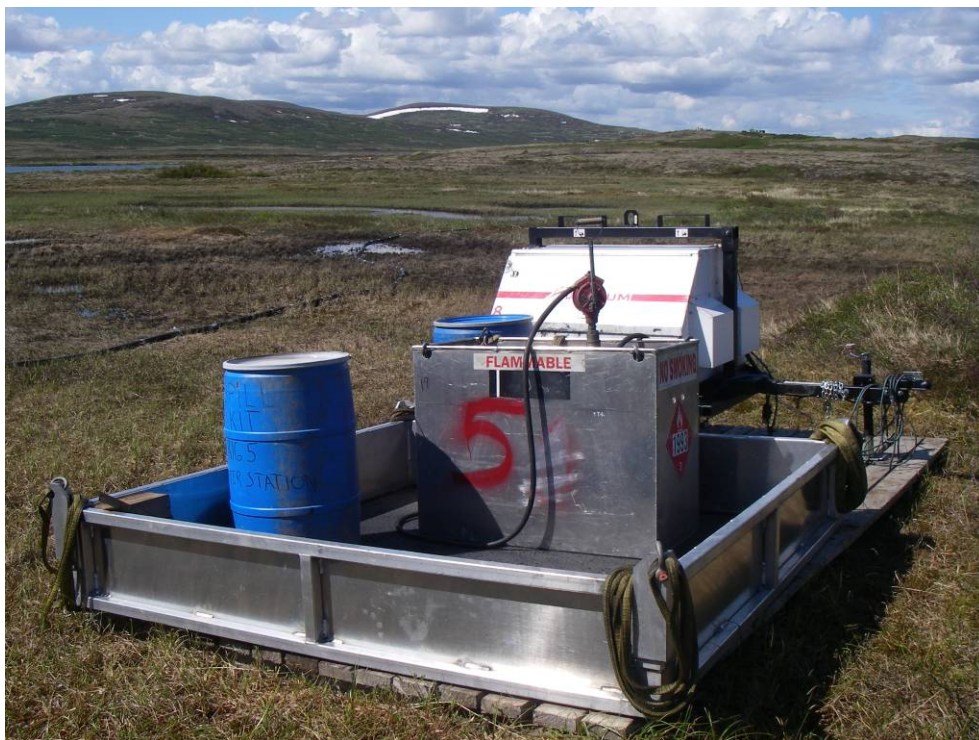
Figure 4. Fuel containment area, drill rig 8407 (No. 5).

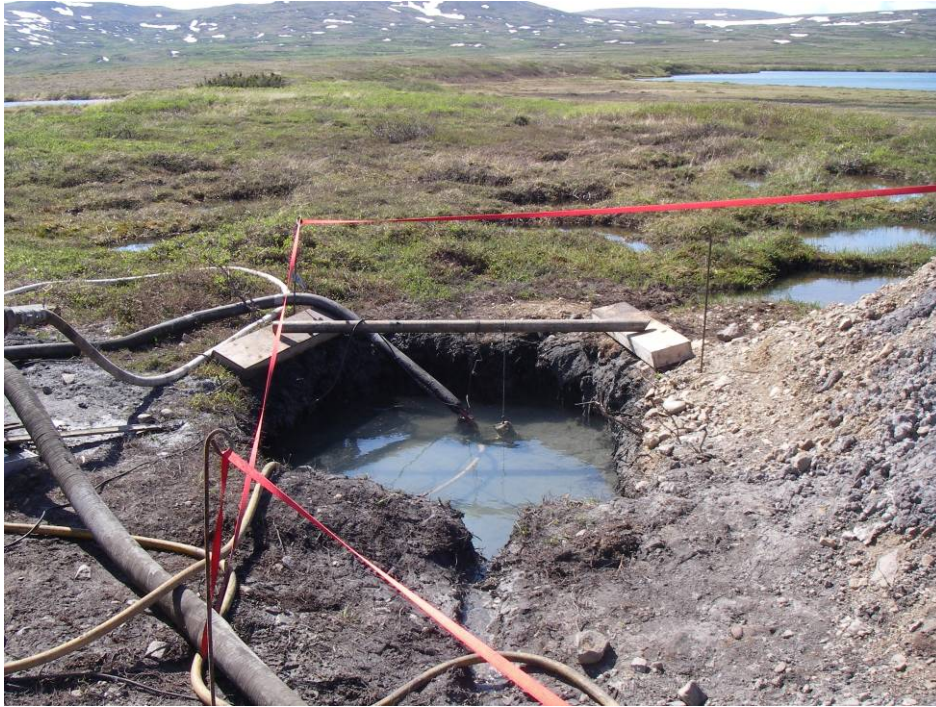
- Sump Pit**
 - Location: **near rig (Figure 5)**
 - Discharge trench: **yes**
 - Dimension pit: **not measured**
 - In use: **yes**

Figure 5. Drill water overflow and recycle sump, drill rig 8407 (No. 5).

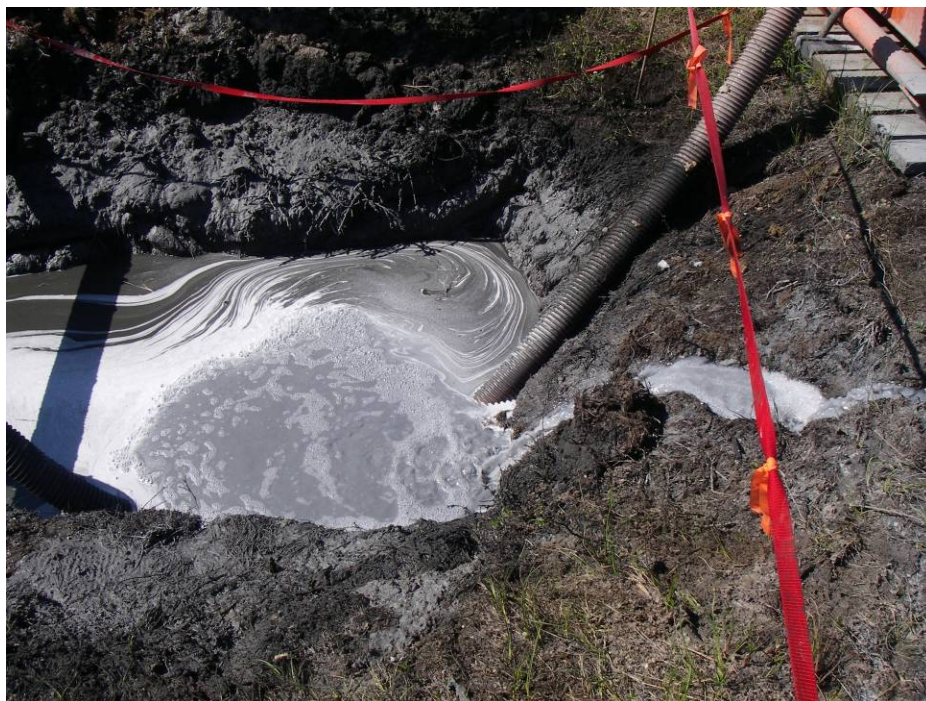
- Water recirculation: **Yes**
 - Artesian zone encountered: **Unknown**
- Sump Pit**
 - Location: **near pad (Figure 6)**
 - Discharge trench: **Yes**
 - Dimension pit: **not measured**

Figure 6. Drill water overflow and recycle sump, drill rig 8412 (No. 6)

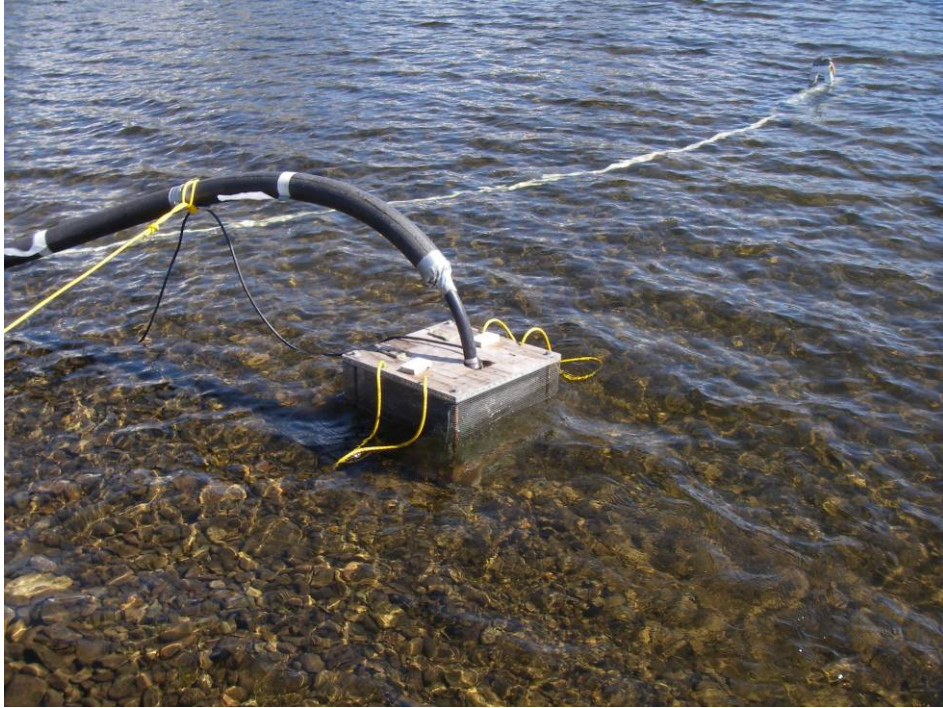
- Location of secondary sump pit: **NA**
 - Hose color: **white**
- Drill Water Supply**
 - Stream/Lake/Pond: **Kettle pond (Figure 7)**
 - Location: **nearby**

Figure 7. Water recycle sump, drill rig number 5.

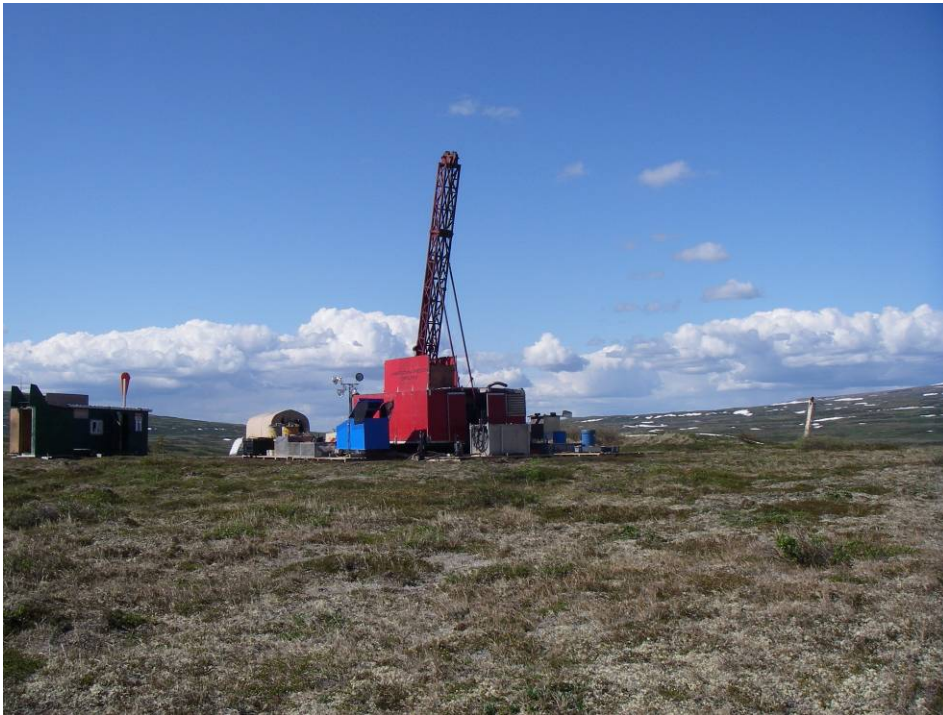
- General impression of water body, i.e. clear,
turbid, tannic colored, etc.? **Good, no
indication of pollution**
 - Intake structure in use: **Yes (Figure 8)**

Figure 8. Drill rig 8415 (No. 2)

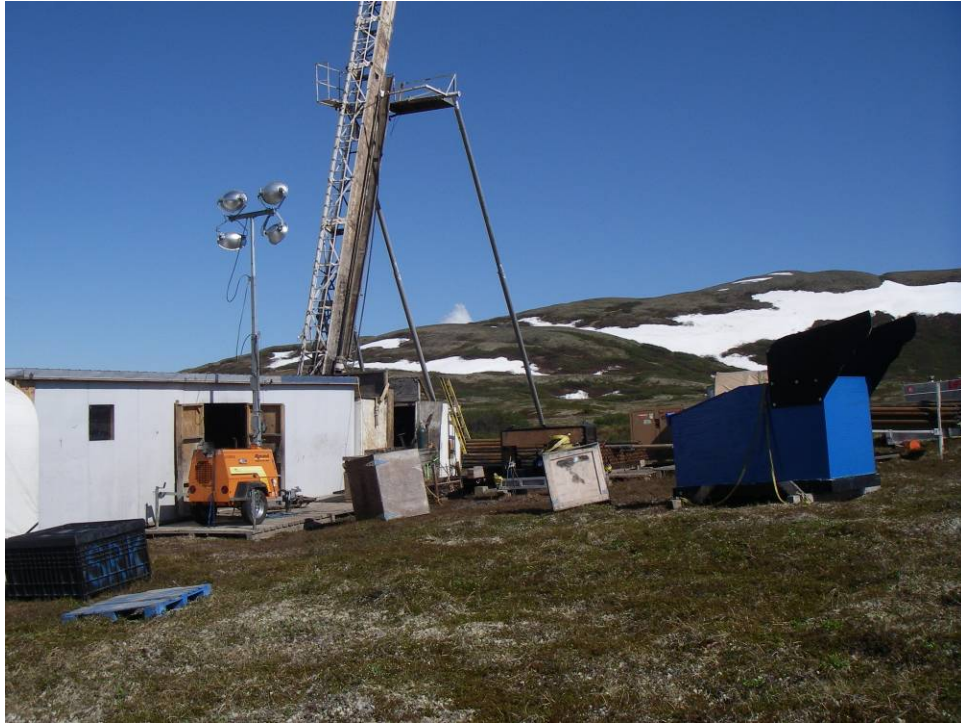
- Condition of Drilling Site**
 - Distance from water body: **> 100 ft.**
 - Location of fuel storage: **On pad.**
 - Sorbent Pads Present or Not: **Yes**
 - Tundra Mat: **Yes**
 - Pipe off Tundra: **Yes**
 - Litter: **None**
 - Spill Indications: **None**
 - Trash Containment: **Yes**
 - Sanitary Facilities: **Yes**
 - Any spills or staining, or 'none' for that matter: **None.**
 - General impression of site: **Clean and orderly.**

Figure 9. Drill rig 8414 (No. 1).

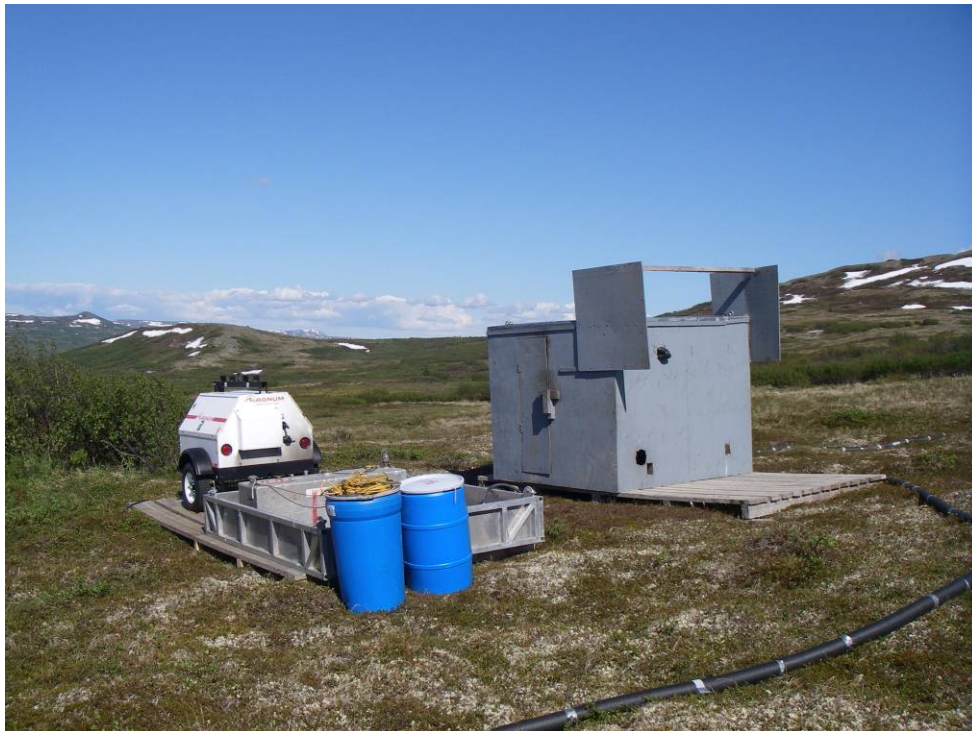
Figure 10. Drill rig 8414 (No. 1) water intake pump, generator, and fuel storage.

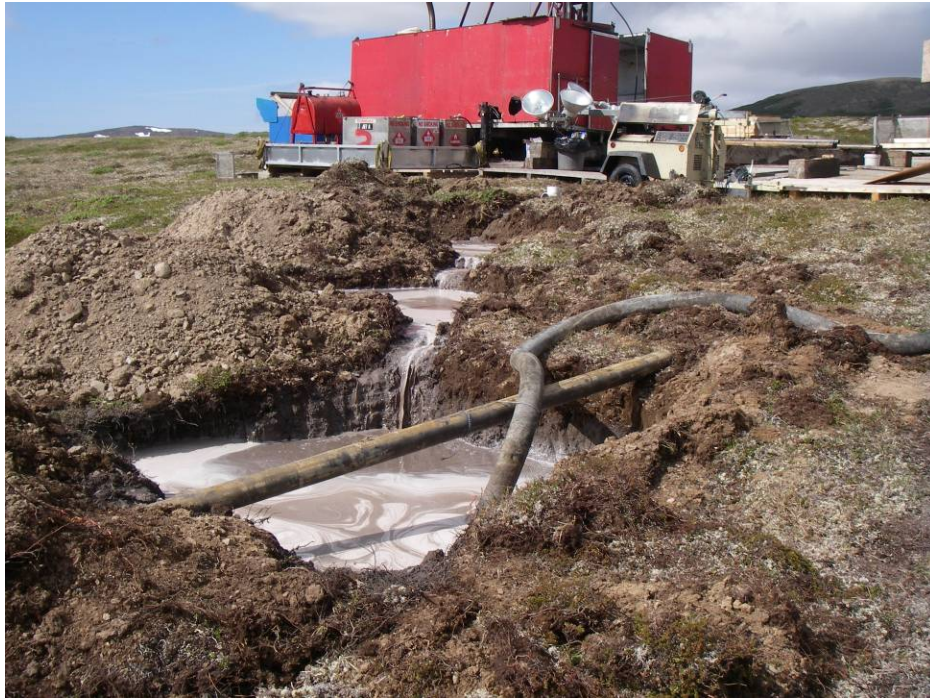
- Sump Pit**
 - Location: **near rig (Figure 11)**
 - Discharge trench: **Yes.**
 - Dimension of pit in use: **Not measured.**
 - Location and extent of discharged material?
Depression away from rig.

Figure 11. Overflow and recycle water sumps, drill rig 8411 (No. 3).

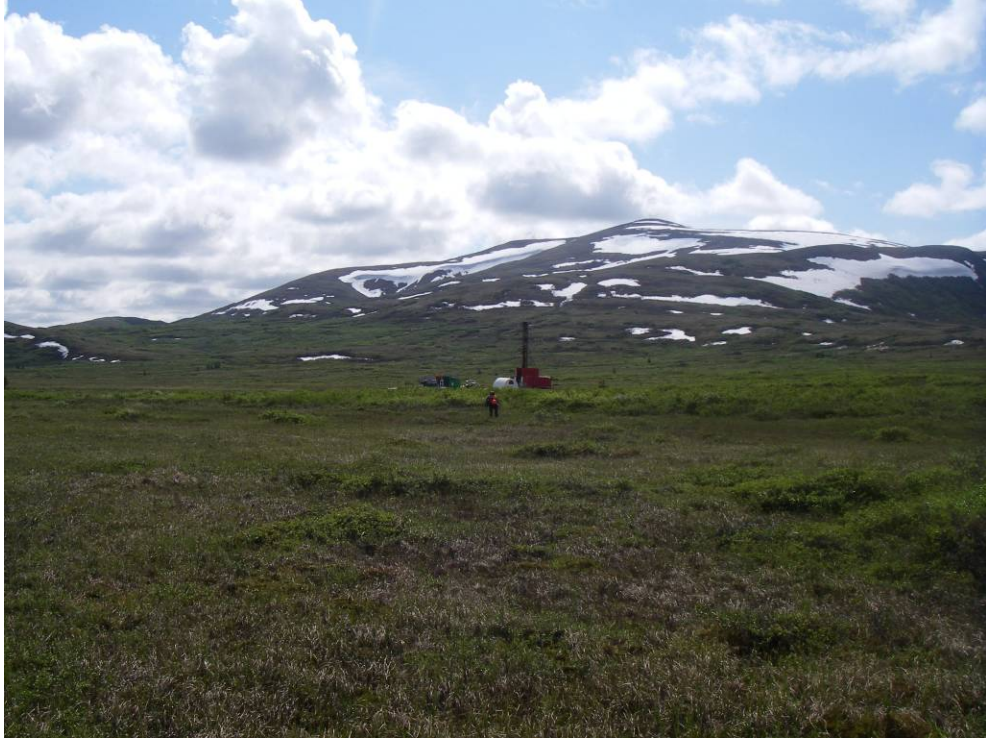
- Condition of Drilling Site**
 - Distance from water body: **> 100 ft.**
 - Location of fuel storage: **On pad.**
 - Sorbent Pads Present or Not: **Yes**

Figure 13. Drill rig 8413 (No. 4).

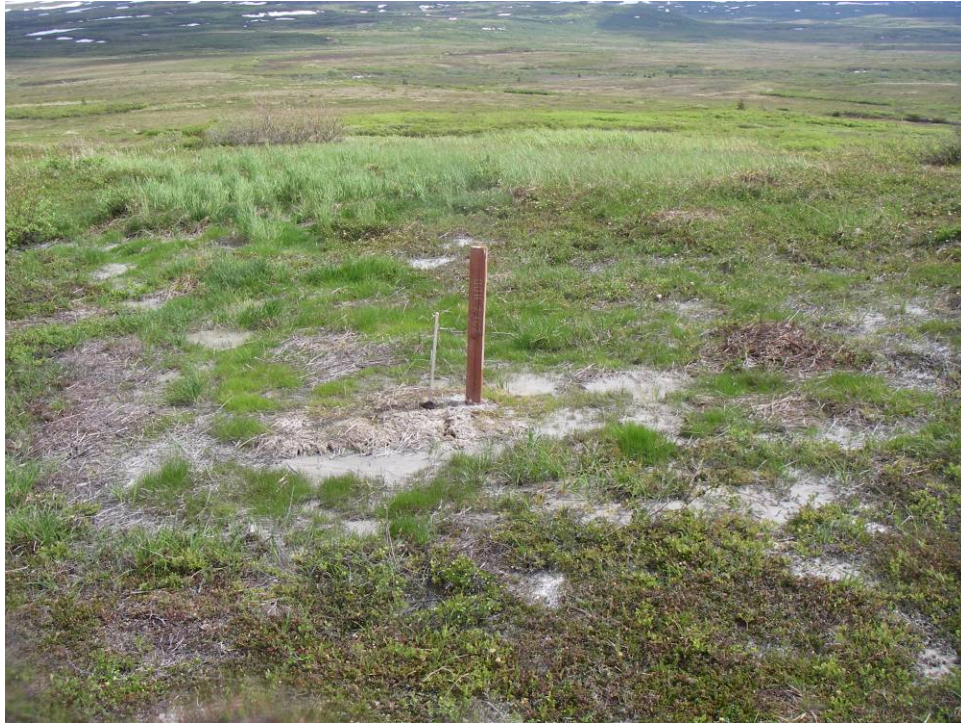
- Plugged: **No**
- Cemented: **Unknown.**
- Standing pipe: **No. Wooden stake marked the location.**
- Sump pit filled in: **Yes**
- Water discharge trench filled in: **Yes.**
- Site re-vegetated: **No.**
- Artesian water present: **No.**
- Any spills or staining, or 'none': **None observed.**

Figure 15. Reclamation site 7362.

Actions Needed: Follow-up on reclaimed sites 7362 and 7389 to ensure the drill holes are cemented and capped, and the reclamation process is completed. Other reclamation sites should be viewed during future visits.

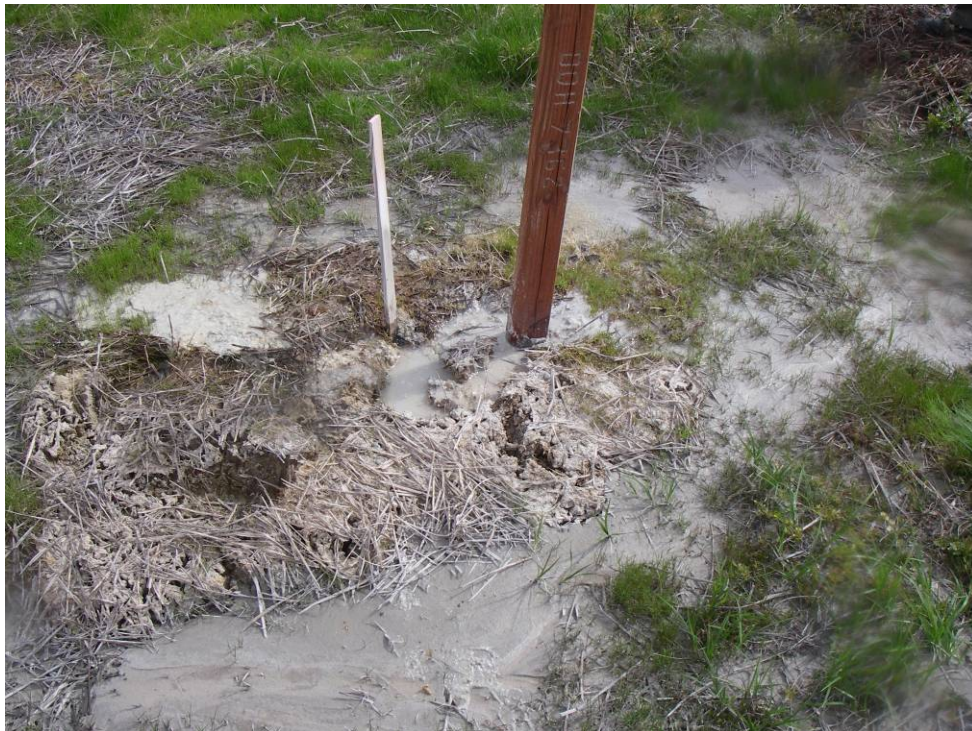
Comments: **Reclamation work had been done at this site. Water appeared to be discharging from the hole (Figure 16). Pebble staff informed us reclamation of this site was ongoing. Future site visits need to follow up and ensure the hole is cemented and plugged.**

Figure 16. Water discharge from drill hole, reclamation site 7362.

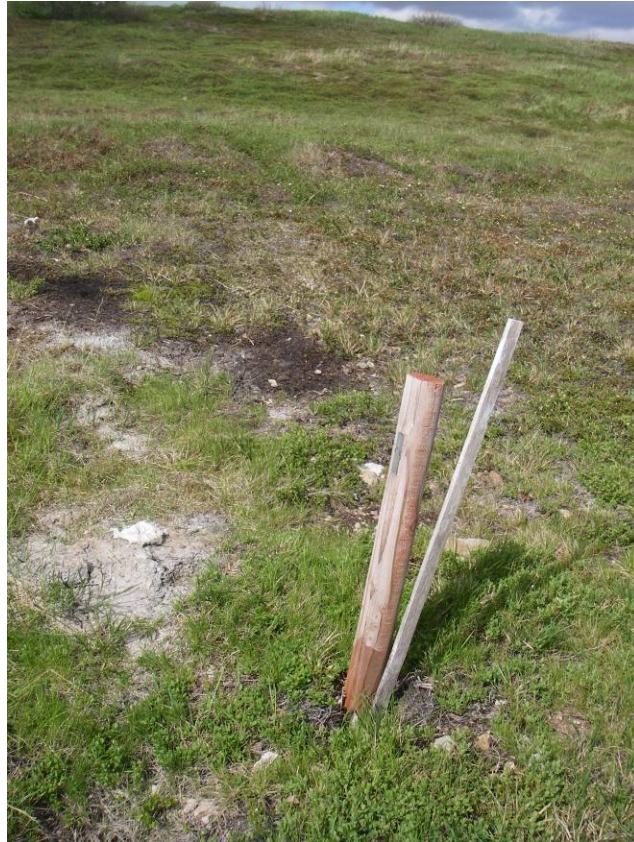
- Plugged: **Yes.**
- Cemented: **Unknown.**
- Standing pipe: **No. Wooden stake marked the location.**
- Sump pit filled in: **Not used. Drilling water discharge was on tundra (prior to change in operation that required sump pit use).**
- Water discharge trench filled in: **Yes.**
- Site re-vegetated: **Yes**
- Artesian water present: **No.**
- Any spills or staining, or 'none': **None observed.**

Comments: **Footprint still visible with bare patches present. Pebble staff informed us site reclamation was ongoing.**

Figure 17. Reclamation site 5331.

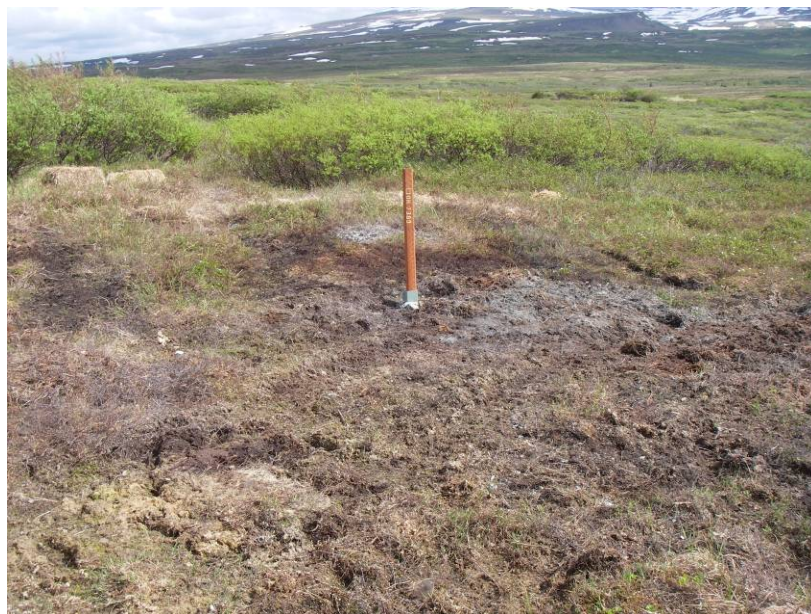
- Plugged: **No**
- Cemented: **NA.**
- Standing pipe: **No. Wooden stake marked the location.**
- Sump pit filled in: **Yes**
- Water discharge trench filled in: **Yes.**
- Site re-vegetated: **No.**
- Artesian water present: **No.**
- Any spills or staining, or 'none': **None observed.**

Comments: **Reclamation work had been done at this site. Water appeared to be discharging from the hole. Pebble staff informed us reclamation of this site was ongoing. Future site visits need to follow up and ensure the hole is cemented and plugged.**

Figure 18. Reclamation site 7389
