Field Monitoring Report -- Pebble Copper/Gold Exploration Project --

Personnel: Rick Fredericksen (DNR/DMLW)	Inspection Date: 23 July 2008
Jim Vohden (DNR/DMLW)	Site Contact: Gernot Wober
Travis Gingerich (DNR/DMLW)	APMA #: A086118
■ Inspection Type: ○ Complete: Drill rigs 1, 2, 3, & 4 were visited, several abandoned drill sites, one piezometer installation, and the Westbay installation ○ Partial: ○ Follow-up: ○ Response to Public Complaint:	■ Wildlife Observed: ○ Bear: ○ Caribou: ○ Moose: ○ Waterfowl: ○ Fish: ○ Other: marmot, red fox, robin
■ Weather Conditions: ○ Temperature: 50-60 degrees F ○ Wind: light to moderate ○ Precipitation: some light drizzle ○ Visibility: 2-10 miles ○ Sky Conditions: cloudy, some sun ○ Ground Conditions: clear, damp	■ Water level at Frying Pan Lake: ○ Observed inflow: not observed ○ Observed outflow: not observed
<p>Comments: Overall the drill rigs were clean and orderly. Fuel spill containment measures were in place. Containment basins generally clean and dry. All drilling operations appeared to be in compliance with associated water use and withdrawal permits. Inspected long term geochemical barrel tests in place near medical camp, as well as piezom

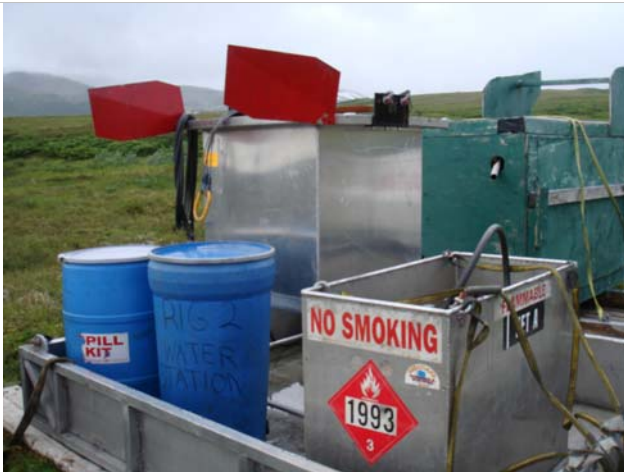
Figure 3. Fuel storage at drill rig 2.

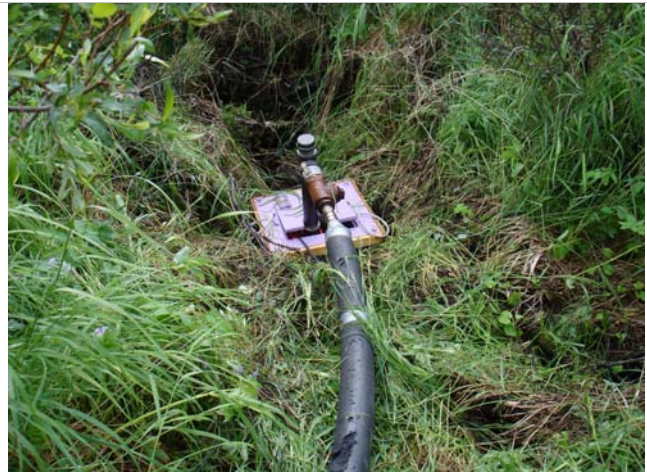
Figure 4. Water intake for drill rig 2.

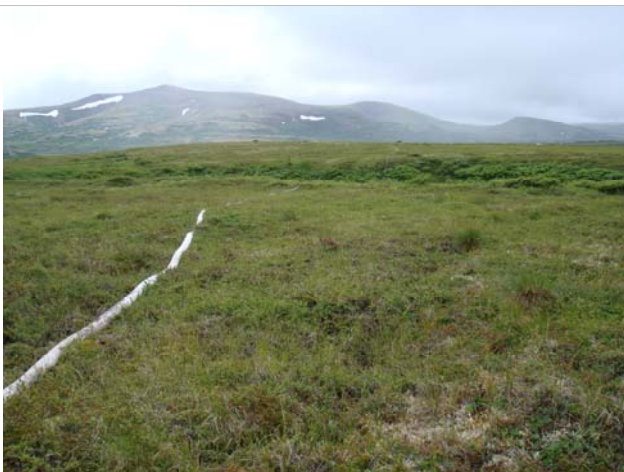
Figure 5. Drill discharge line from drill rig 2.
