Field Monitoring Report -- Pebble Copper/Gold Exploration Project --

Personnel: Steve McGroarty (ADNR)	Inspection Date: August 27, 2008
David Johnson (ADEC)	Site Contact: Lena Brommeland
	APMA #: A086118
<input checked="" type="checkbox"/> Inspection Type: Routine - Partial	<input checked="" type="checkbox"/> Wildlife Observed:
<input type="checkbox"/> Complete:	<input type="checkbox"/> Bear: None
<input type="checkbox"/> Partial:	<input type="checkbox"/> Caribou: None
<input type="checkbox"/> Follow-up:	<input type="checkbox"/> Moose: None
<input type="checkbox"/> Response to Public Complaint:	<input type="checkbox"/> Waterfowl: None
	<input type="checkbox"/> Fish: None
<input checked="" type="checkbox"/> Weather Conditions:	<input type="checkbox"/> Other: One ground squirrel & one ptarmigan
<input type="checkbox"/> Temperature: 50 f	
<input type="checkbox"/> Wind: Light	<input checked="" type="checkbox"/> Water level at Frying Pan Lake:
<input type="checkbox"/> Precipitation: N/A	<input type="checkbox"/> Observed inflow: not observed

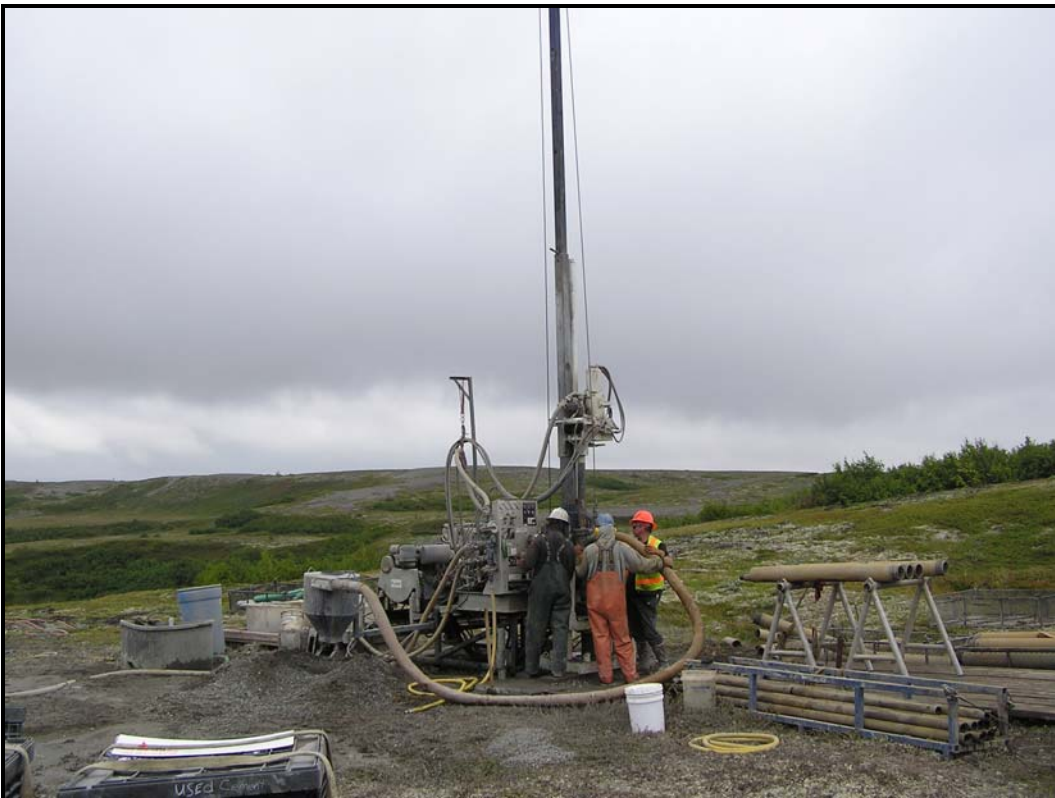
Figure 2: Drill cuttings from geotechnical hole.

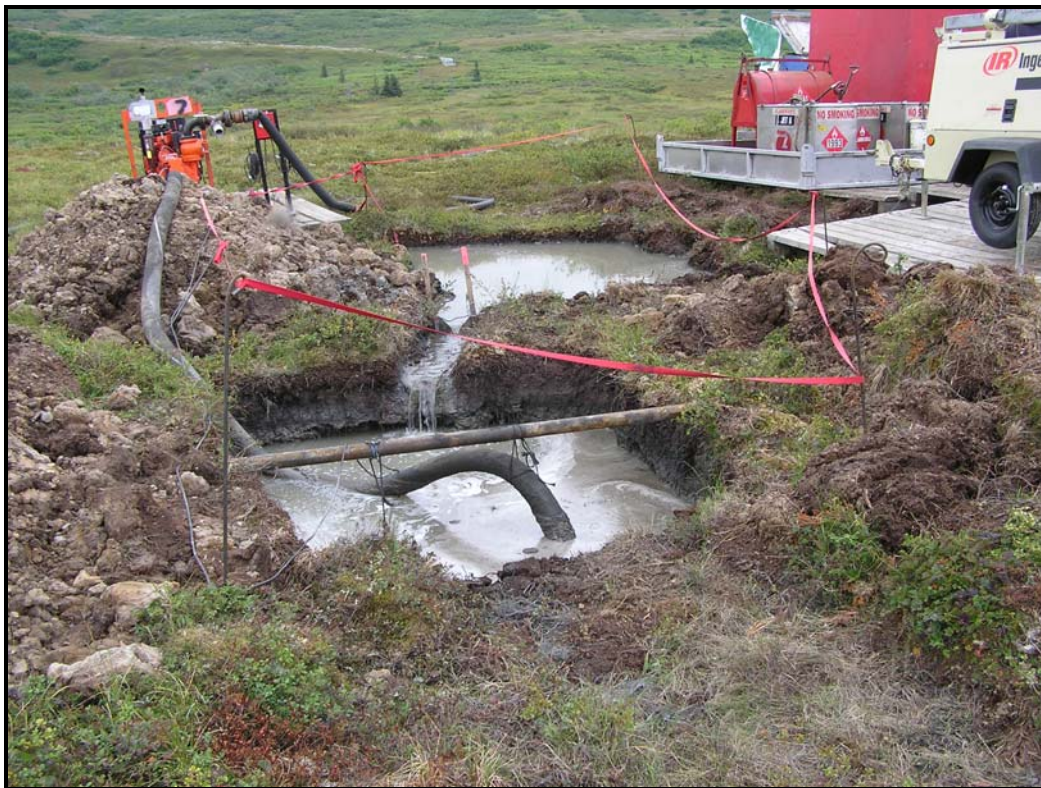
Figure 6: Primary and secondary sumps at Drill Rig # 3.

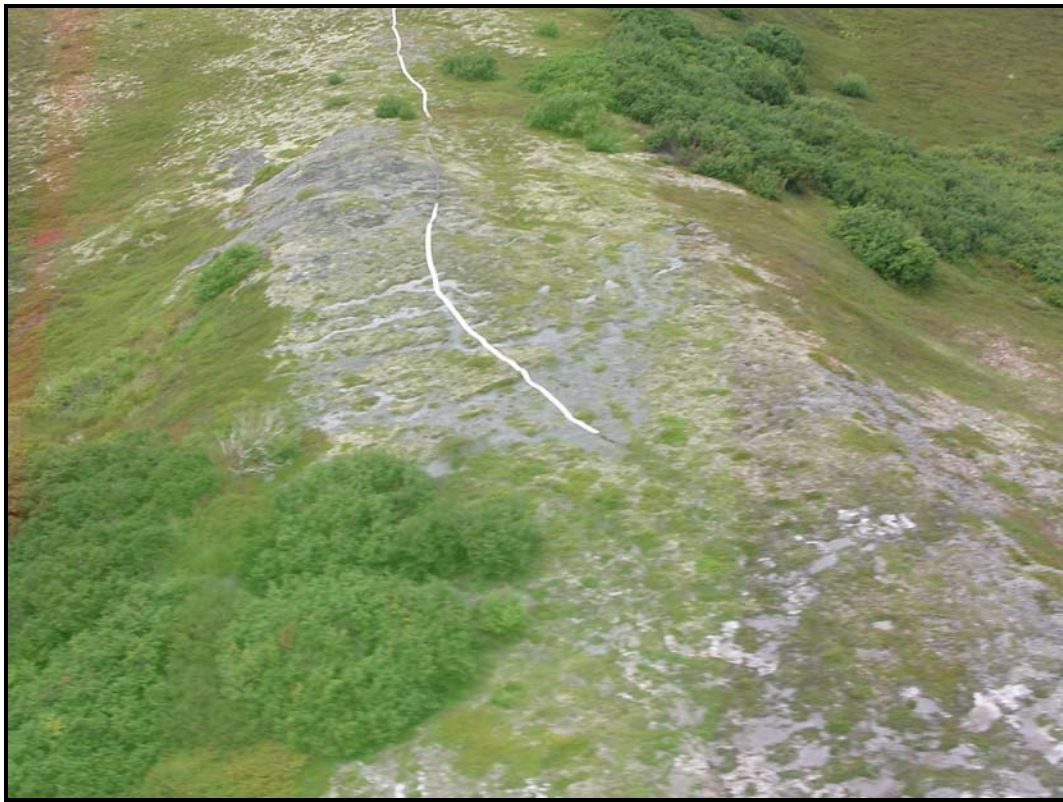
Figure 10: Discharge location for Drill Rig # 2.

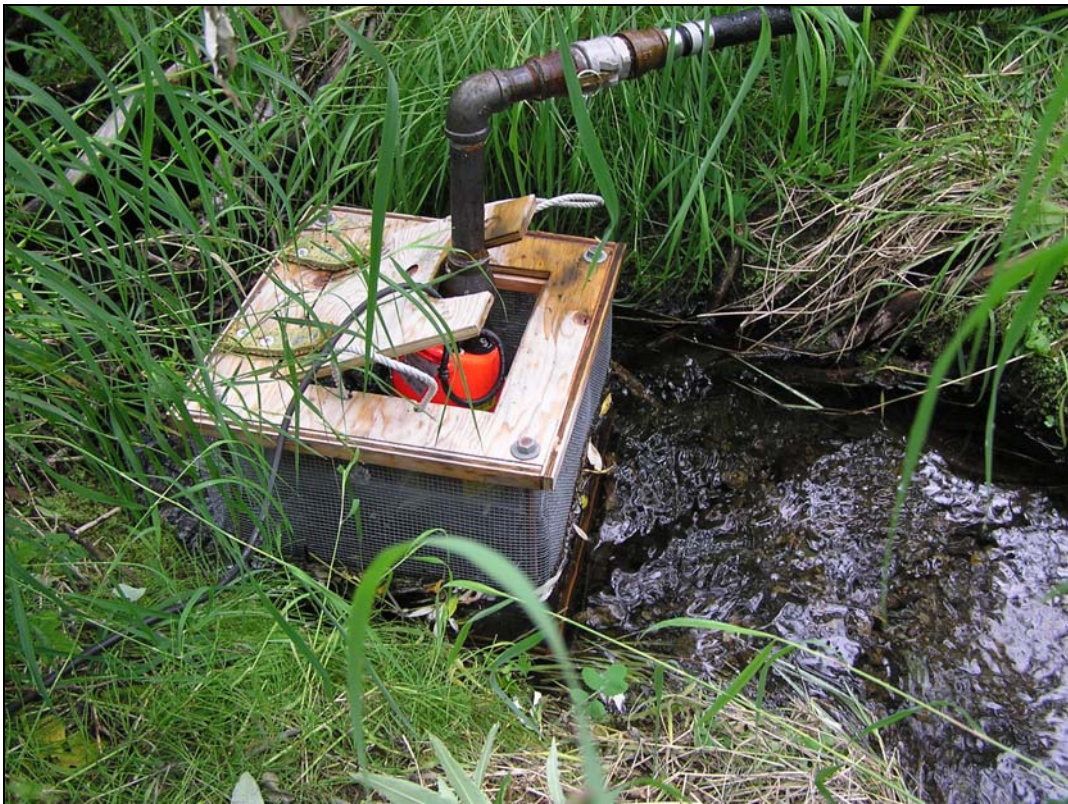
Figure 14: Screened intake for Drill Rig # 2.

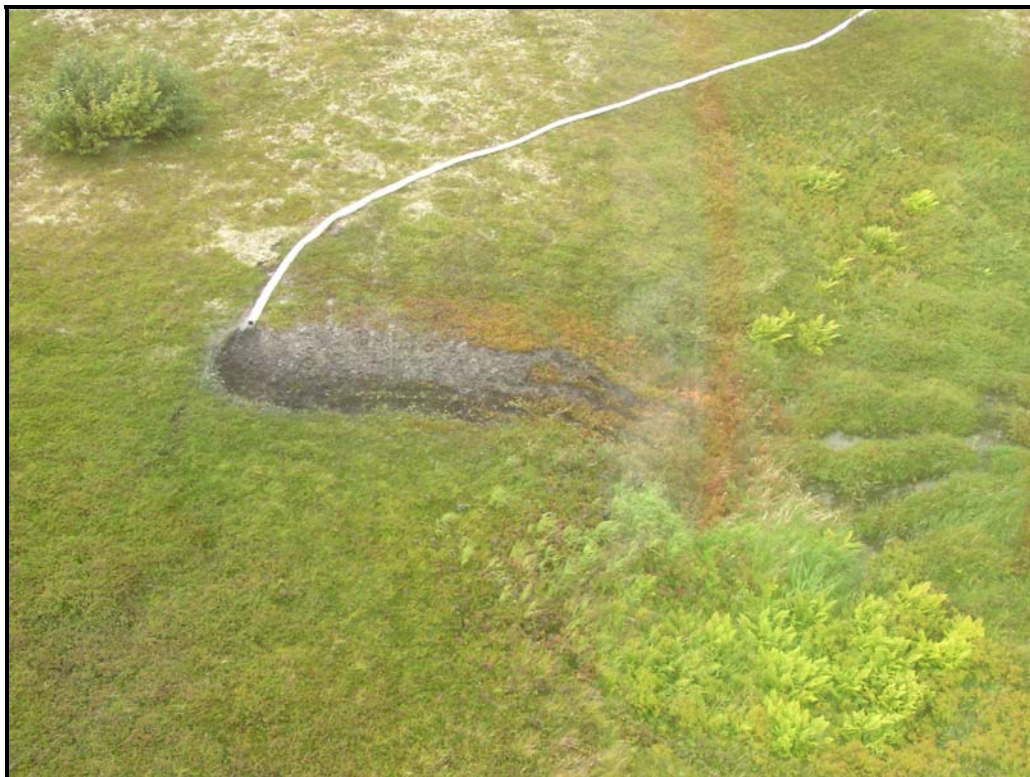
Figure 18: Discharge point for Drill Rig # 5.

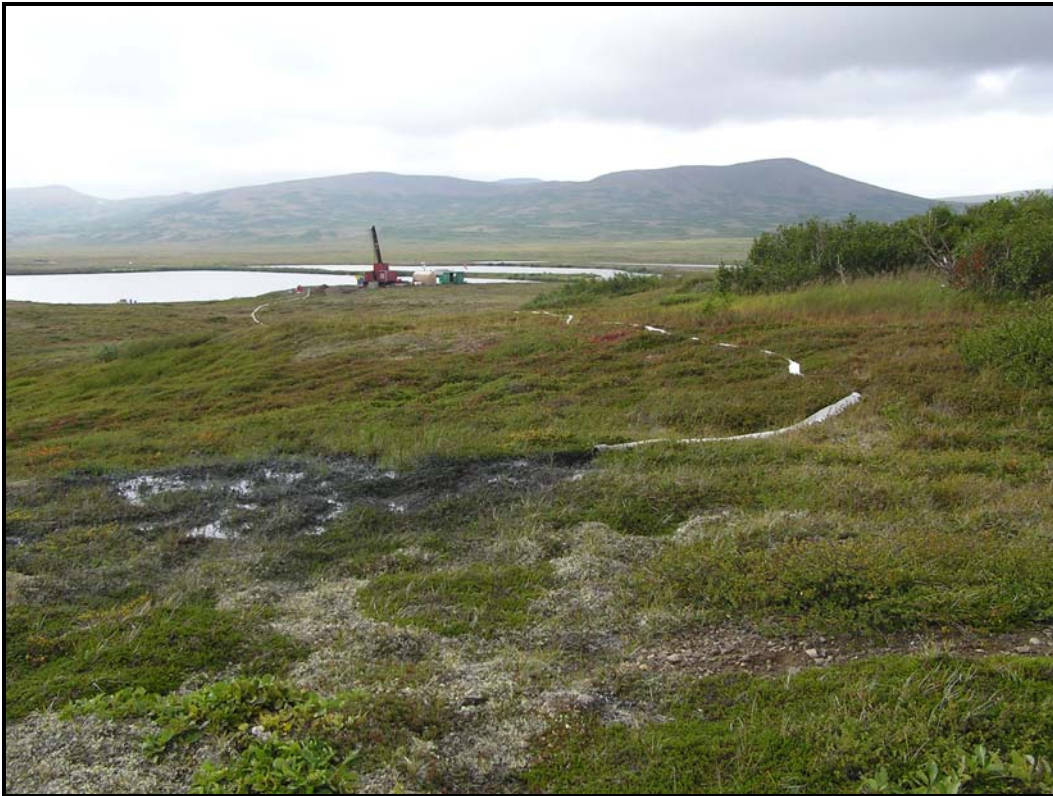
Figure 20: Discharge point with Drill Rig # 6 in background.

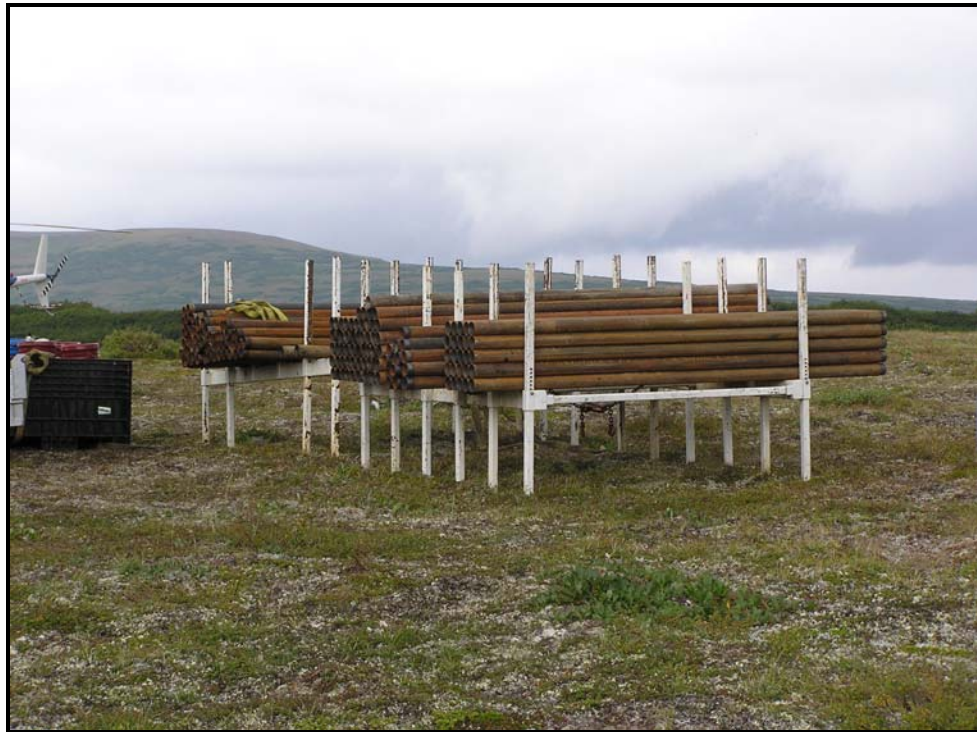
Figure 22: Sections of drill pipe on racks.

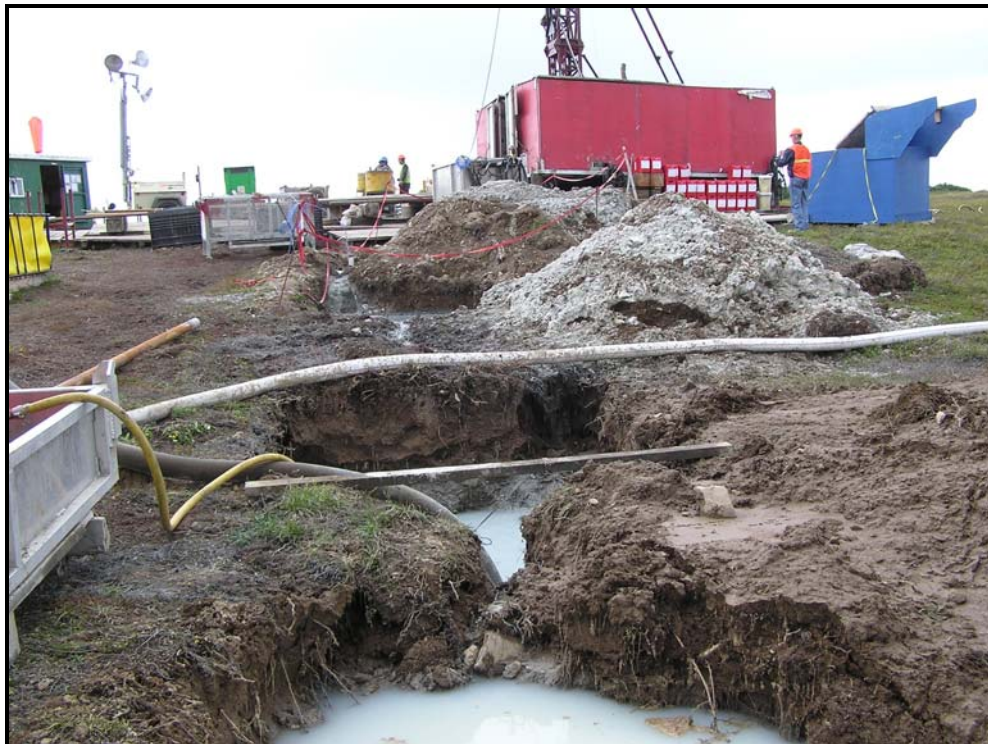
Figure 26: Sumps for Drill Rig # 4.

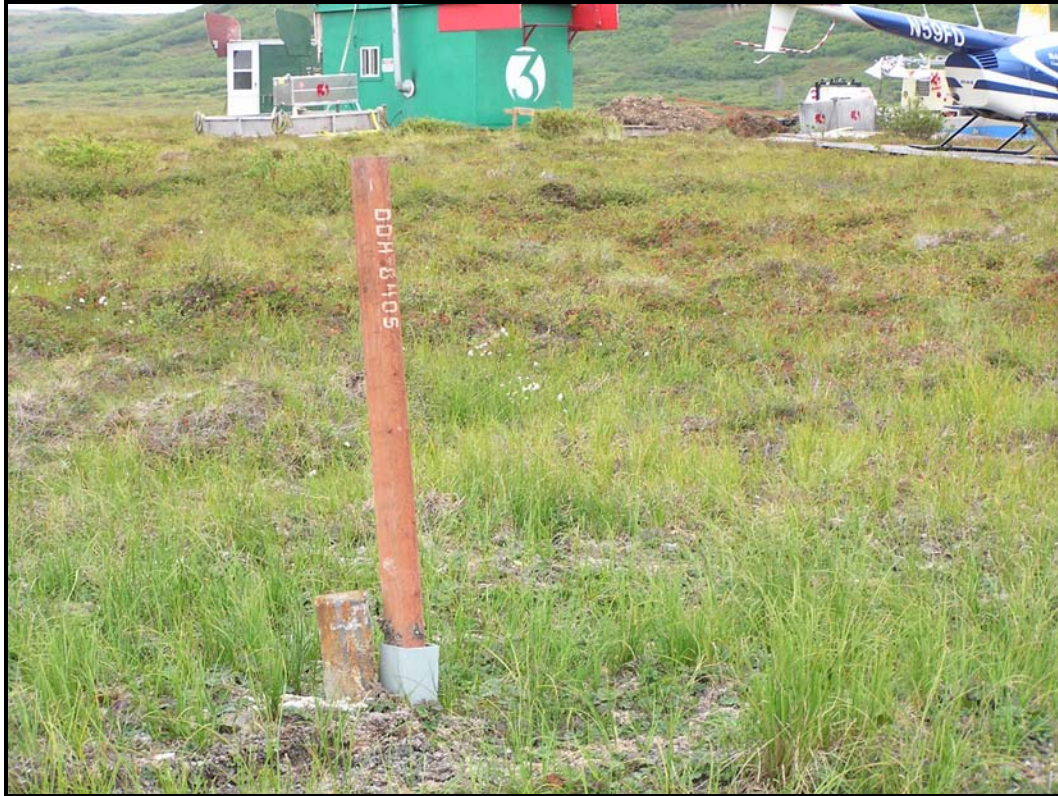
DDH-8405 site was observed near Drill Rig # 3. The site was free of litter and debris. The disturbed area had straw mulch. The drillhole casing extended above the ground surface approximately one foot. It was not possible to determine whether or not this drill hole had been plugged.

Figure 29: Reclaimed site - DDH # 8405.

Figure 30: Reclaimed site of DDH # 8405.

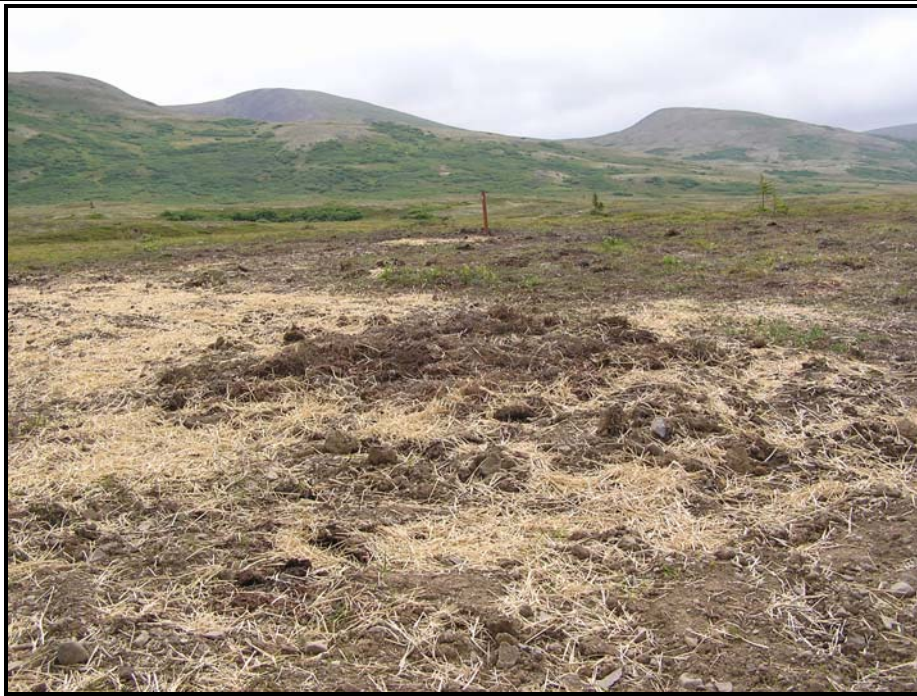
DDH-8415 site was observed near Drill Rig # 5. The site was free of litter and debris. The disturbed area had straw mulch. The drillhole casing extended above the ground surface approximately one foot. It was not possible to determine whether or not this drill hole had been plugged.

Figure 32: Reclaimed drill site for hole No. 8415.

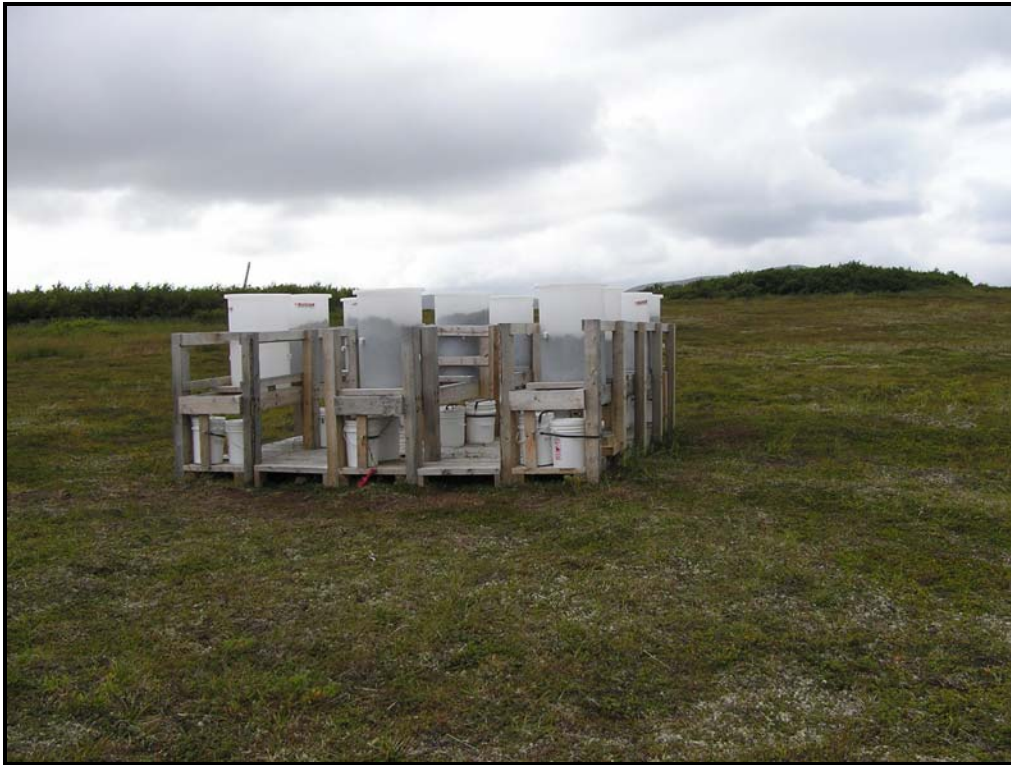
Figure 34: Geochemical barrel testing station.

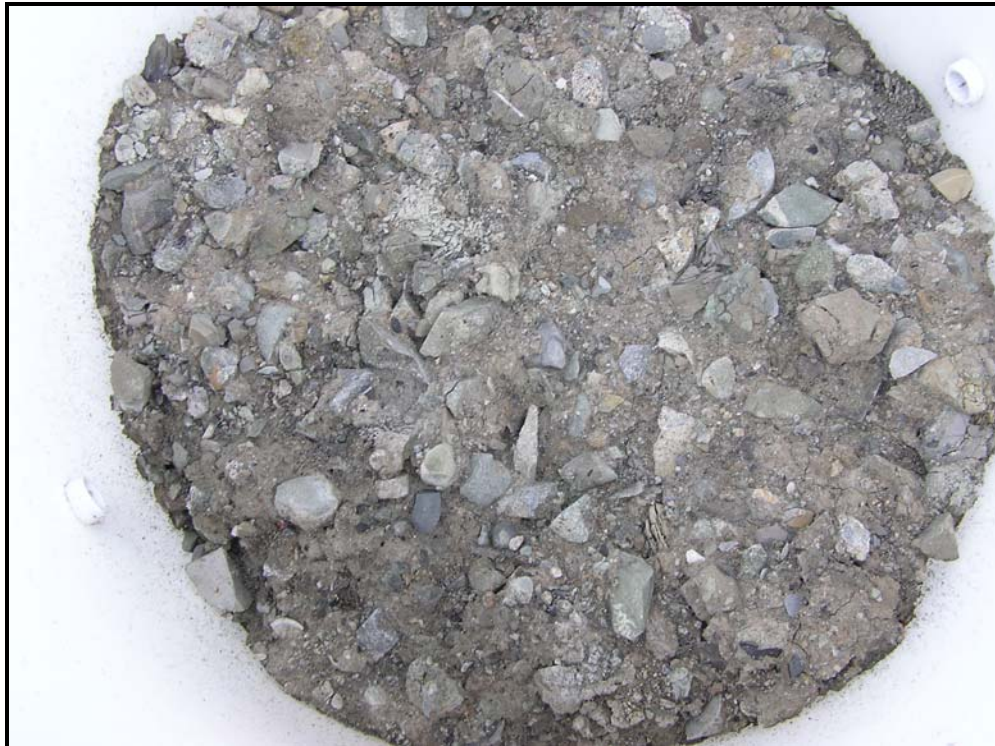
Figure 35: Material in geochemical barrel test.

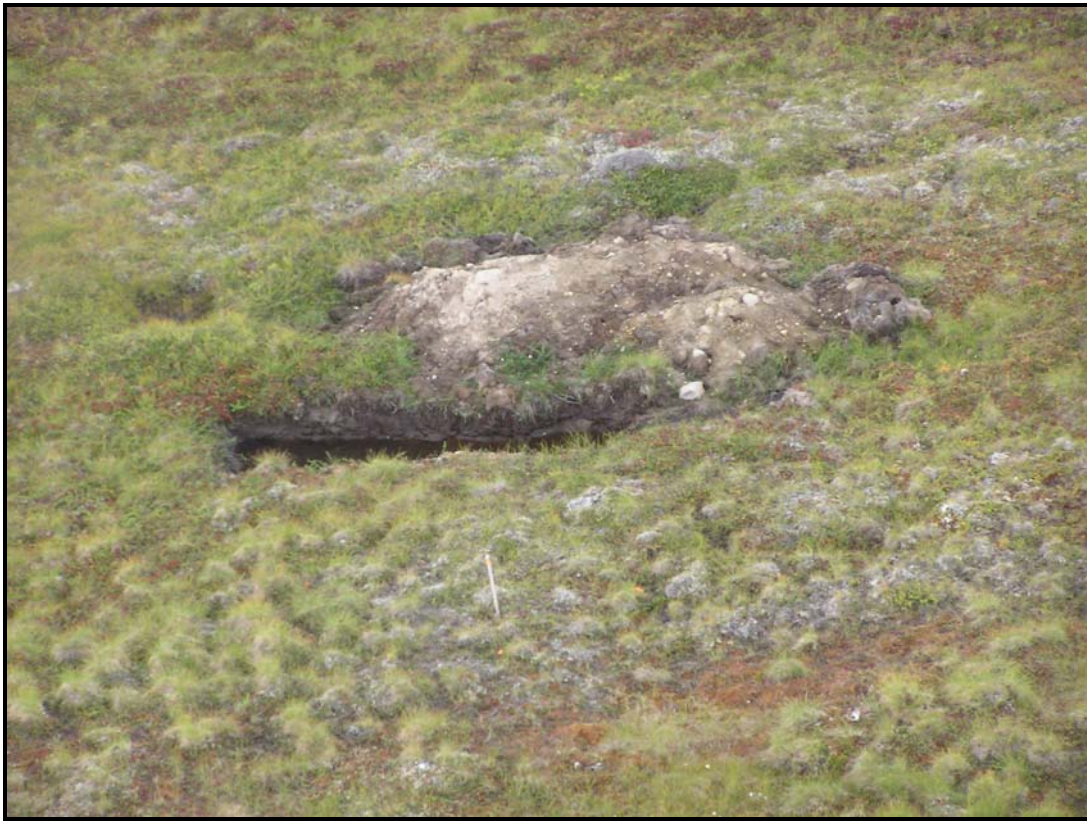
During the flight back from the project area to Iliamna, we observed an unreclaimed trench at 59 52.00.6 / 155 09 45.1. These coordinates indicate that the unreclaimed trench is located on State Mining Claim PEB EB 7 (ADL 642344).

Figure 36: Unreclaimed trench at 59 52 00.6 / 155 09 45.1.

<input type="checkbox"/> Visibility: > 1 mile	<input type="checkbox"/> Observed outflow: not observed
<input type="checkbox"/> Sky Conditions: PC/Cloudy	
<input type="checkbox"/> Ground Conditions:	
<p>Comments: Most drill sites were clean and orderly.</p>	
<p>Recommendations: None.</p>	
<p>Actions Needed: It was not apparent whether or not DDH # 8405 and DDH # 8415 were plugged when sites were reclaimed; please confirm whether or not this is the case. Please determine whether the unreclaimed exploration trench is located on PLP claims and if so, please indicate when it will be reclaimed.</p>
