# Field Monitoring Report

## -- Pebble Copper/Gold Exploration Project --

Inspection Date: September 23 & 24, 2008

APMA #: A086118

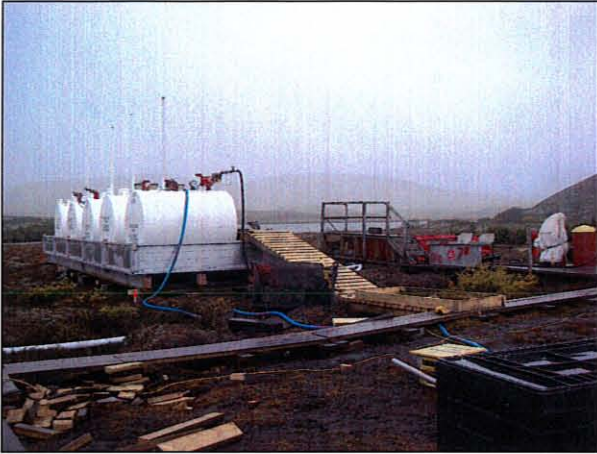
Figure 1. Fuel storage facility, former site on right side of picture.

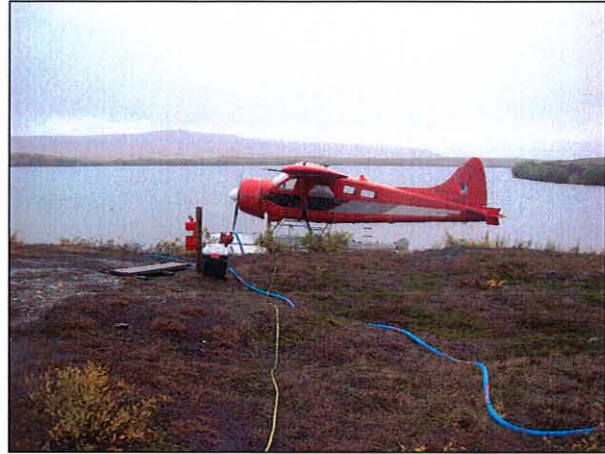
Figure 2. Fuel transport brought in via Beaver on floats, 200 gallons/trip.

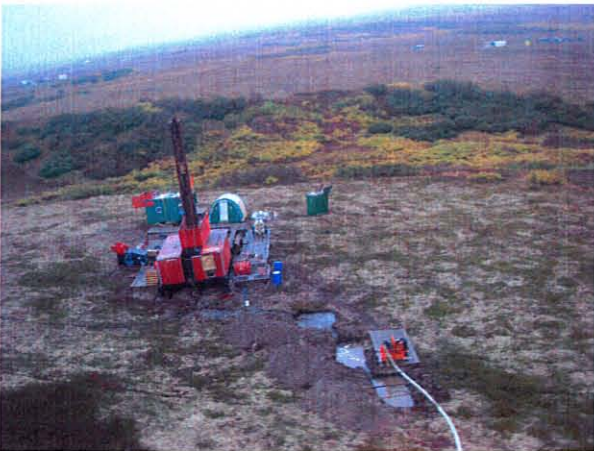
Figure 3. Drill rig 2 with series of three sump pits.

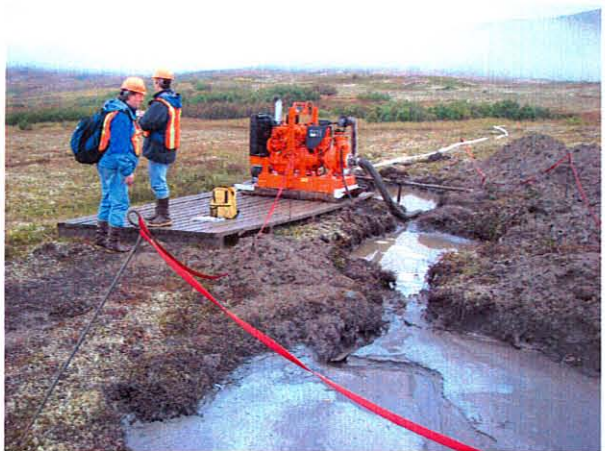
Figure 4. Series of three sump pits with Godwin pump and discharge to uplands.

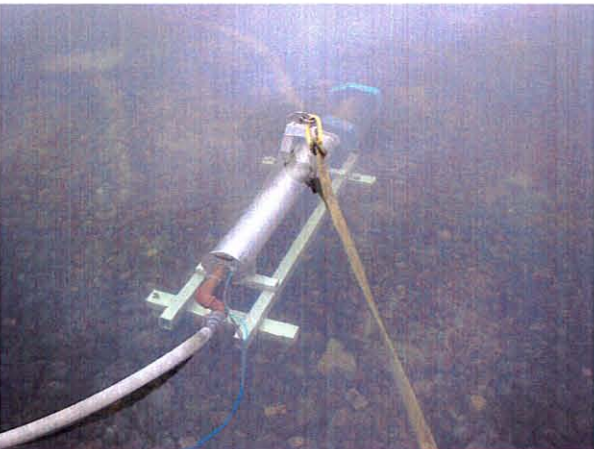
Figure 5. Water intake pump and screen.

**Actions Needed:** Inspect and repair water intake screens prior to use in fish bearing waters. Observed two screened intake boxes, one with holes larger than the mesh size, stored near rig 6.

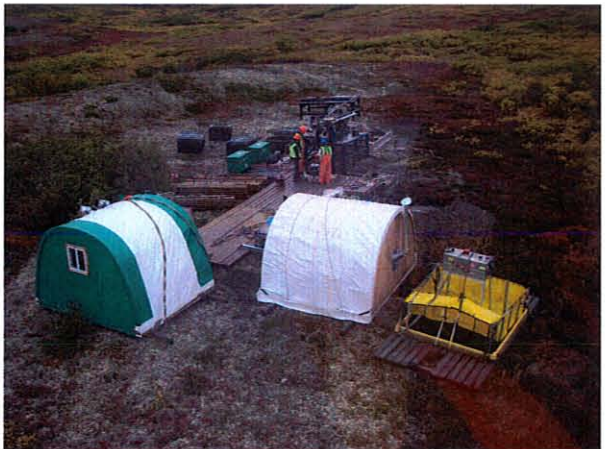
- Drill additives in use: n/a
- Water recirculation: no
- Water discharged: no
- Artesian zone encountered: yes, encountered at 47 and 87 feet, sealing with chips and cement.

Figure 6. Drill rig 9, geotechnical drill hole.

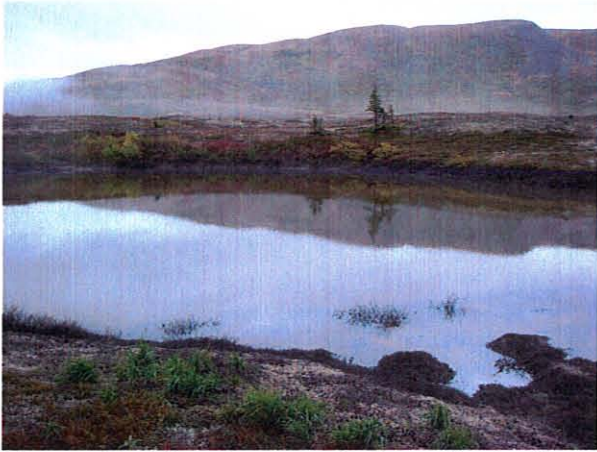
Figure 7. Riparian vegetation of a kettle pond impacted by previously elevated water levels. Located southeast of Rig 5.

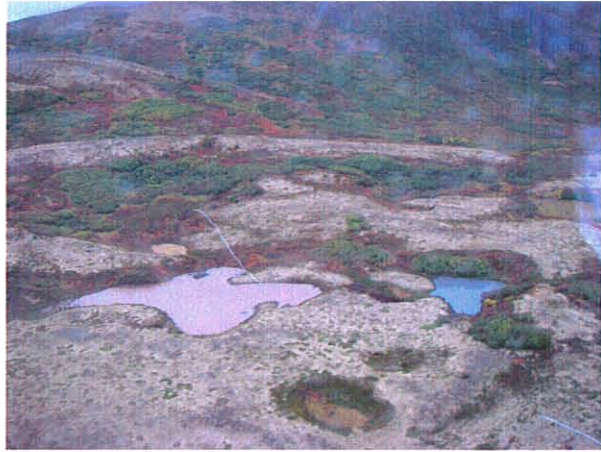
Figure 8. Discharge water pooling in swales. Located southeast of Rig 5, near foothill.

**Recommendations:** Continue to provide staff with updated operations map and inform staff of any new developments or changes in operational plans prior to site visits. Consider skirting fuel containers to shed precipitation away from tertiary containment structures. Consider moving upland discharge points frequently or dispersing discharge over a larger area to avoid impacting ground cover vegetation and potentially altering water quality in kettle ponds adjacent to discharge locations. Replace pressure relieving (leaking) water lines with newer high pressure hoses to avoid potential soil surface erosion.
