Field Monitoring Report

-- Pebble Copper/Gold Exploration Project --

Inspection Date: October 28 & 29, 2008

APMA #: A086118

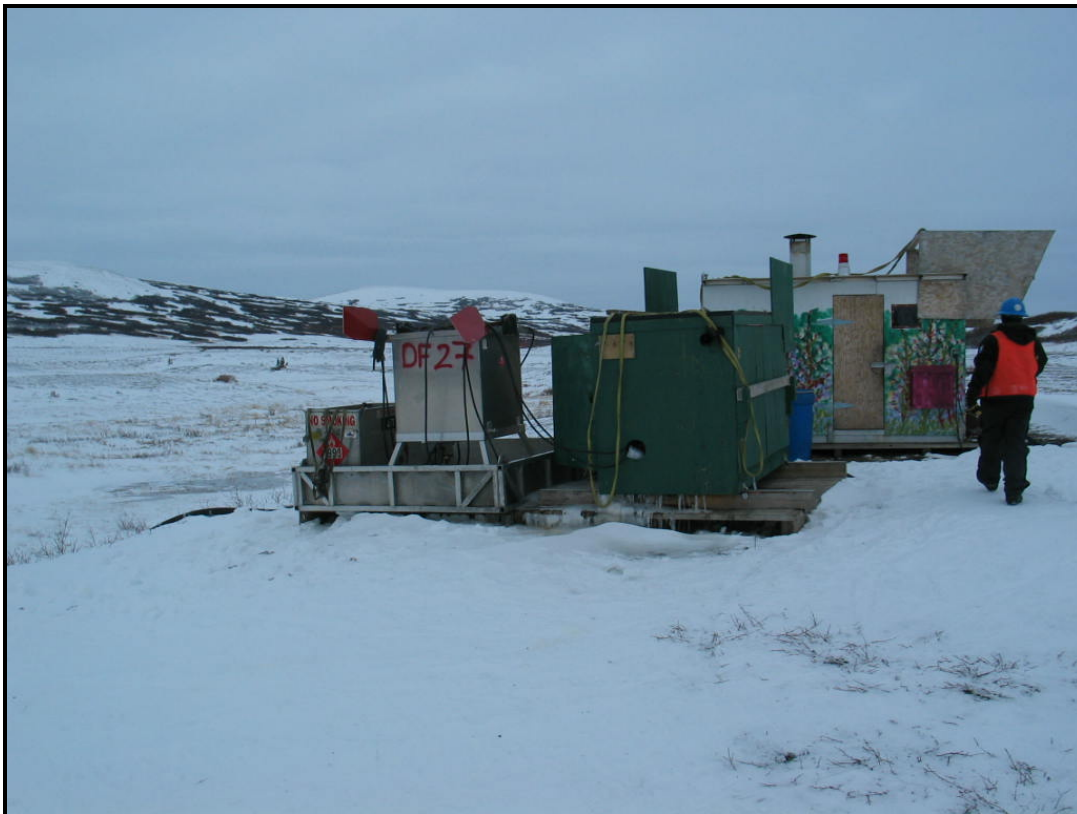
Photo #16. Water pump for drill #3.

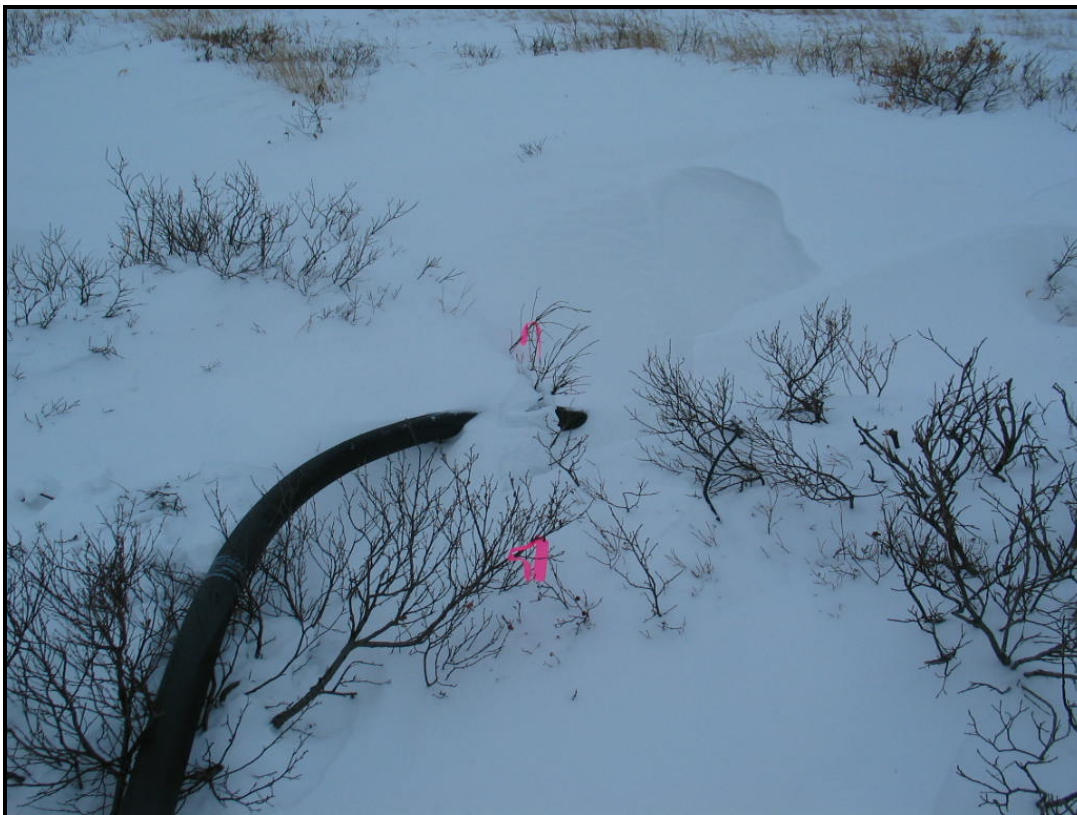
Photo #18. Water intake for drill #3.

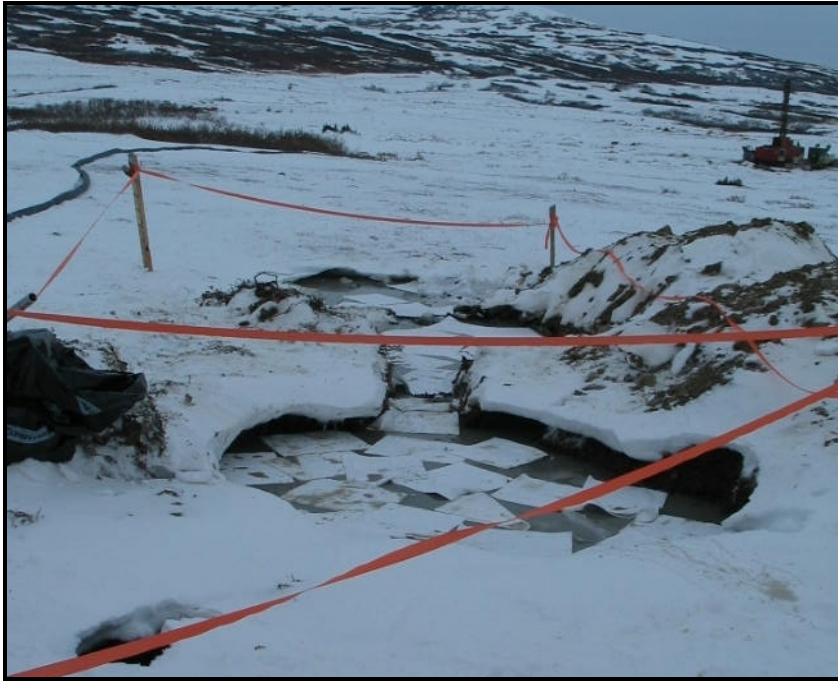
Photo #19. Sorbent pads on sump pits at drill #4.

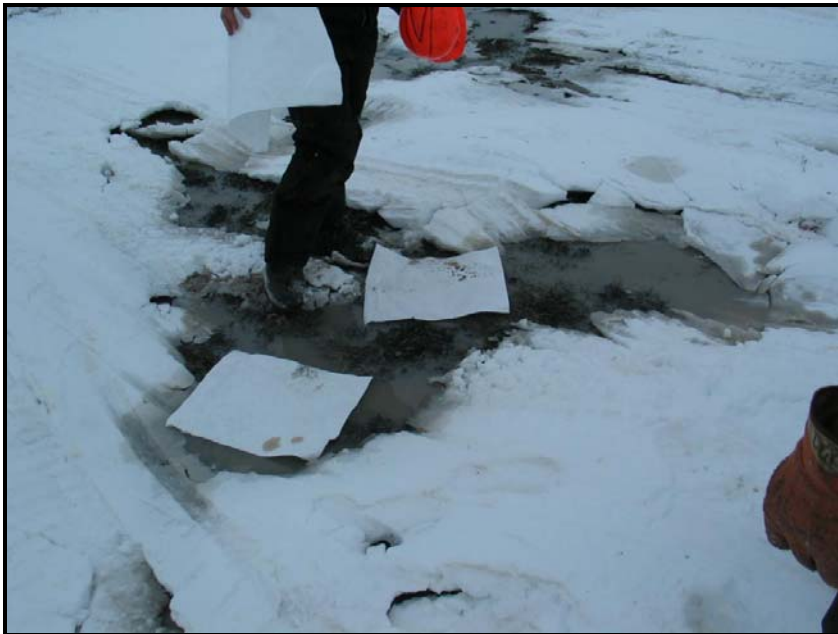
- Distance from waterbody: 600'
- Location of fuel storage: At drill on tundra pad
- Sorbent pads present: Yes
- Tundra mat: Yes
- Pipe off tundra: Yes
- Litter: None
- Trash containment: Yes
- Sanitary facilities: Yes
- Any spills or staining: Approx. 1 gal. hydraulic fluid was spilled this morning. Most was captured at the time of spill. Some got into the sump. There were a few places where a minor sheen could be seen on the sumps and discharge area. Drillers were placing sorbent pads to collect remaining fluid.
- General impression: Clean and orderly

Photo #20. Sorbent pads being placed on discharge from drill #4.

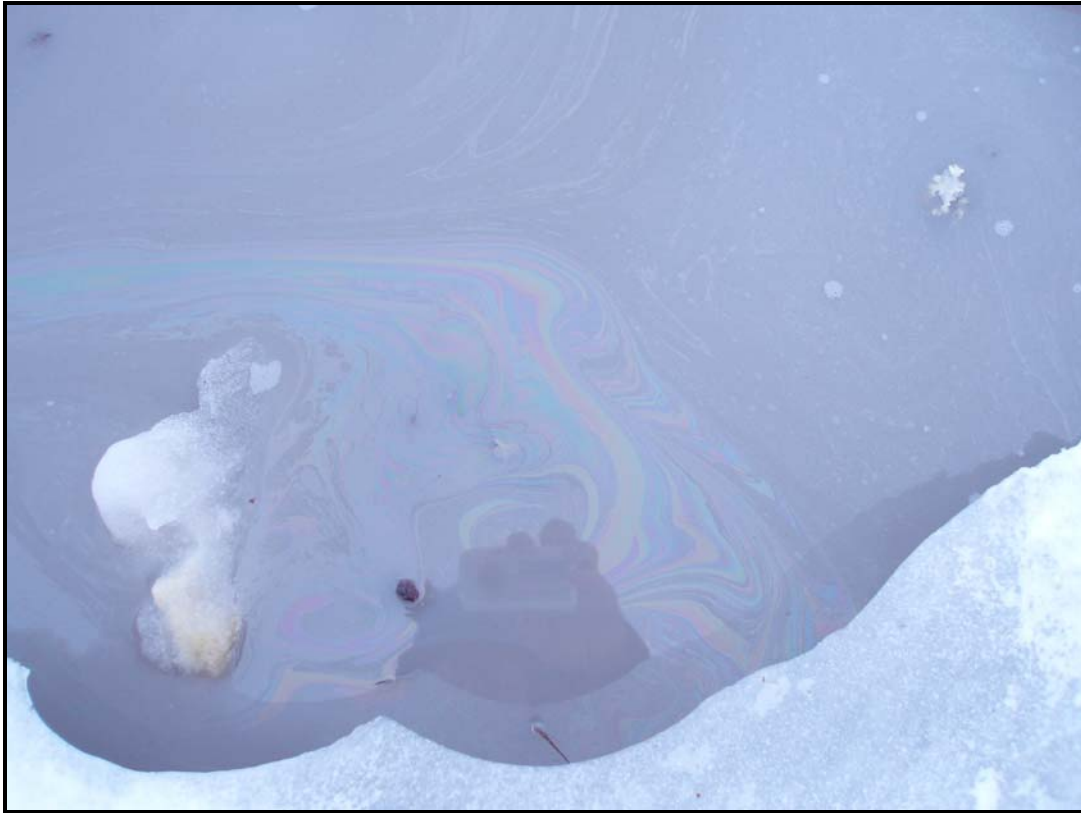
Photo #21. Sheen from hydraulic fluid on discharge from drill #4.

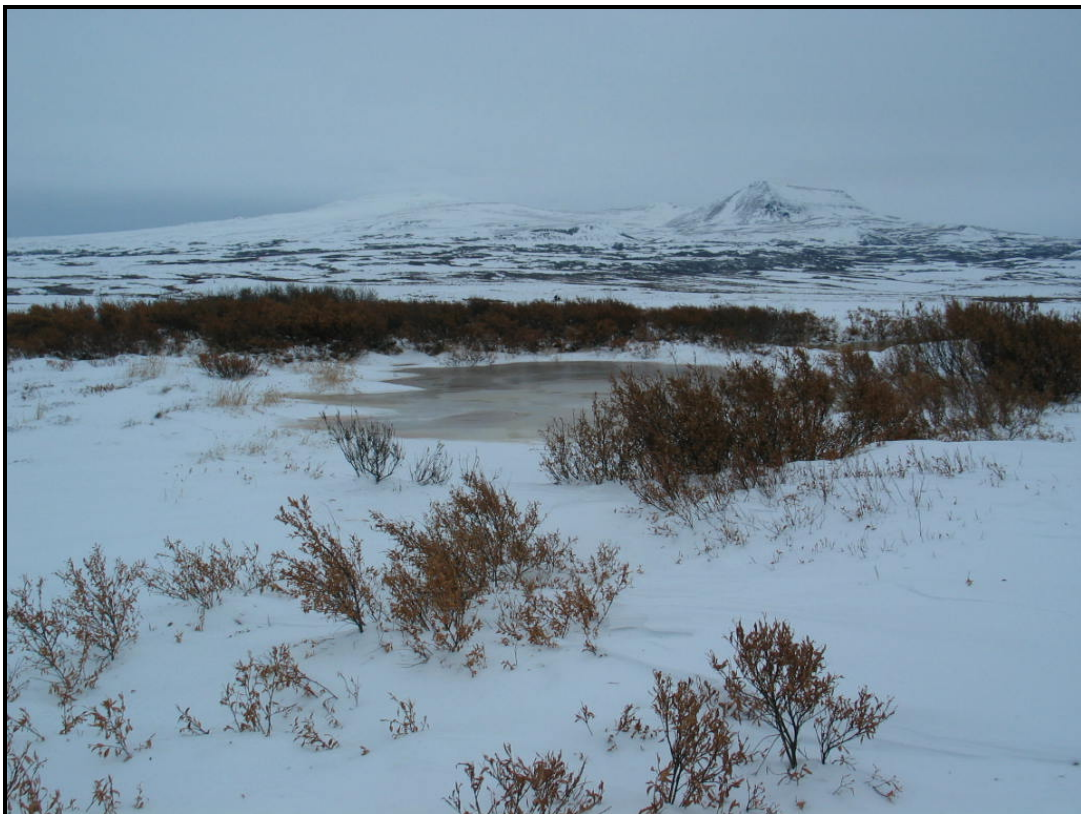
- Location and extent of discharged material: Approx. 23 gpm flowing down hill to NE about 250'. Collecting in a depression. Photo.
- Topsoil, muck, tundra stockpiled: Yes
- Location of secondary sump pit: Adjacent to pad
- Hose color:

Photo #22. Depression catching discharge from drill #4.

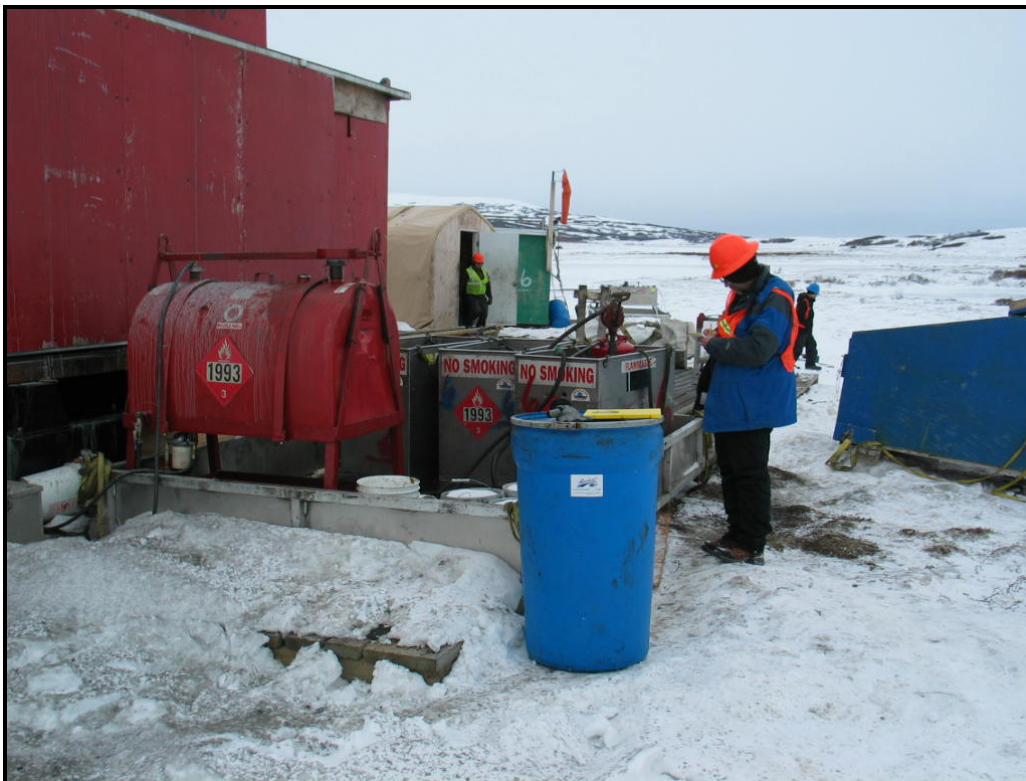
Photo #30. Fuel containment at drill #6.

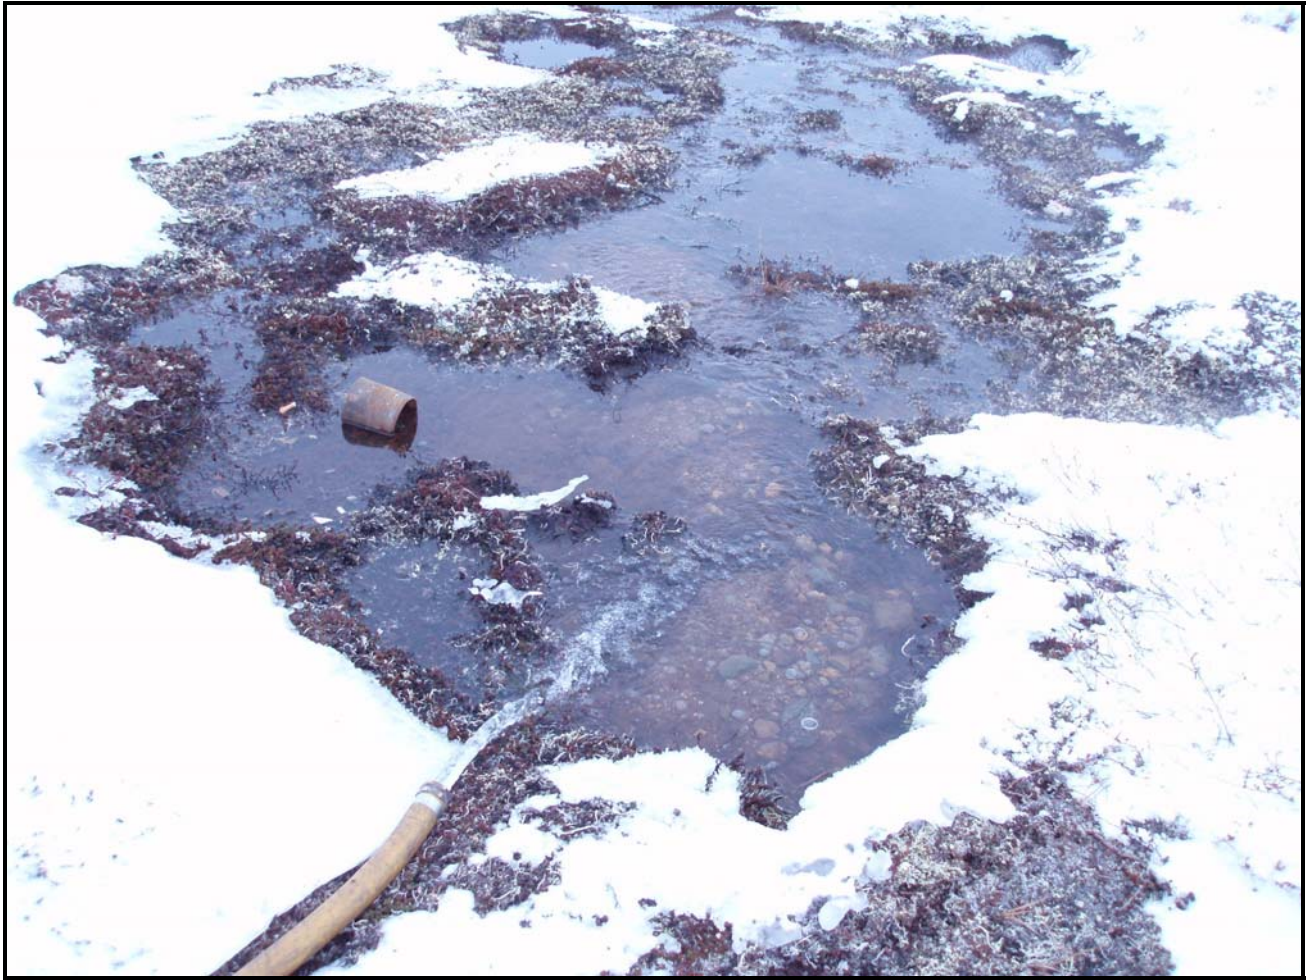
- Drill additives in use: EZ MUD, Extreme #1
- Water recirculation: Yes
- Water discharged: Yes, excess water from water line being discharged from 1" hose.
- Artesian zone encountered: Unknown

Photo #32. Excess water being discharged onto the tundra at drill #6.

- State regulatory agencies and the PLP should further discuss the relative merits of handling drill fluids by discharge onto the ground, discharge into dry depressions, or recirculation.
- If sorbent pads are in use, they should be picked up before helicopters enter the rig area.
- The discharge of excess water directly onto the ground in a concentrated stream could cause erosion. The effects of direct discharge should be evaluated, and possibly some sort of diffuser should be placed to reduce damage. Something as simple as a sheet of plywood, possibly with a rough surface, might be effective.
- Request information from PLP on whether seed mix used for rehabilitation of drill sites is consistent with native vegetation.
