Field Inspection of the Pebble Copper/Gold Project

July 26-27, 2007

Part I

Bill Cole

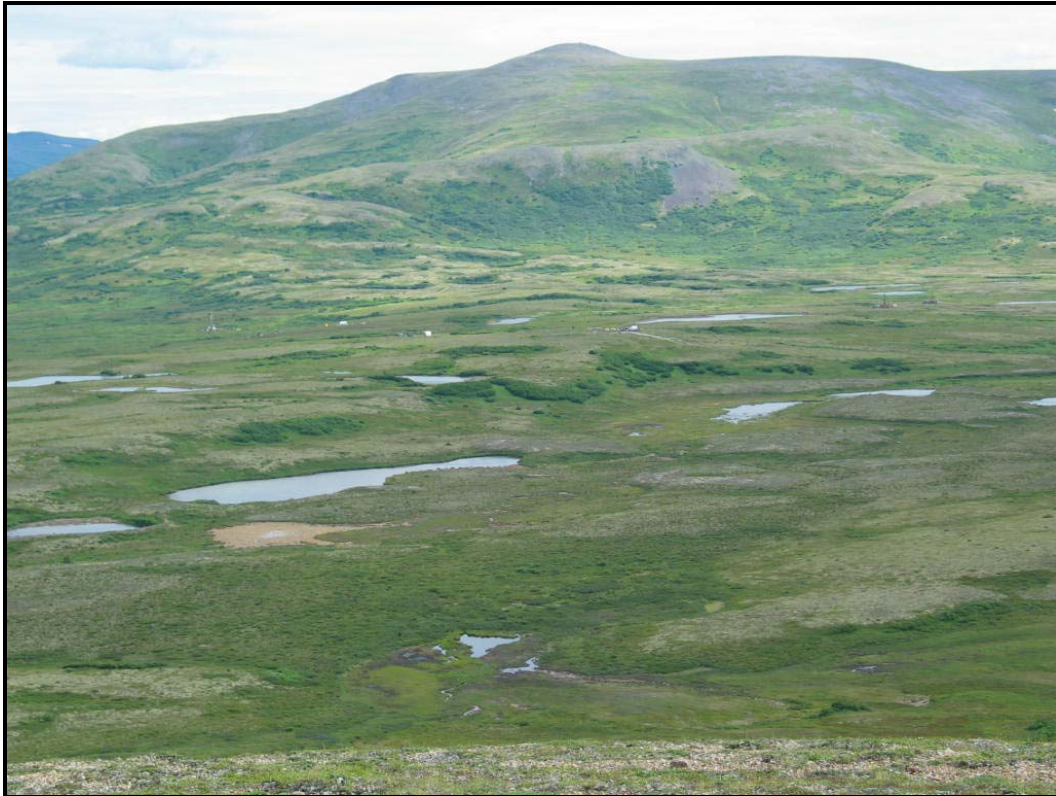
Photo #1. View from west side of the Pebble Deposit, looking east across the valley.

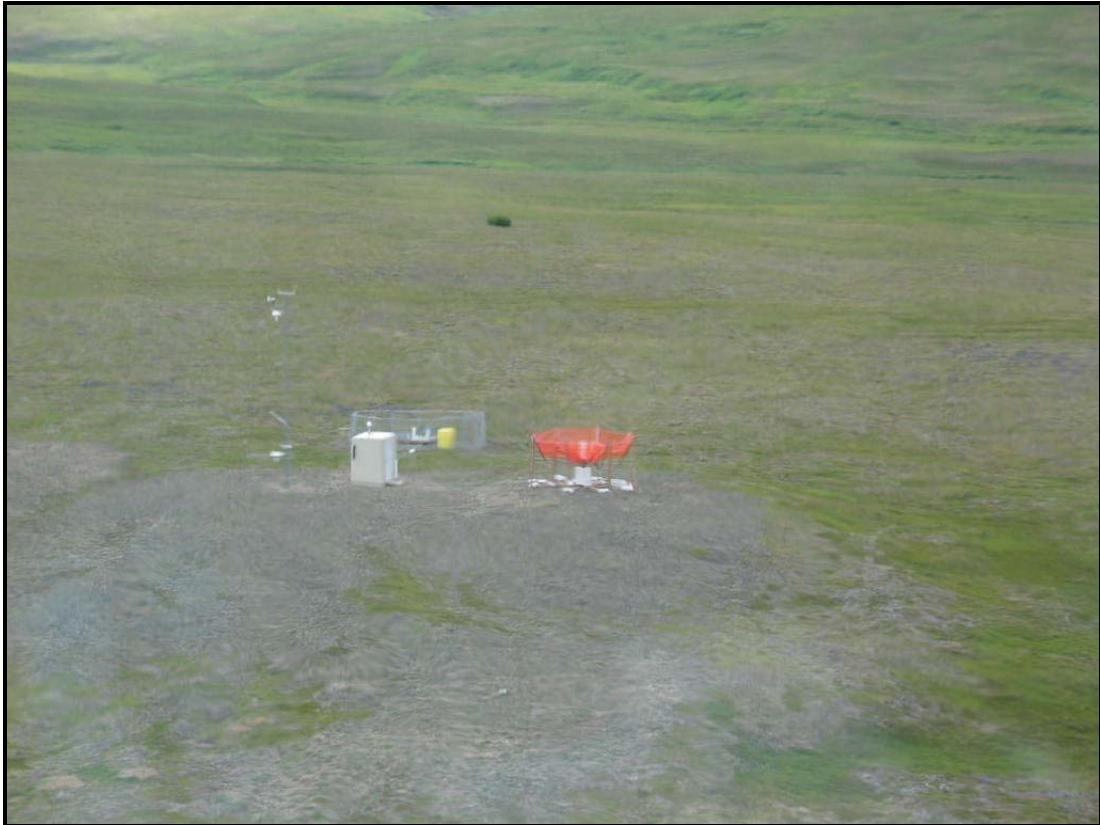
Photo #4. Weather station on ridge at proposed millsite. Drainage in the background is within the proposed tailings pond.

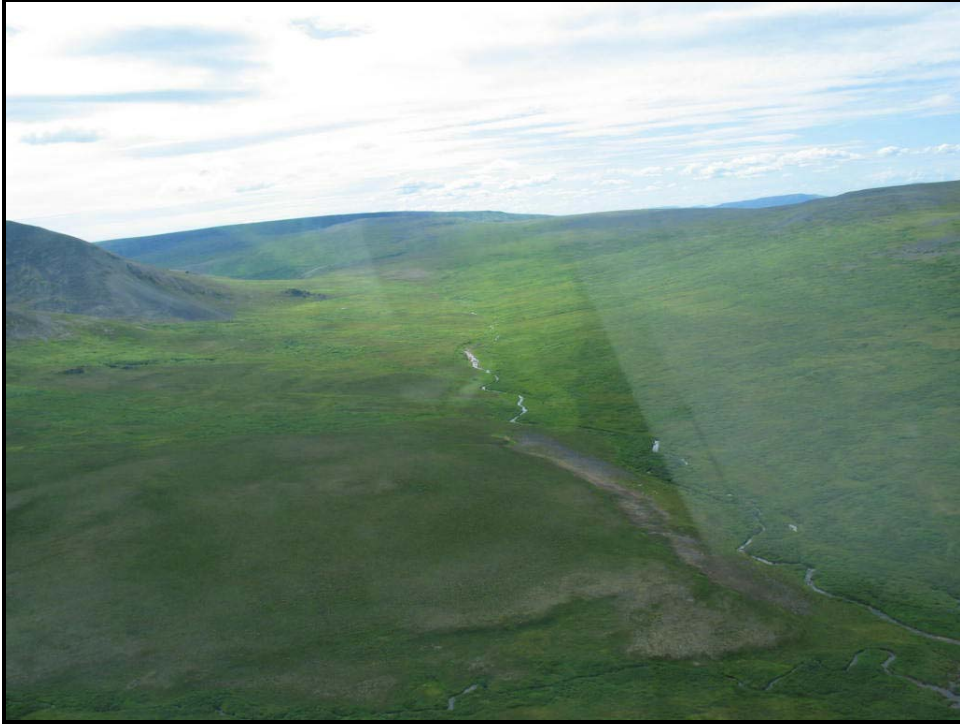
Photo #5. Aerial view looking south up the drainage where tailings pond is planned. A second dam would be required, probably somewhere around the curve in the distance.

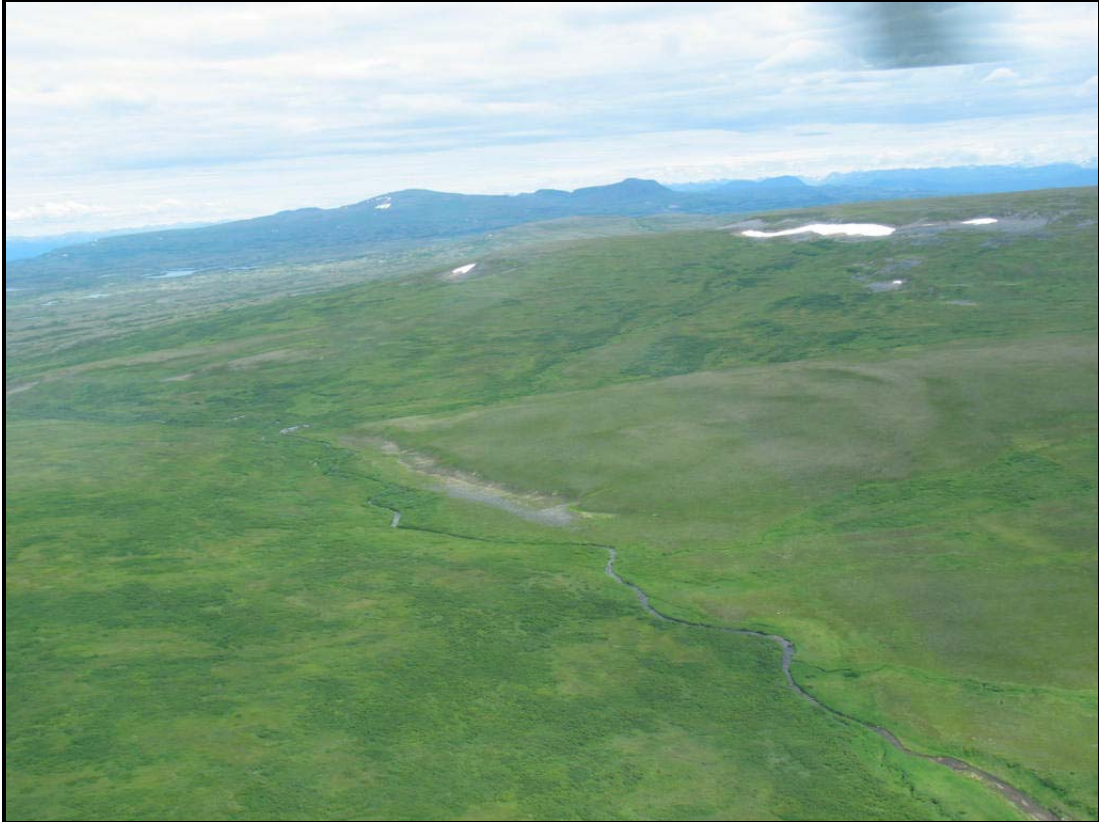
Photo #7. North end of the proposed tailings pond area. The dam would be in the middle distance, approximately where the ridgeline steepens to the left.

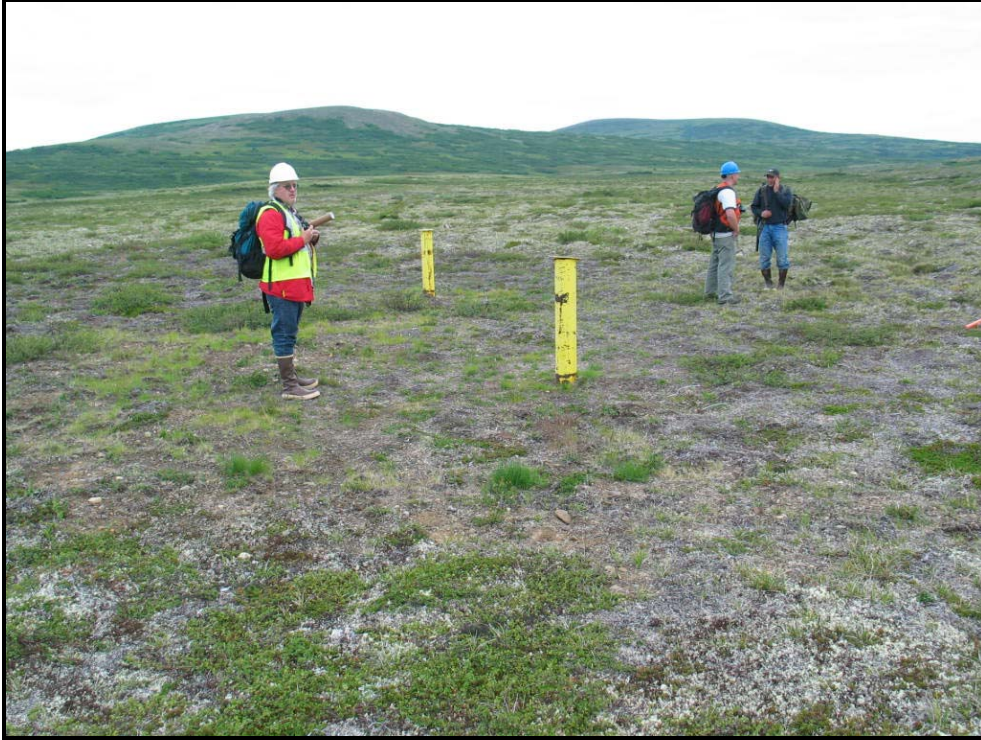
Photo #9. Piezometer wells P4A.

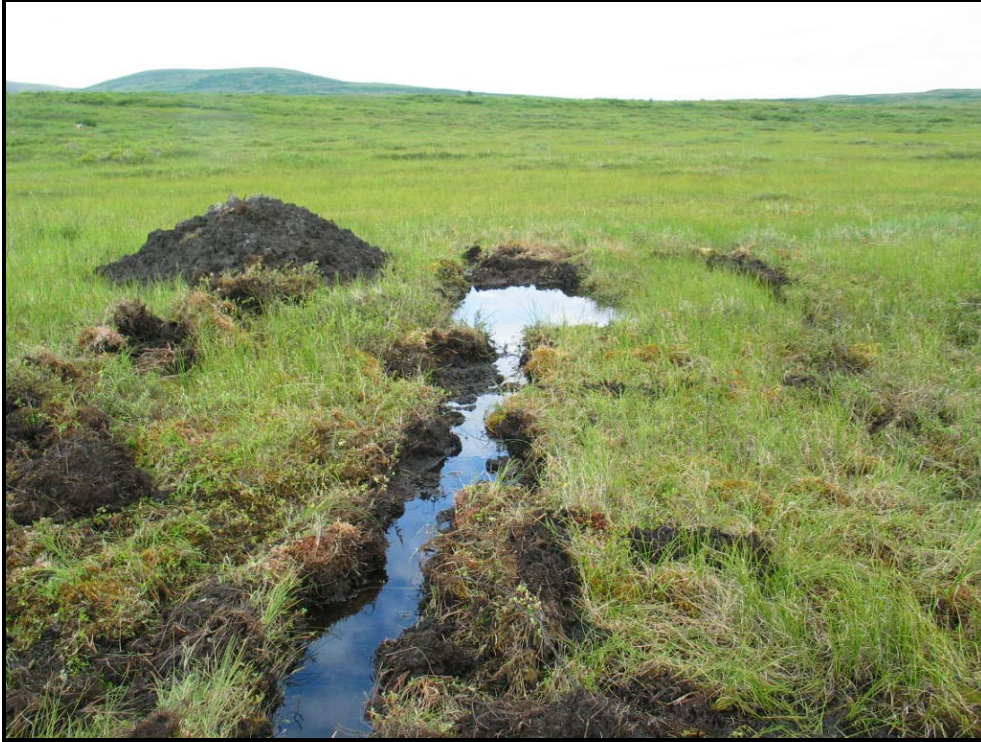
Photo #12. Drainage ditch and sump at new drill site.

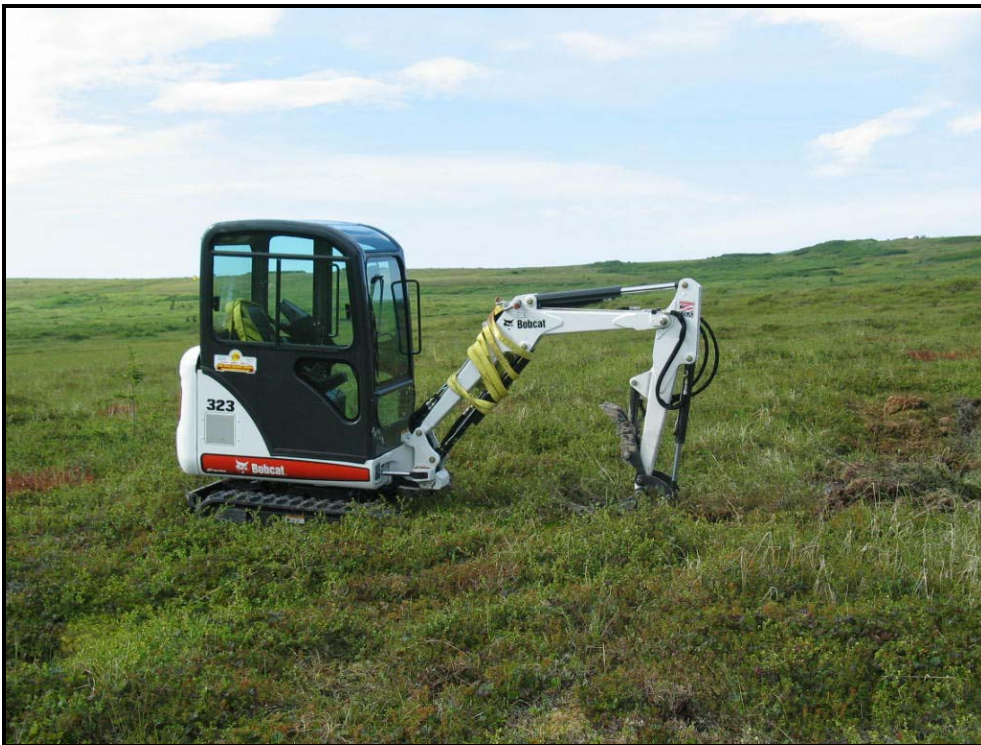
Photo #13. Small backhoe used for digging sumps. The backhoe is air lifted between sites.

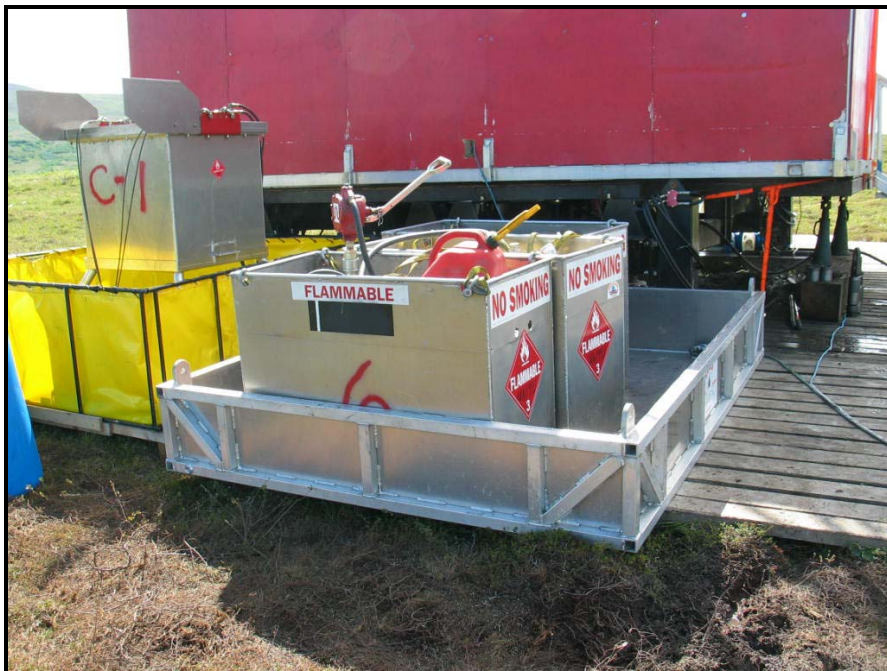
- Fuel is slung to the drills in 118 gallon, double walled aluminum tanks. The tanks are placed in a large, heavy aluminum container, then the fuel is pumped into the main fuel storage tank. The purpose of the aluminum container is to eliminate the risk of tearing the plastic containment liner. (Photo #17)

Photo #17. Double walled, 118 Gal. fuel transport tanks in aluminum containment.

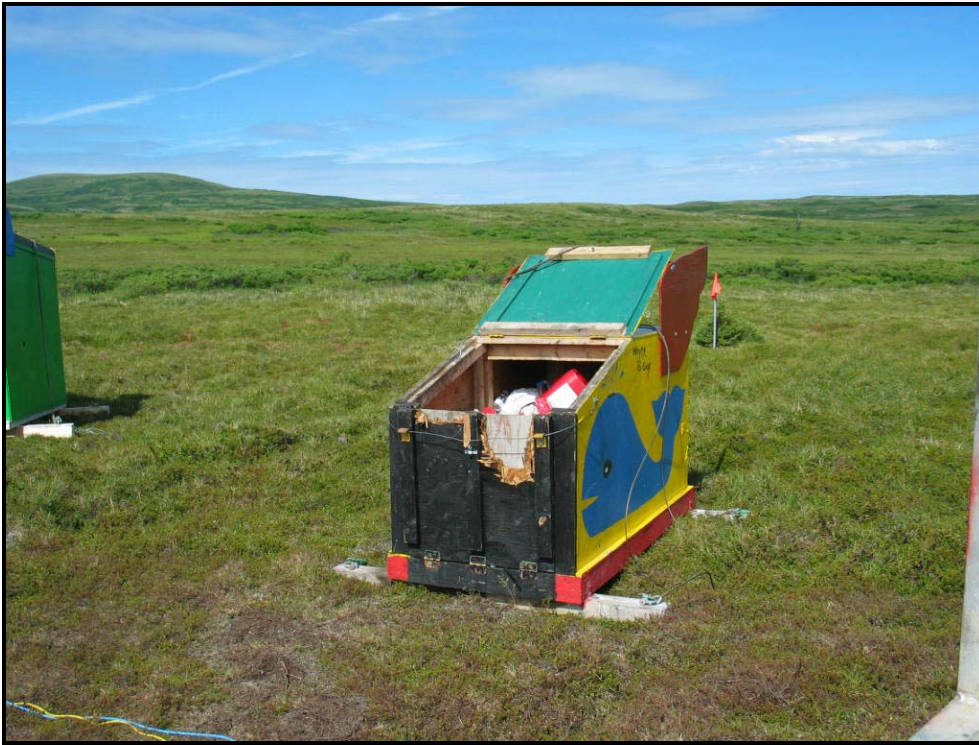
Photo #20. Trash container at drill #6.

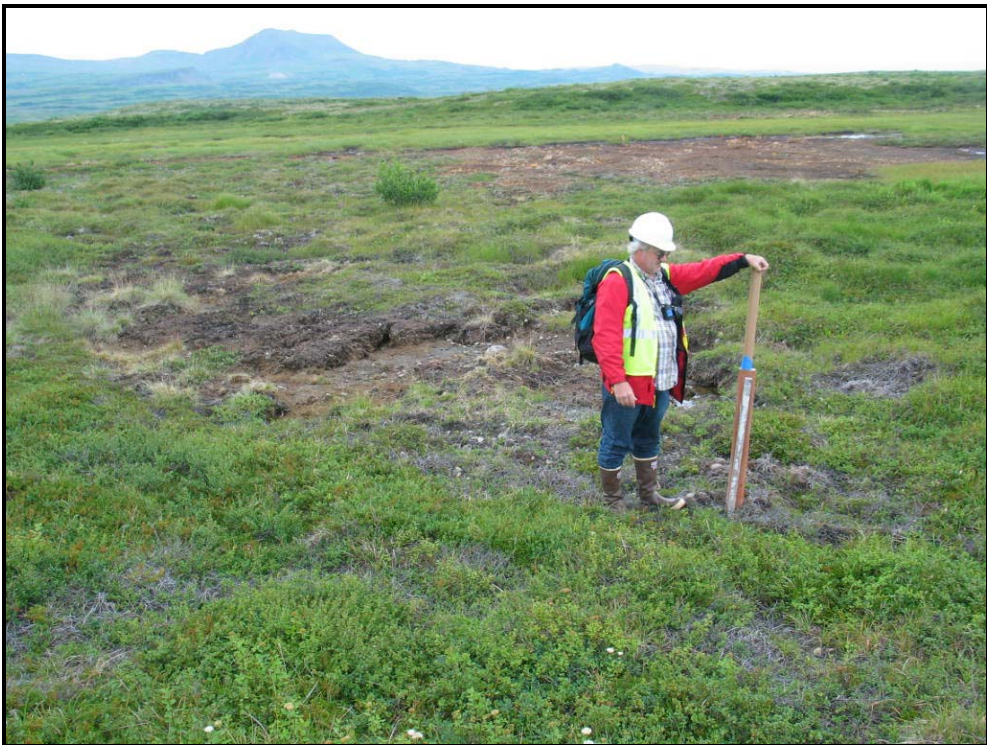
Photo #34. Jeff Rogers of DMLW at DDH 4214. Metal oxides associated with the discovery outcrop can be seen in background.

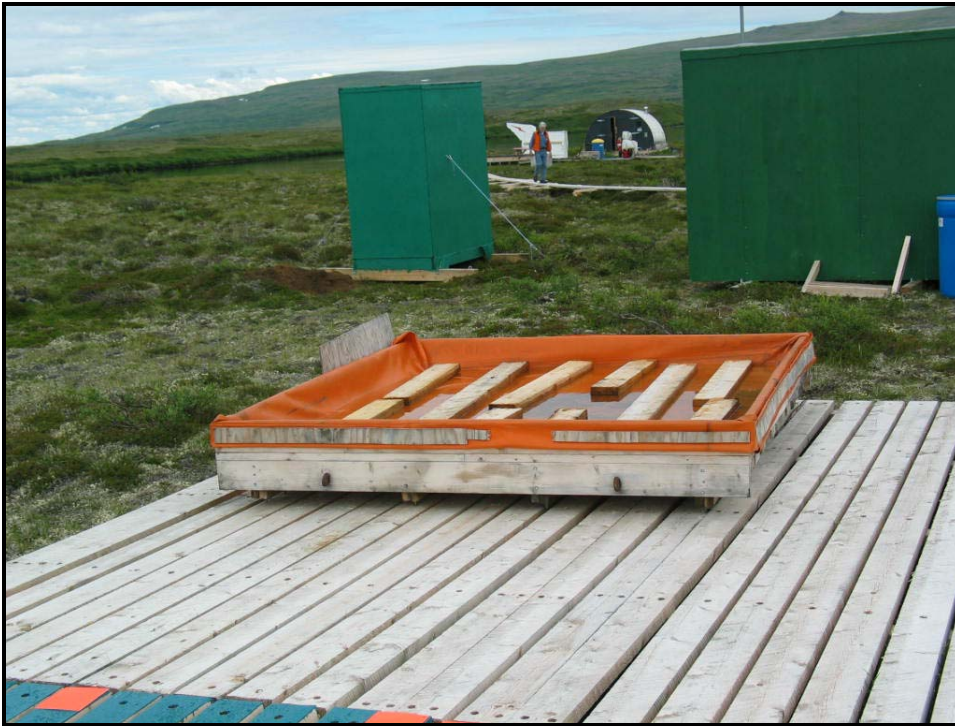
Photo #50. Lined containment for slinging fuel tanks in to 3,000 gallon fuel depot.

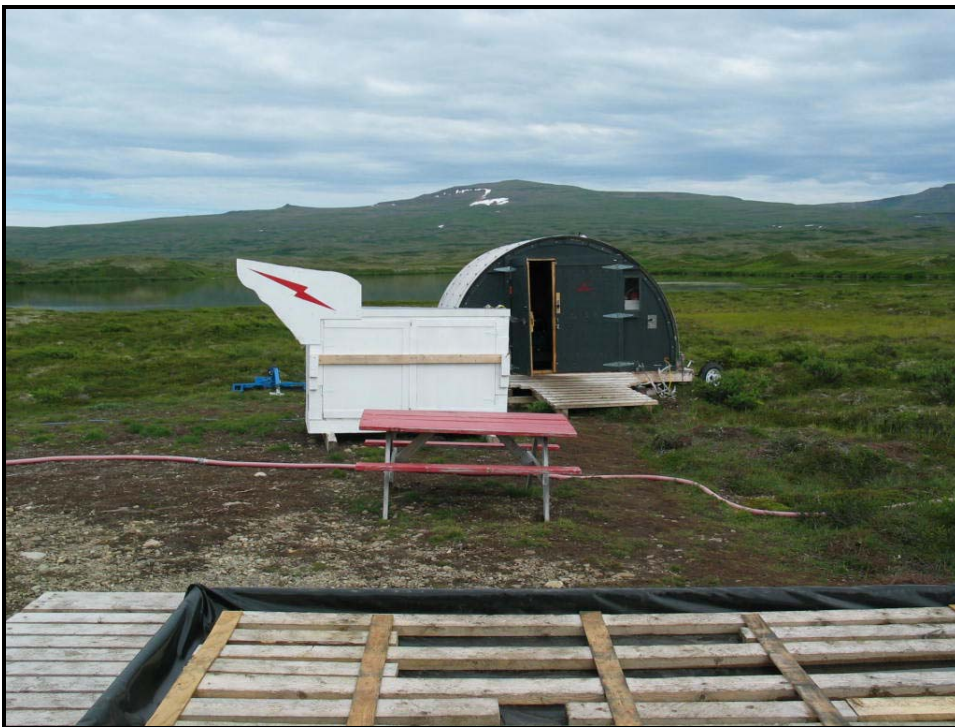
Photo #51. Quonset hut and white container filled with spill materials. Big Wiggly Lake is in the background.

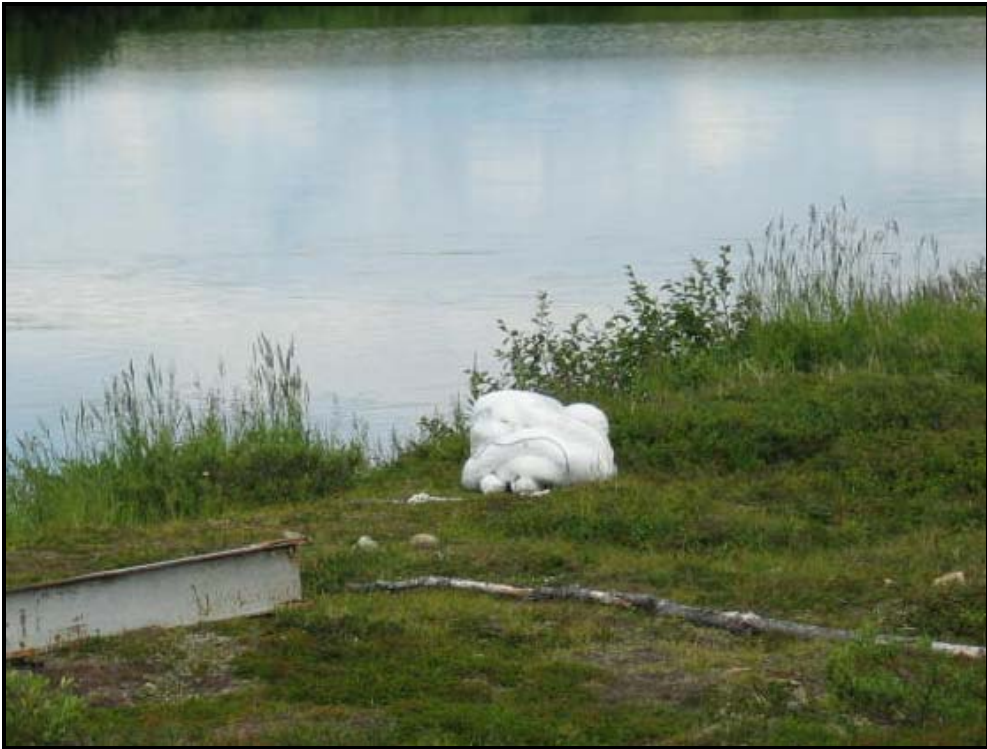
Photo #52. One of two float booms for containing fuel spills on Big Wiggly Lake.

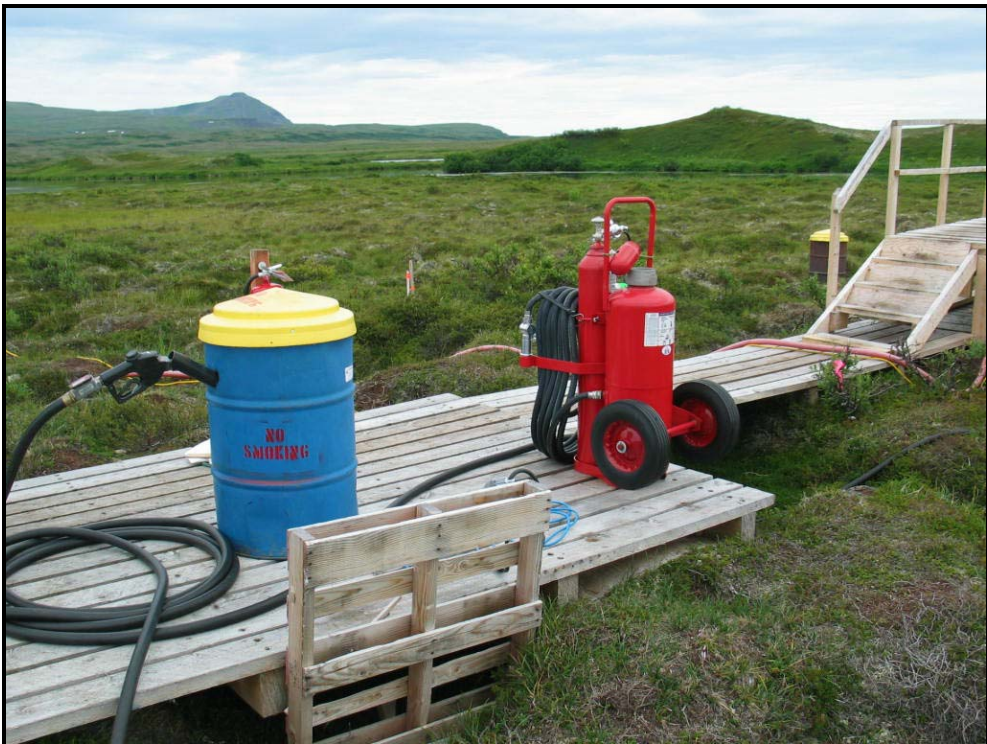
Photo #53. Large fire extinguisher at Big Wiggly fuel storage facility.

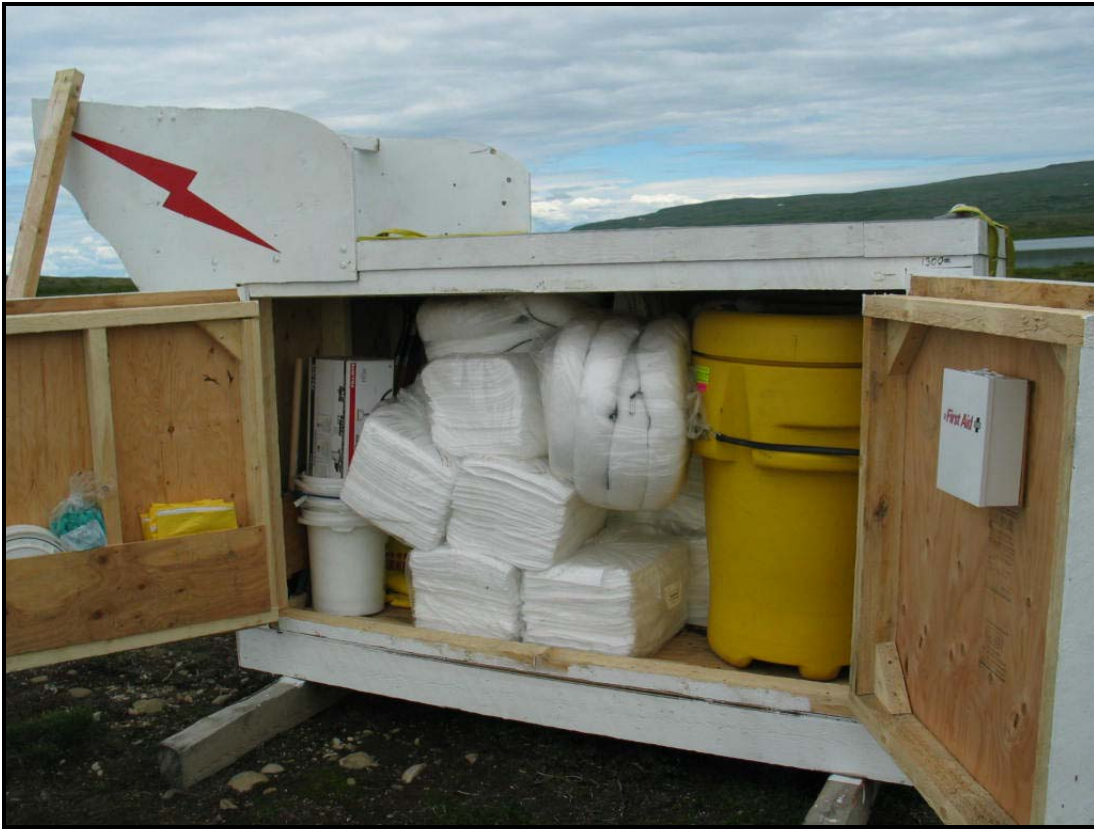
Photo #54. White container full of spill equipment. A first aid kit is on the door to the right.

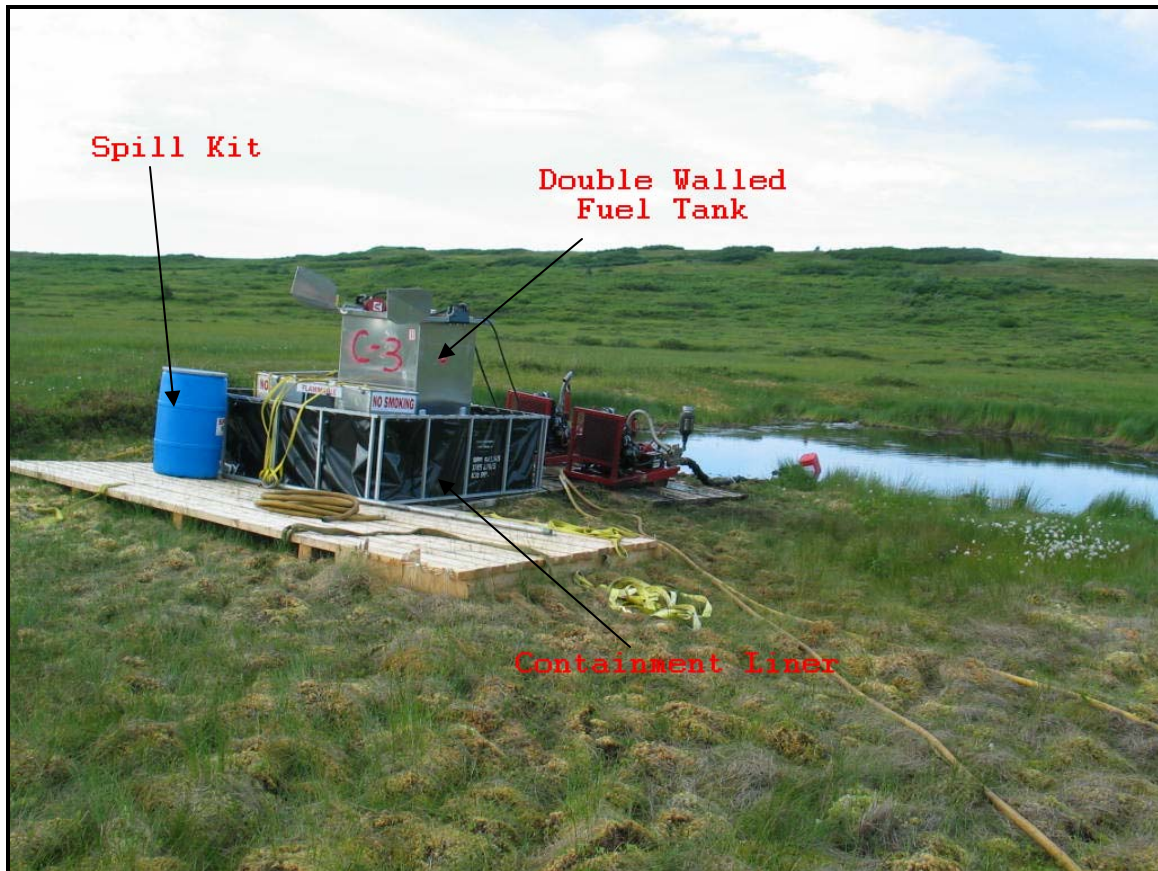
Photo #55. Water pumping facility taking water from a small pond.

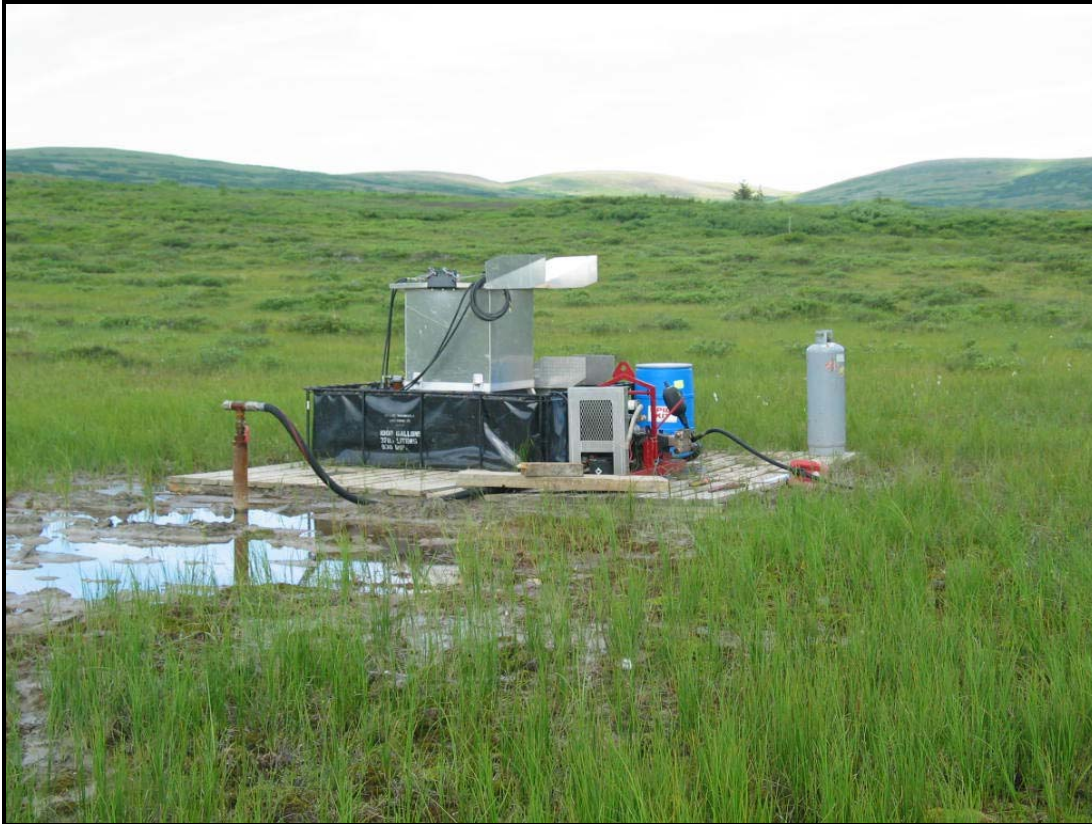
Photo #56. Water pumping facility taking water from a recently drilled hole.

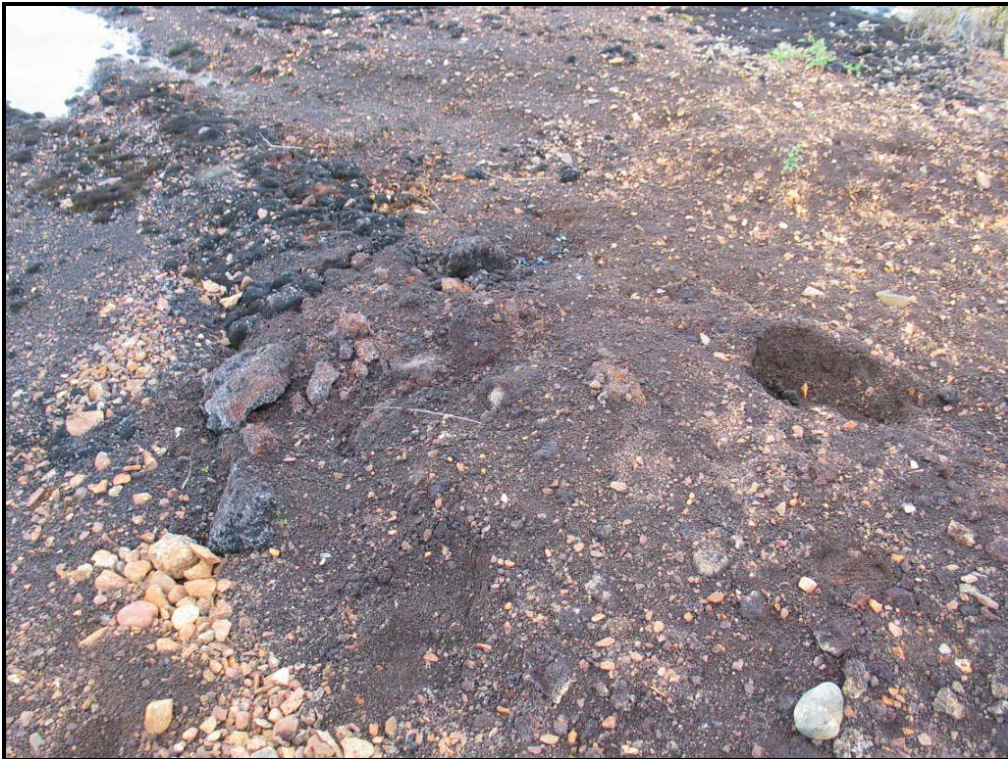
Photo #64. Heavy iron and manganese oxide staining in discovery area.

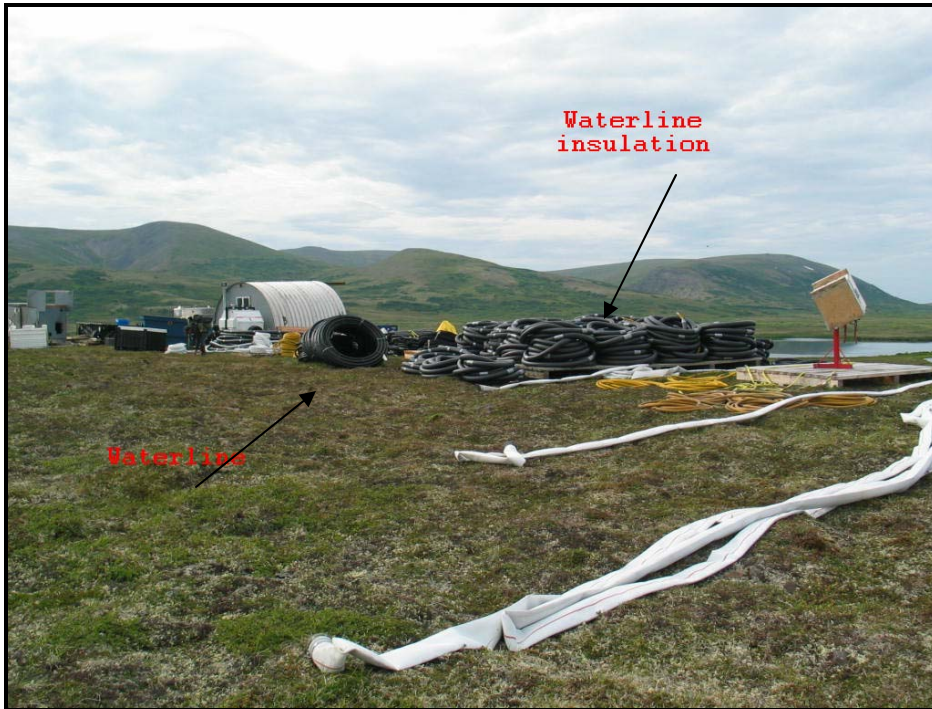
Photo #70. Waterline storage area.

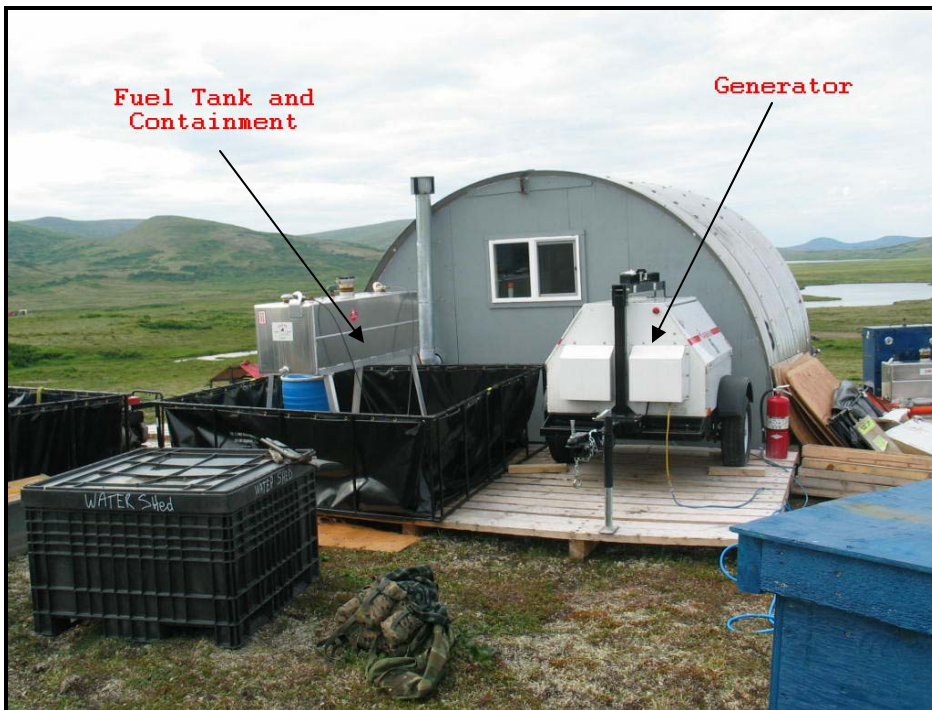
Photo #71. Waterline storage facility.
