## Field Inspection Report -Pebble Copper/Gold Exploration Project-

Inspection Date: April 17, 2008

APMA No.: A086118

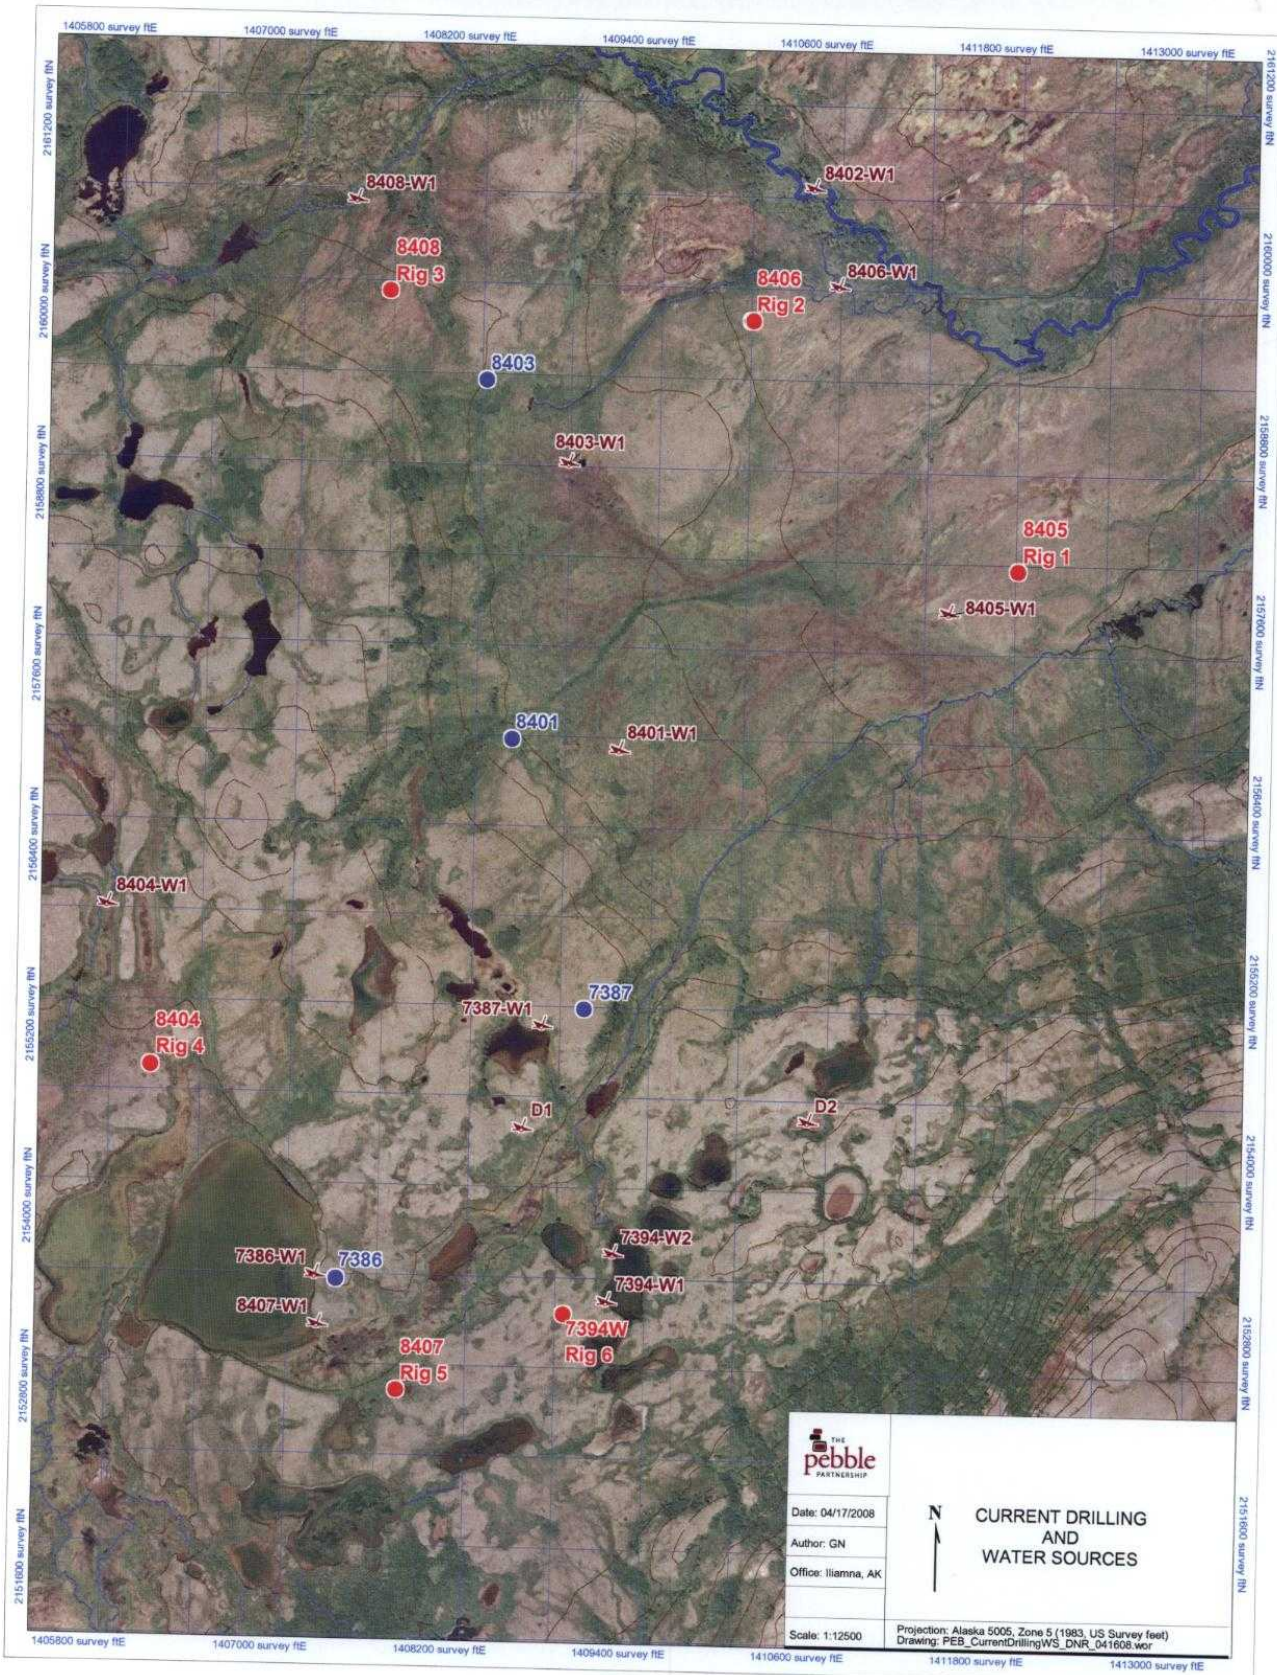
- Distance from water body: **>100 ft.**
- Location of fuel storage: **On pad.**
- Sorbent Pads Present or Not: **Present**
- Tundra Mat: **Yes**
- Pipe off Tundra: **Yes**
- Litter: **None**
- Activity: **Drilling**
- Trash Containment: **Present**
- Sanitary Facilities: **Present**
- Any spills or staining, or 'none' for that matter:  
**None**
- General impression of site: **Clean.**

Figure 1. Rig no. 1 on drill site no.8405. Note tundra pad.
