# Field Monitoring Report

## -- Pebble Copper/Gold Exploration Project --

Inspection Date: September 23 & 24, 2008

APMA #: A086118

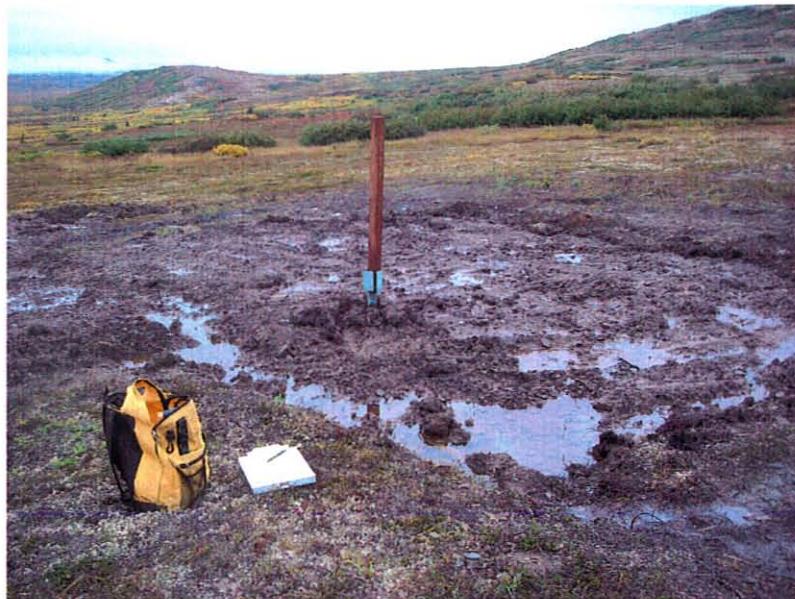
- Plugged: yes
- Cemented: unknown
- Standing pipe: none
- Sump pit filled in: yes
- Water discharge trench filled in: yes
- Site revegetated: no
- Artesian water present: no
- Any spills or staining: none
- Comments/General impression: Appears to have been leveled recently, exposed soil needs to be stabilized and seeded.
