Seismic Stability of Impoundments

Peter M. Byrne, Ph.D., P. Eng.

ABSTRACT A number of impoundment have failed or suffered large displacements during past earthquakes. In most cases the damage has occurred as a result of a large drop in the stiffness and strength of soil referred to as liquefaction. Our understanding of liquefaction has increased dramatically in the past 30 years due to: observations from field case histories; extensive laboratory testing of soil elements under cyclic loading; model testing of earth structures under simulated earthquake loading; and development of numerical modeling procedures.

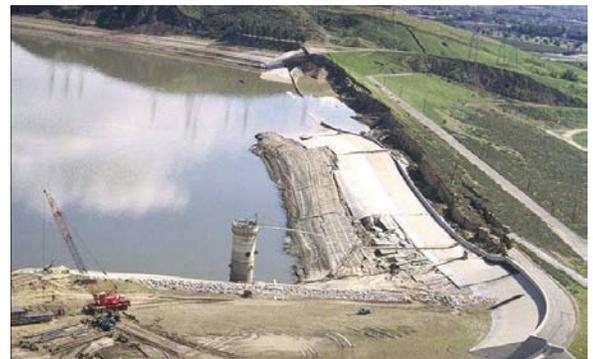
Fig. 1. Failure of the lower San Fernando dam.

A number of impoundment type earth structures have failed or suffered large displacements during past earthquakes. In most cases the damage has occurred as a result of a large drop in the stiffness and strength of soil referred to as liquefaction. Classic examples of liquefaction damage are the behaviour of the San Fernando dams during the 1971 San Fernando earthquake, California. The crest of the upper dam moved downstream about 2m, while a flow slide on the upstream side of the lower dam some moments after the severe shaking, removed the crest of the lower dam as shown in Fig 1.

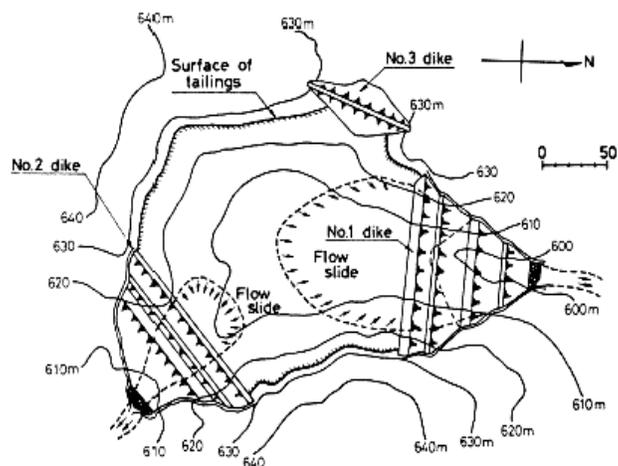
Fig. 2. Plan of Mochikochi tailings dams (Okusa and Anma 1980).

A number of mine tailings impoundment dams have also suffered severe damage during past earthquakes. The best examples here are the Mochikoshi dams in Japan which failed during the 1978 Izu-Ohshim-Kinkai earthquake due to liquefaction induced flow slides resulting in release of the tailings as shown in Fig 2. One dam failed during the shaking, while a second failed 24 hours later.

The 1978 Izu-Ohshim-Kinkai, Japan earthquakes caused two tailings dams owned by the Mochikoshi gold mining company to fail due to liquefaction of the tailings materials behind the dams. The earthquake comprised of a main shock with magnitude M7 and a large after shock with M5.8. The earthquake was shallow, having a focal depth of about 10 km. Information on the failure of Mochikoshi tailings dams can be found in Marcuson et al. (1979), Okusa and Anma (1980), Okusa et al. (1984), Ishihara (1984), and Jitno and Byrne (1995). A plan view of the tailings dams is shown in Fig. 2.

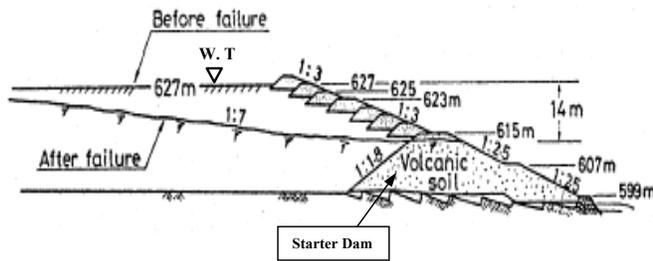
Fig. 3. Cross-section of dam No. 1 (Ishihara 1984).

The cross-section of the dam is presented in Fig. 3 and shows geometry before and after the failure. The tailings impoundment was used to store gold mine waste, and the dam was built using an upstream construction method with a starter dam comprised of Volcanic soil. The impoundment had been in operation since 1964.

Dam No. 1 had a maximum height of 28 m, a crest length of 73m, and a crest width of 5 m. The water table at the time of earthquake was approximately 3m below the slope surface and in the pond at top surface. The tailings dam failed catastrophically during the main shaking and resulted in flow of tailings down the valley over a distance of about 800 m (Ishihara 1984).

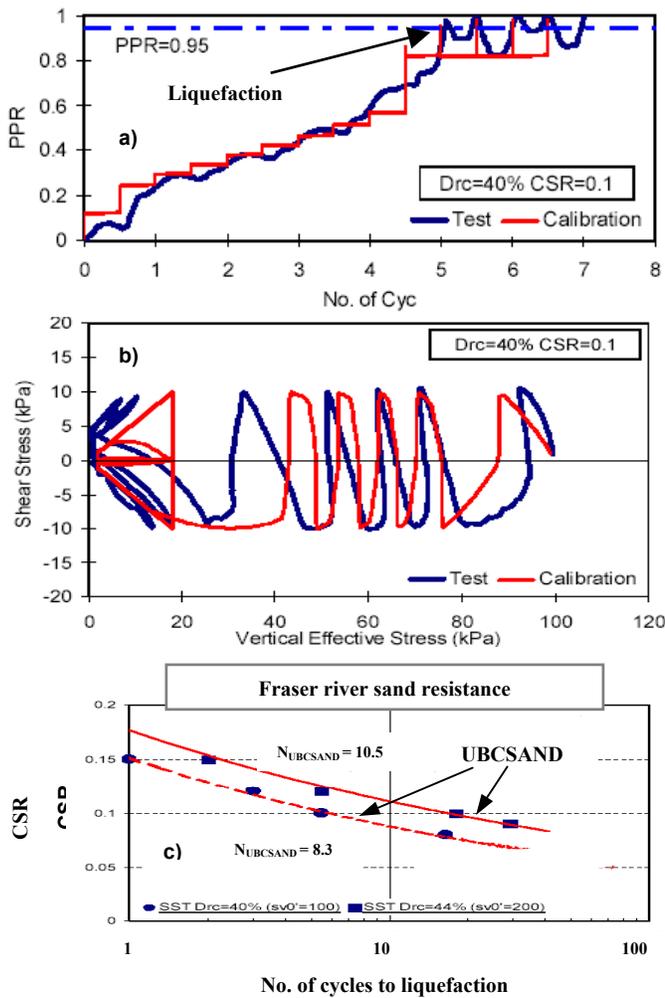
Fig. 4. Comparison of predicted and measured response, a) excess pore pressure, b) stress path, c) No. of cycles.

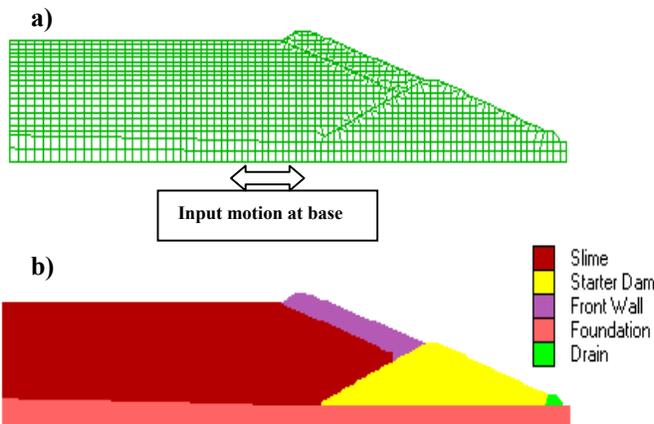
Fig. 5. Dam model (a) Grid, (b) types of materials.

The model grid together with material types representing different grid parts of the dam in the analysis is illustrated in Fig.5.

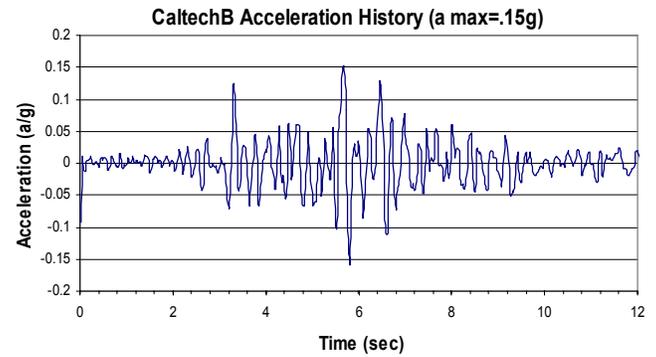
Fig. 6. Input earthquake acceleration record.

at the Caltech B Station (California Institute of Technology) and normalized to $a_{max} = 0.15g$ was applied at the base of the model, and is as shown in Fig. 6.

This earthquake has a shallow focal depth similar to Izu-Ohshim-Kinkai earthquake, but a lower magnitude, M6.5 vs. M7, and is thought to be reasonably appropriate.

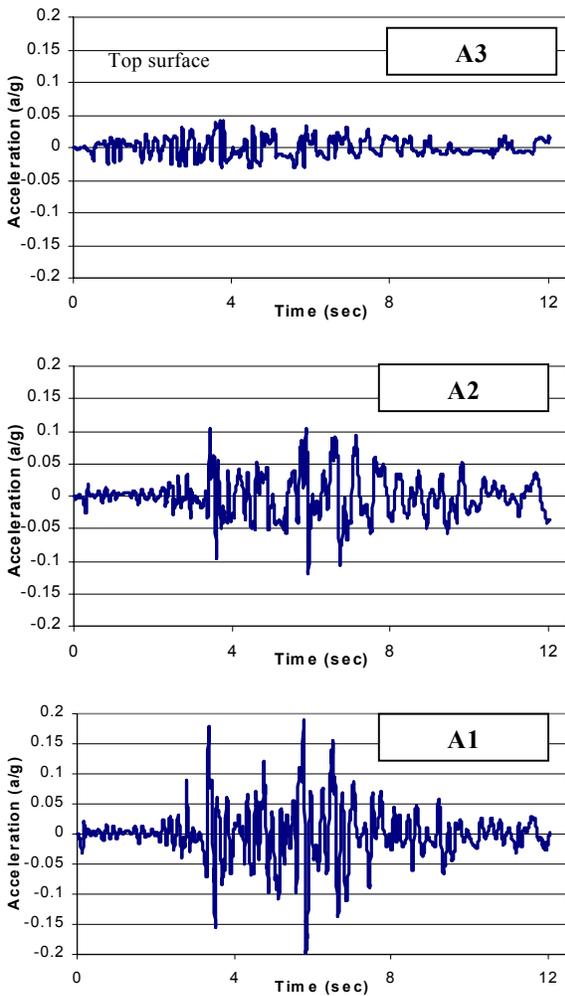
Fig. 7. Acceleration time history at different depths.

Fig. 7 shows the predicted acceleration time histories for specific points at different depths (see Figs. 9 for locations). It indicates that the input motion is amplified to some extent at depth, e.g. A1 and then de-amplified in the upper tailings at A2 and A3 due to the occurrence of liquefaction.

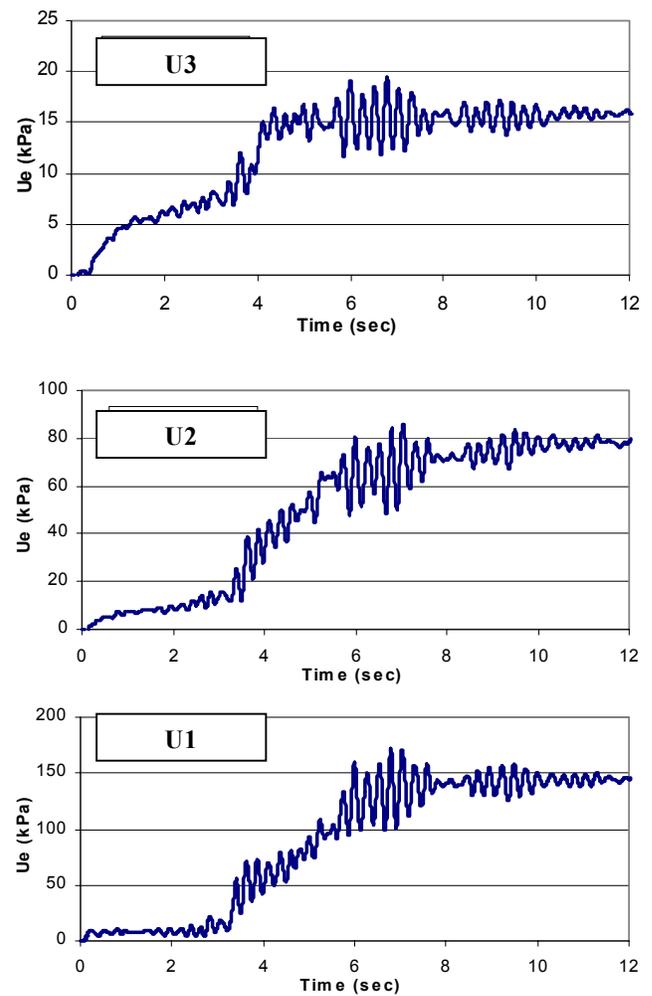
Fig. 8. Excess pore pressure at different depths.

Predicted excess pore pressures as a function of time are shown in Fig. 8. It may be seen that the pore pressures rise rapidly in the time 3 to 8 Secs. corresponding to the period of strong shaking and then level off. Significantly higher excess pore pressures are generated at depth, indicating upward flow of water.

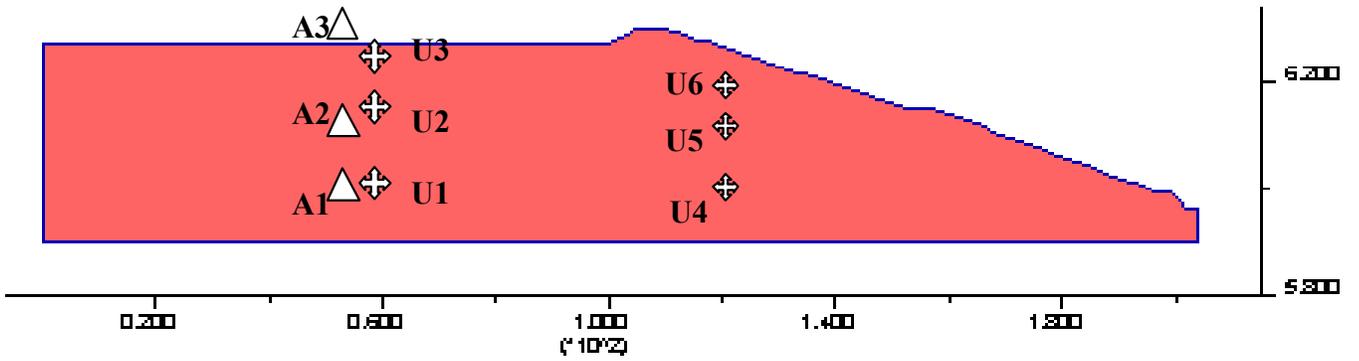
Fig. 9. Relative positions of locations for acceleration and excess pore pressure recording in analysis.

The response of the dam during the earthquake in terms of acceleration, excess pore pressure (U_e), excess pore pressure ratio (R_u) and deformations is presented in Figs. 7 to 12. Fig. 9 shows the relative positions of locations selected for illustrations here.

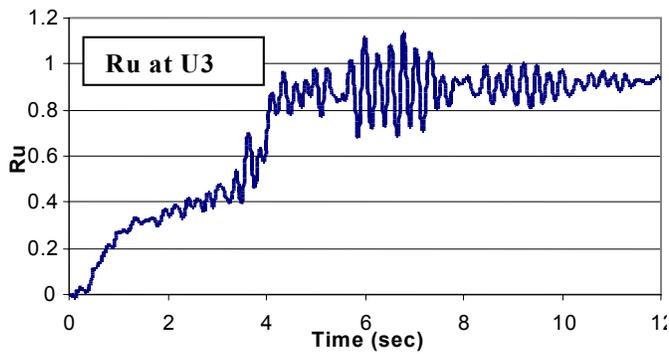
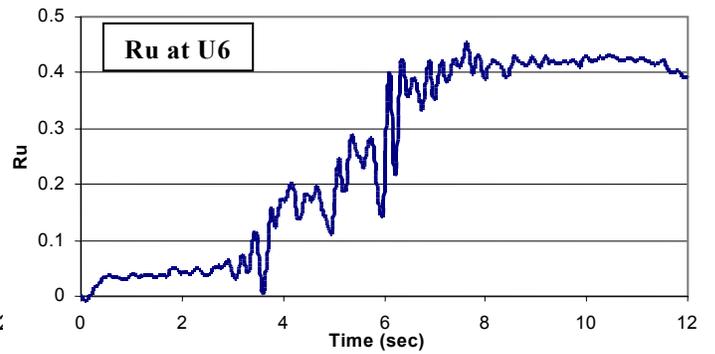
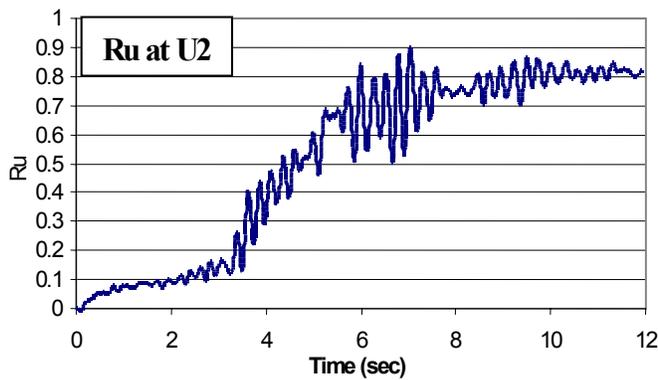
Fig. 10. Pore pressure ratio (R_u) at different depths

Predicted excess pore pressure ratios R_u are shown in Figs. 10 and 11, where R_u is the ratio of the excess pore pressure to the initial effective stress. $R_u = 1$ represents a condition of 100% pore pressure ratio and complete liquefaction. Fig. 10 represents condition under level ground conditions back from the crest of the dam. It may be seen that near the surface the pore pressures rises to $R_u = 1$ corresponding to 100% pore pressure rise and a fully liquefied state. At increasing depths, predicted R_u values are somewhat lower ($R_u = 0.7$).

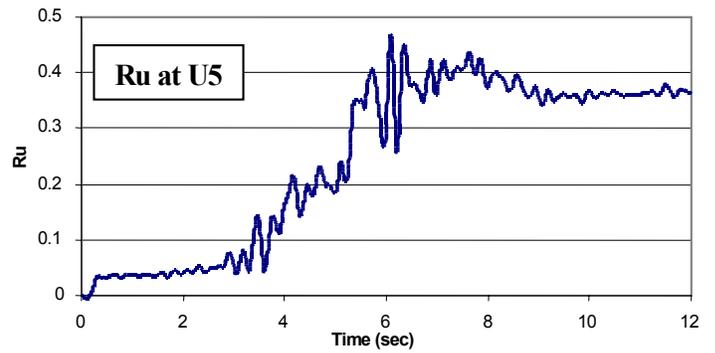
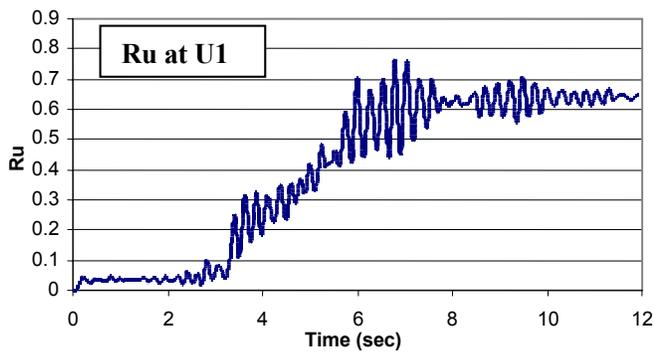
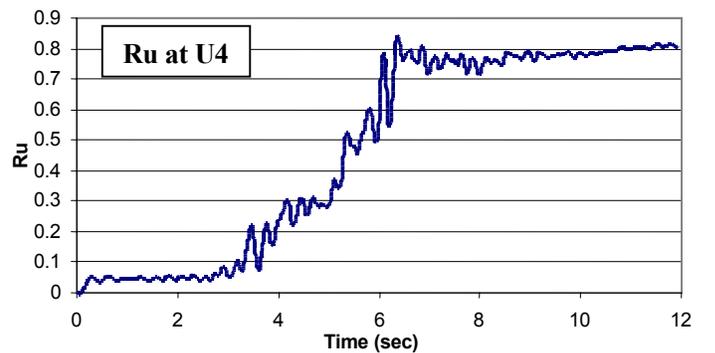
Fig. 11. Pore pressure ratio (R_u) beneath the slope

Beneath the sloping face of the dam, the predicted maximum R_u values as illustrated in Fig. 11 are significantly lower, in the range 0.4 to 0.8 as opposed to 0.7 to 1.0. This is consistent with the results of dynamic centrifuge model tests where significantly lower R_u values are observed beneath sloping as compared to level ground (Taboda and Dobry, 1995).

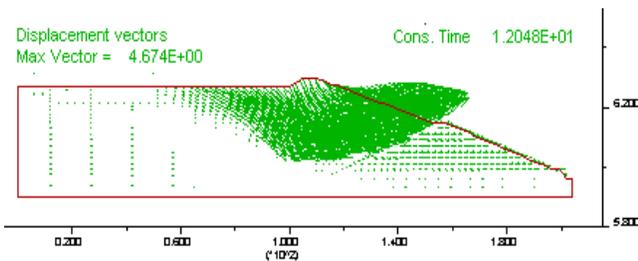
Fig. 12. Displacement vectors due to earthquake.

The predicted deformations of the dam at the end of earthquake shaking are illustrated in Fig. 12 and Fig. 13 in terms of displacement vectors and distorted grid and indicate large displacement of about 5m. The tailings are predicted to liquefy and move up and over the starter dam resulting in upward movement of the front wall consistent with the failure mode observed by the guardian at the time of the failure.

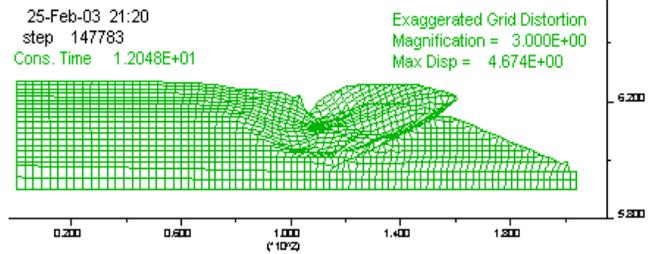
Fig. 13. Distorted grid (3 times magnified for clarity).

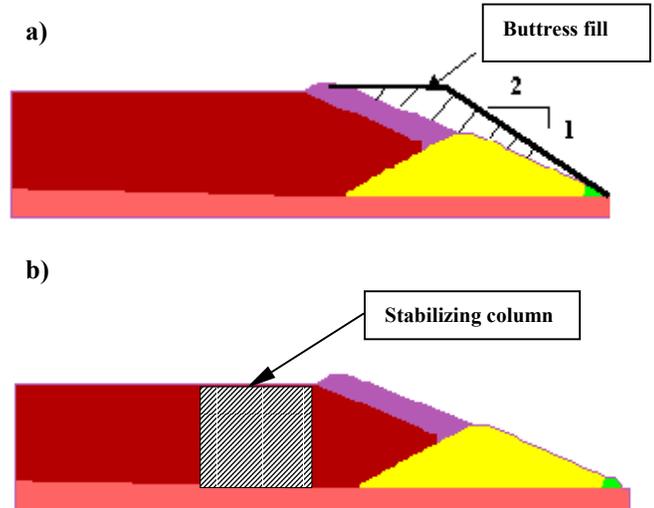
Fig. 14. Remediation of Mochikoshi dam, a) buttress fill, b) stabilizing column

- The Mochikoshi dam could have been stabilized by a free draining buttress fill or by a stabilized column as shown in Figs. 14a and 14b.
- Horizontal layers of low permeability, barrier layers, impede vertical drainage of excess porewater pressure and can greatly reduce stability as they may cause a water bubble to form at the base of the layer during or after the shaking as observed by Kokusku et al. (2000) in shaking table tests and shown in Fig. 15. Such layers may have caused the delayed failures at the Lower San Fernando dam and at the Mochikoshi No. 2 Dike.

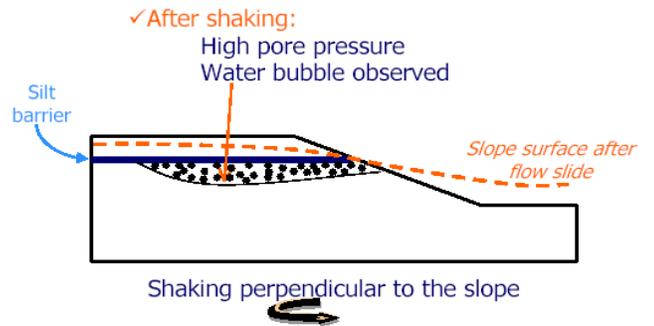
Fig. 15. Water bubble under barrier layer due to shaking.

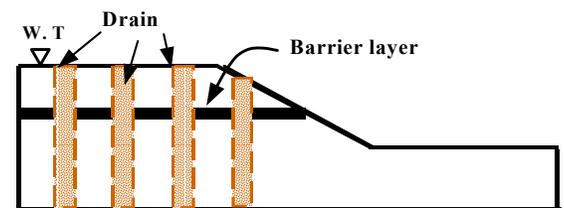
Fig. 16. Drains to curtail bubble effects

- The bubble effect can be prevented by vertical drains that penetrate the barrier layers as illustrated in Fig. 16. The design of these drains can be assessed from dynamic coupled flow effective stress analyses.
