Field Inspection of the Pebble Copper/Gold Project

July 26-27, 2007

Part I

Bill Cole

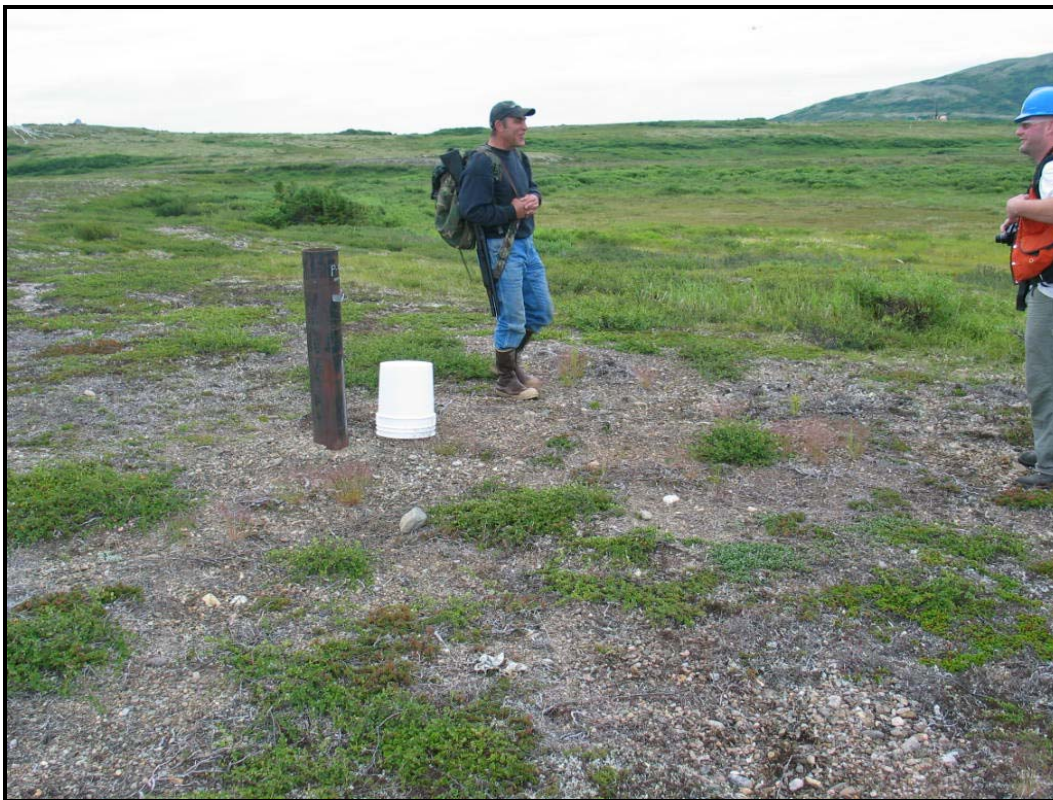
Photo #8. Piezometer well #P4.

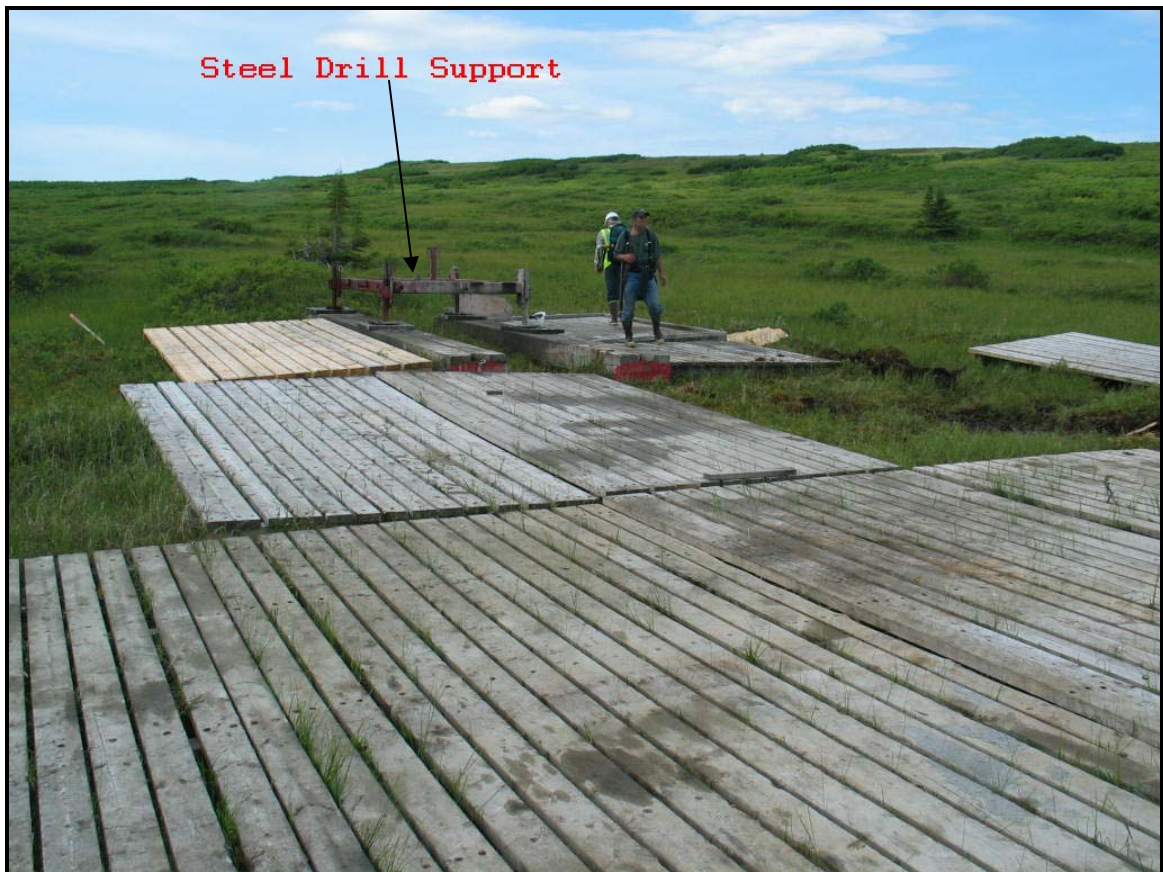
Photo #11. New drill site ready for the drill.

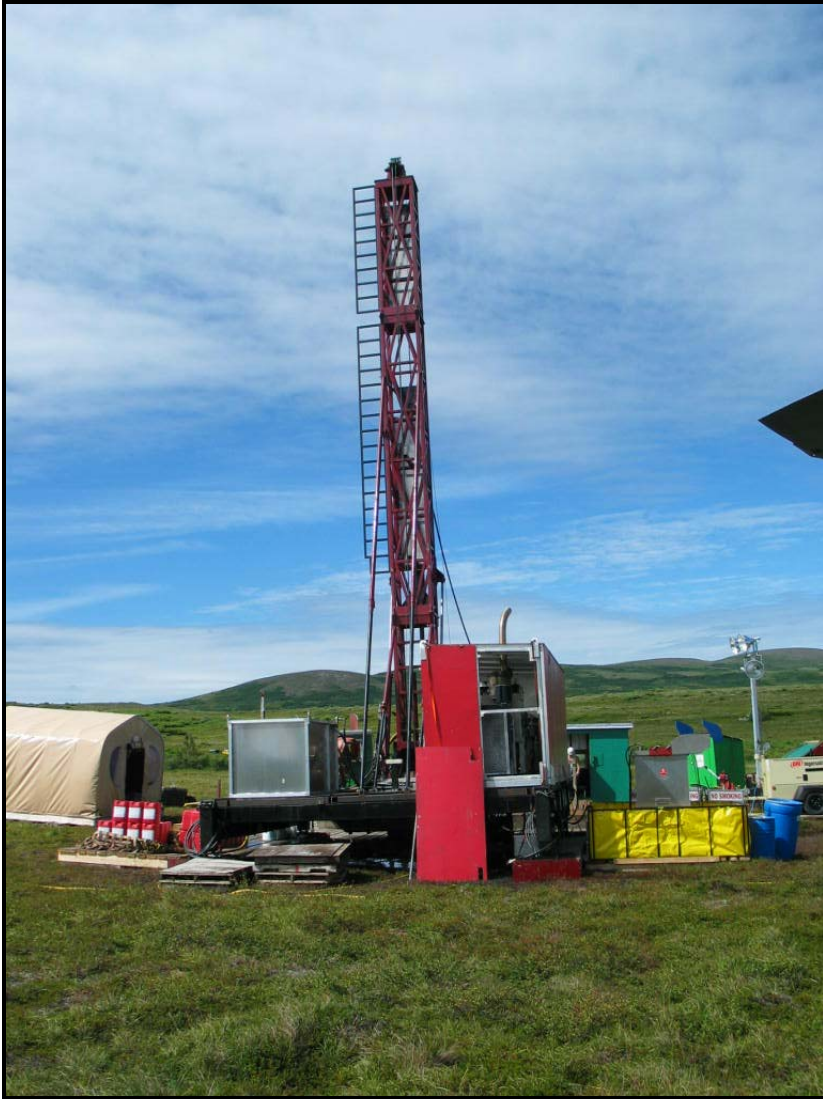
Photo #15. Drill #6.

- Crew quarters, for shelter and safety in the event that weather prevents the helicopters from changing worker shifts. The crews have sufficient food and heating fuel for several days. (Photo #16)
- Storage structure – usually a Quonset hut. (Photo #15, Tan colored structure)
- Tundra matting – discussed above.

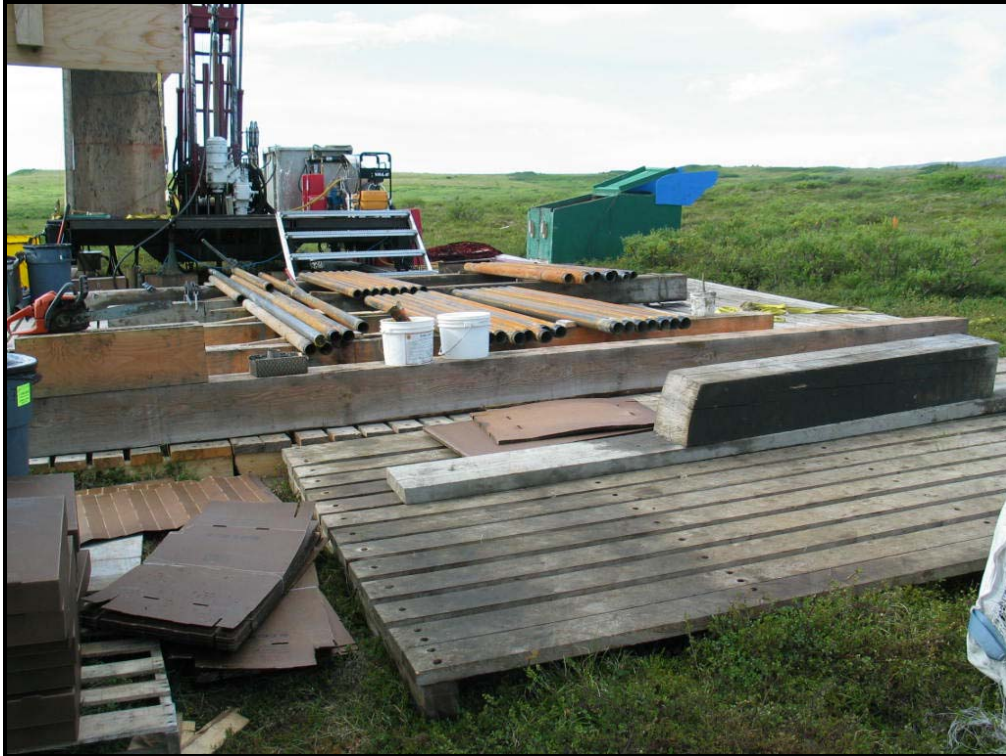
Photo #21. Drill #7.

Drill #7 (See photo #21) was operating in a lowland about 300 yards south of Upper Talarik Creek, close to a wetlands. The drilling return was being pumped about 150 yards up hill away from the wetland. The water seeps into the ground over a short distance. (See photos #24-26.)

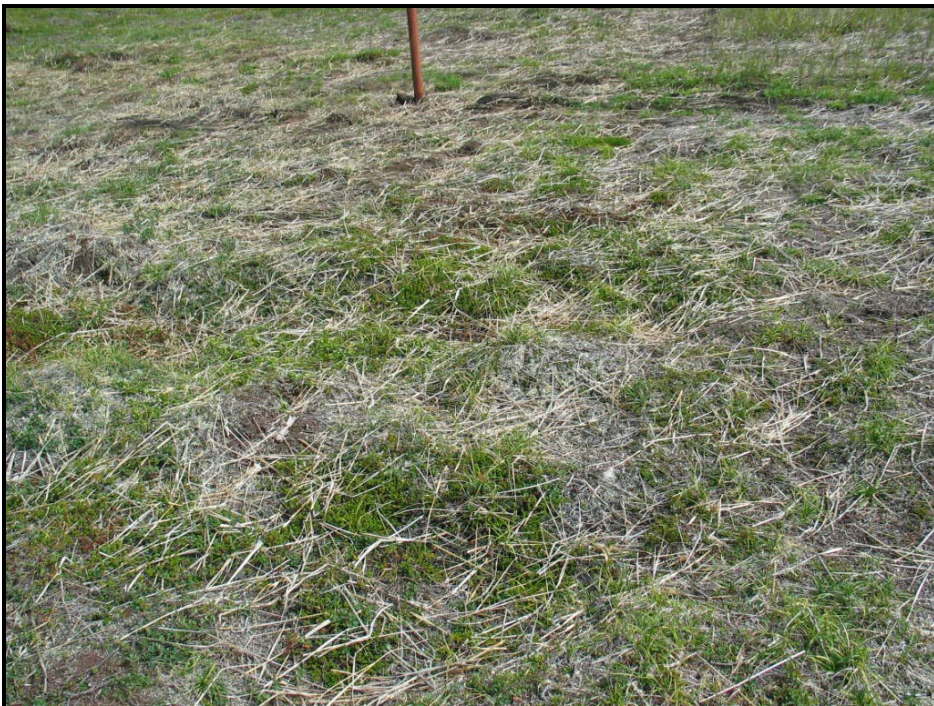
Photo #36. DDH 6350 reclamation.

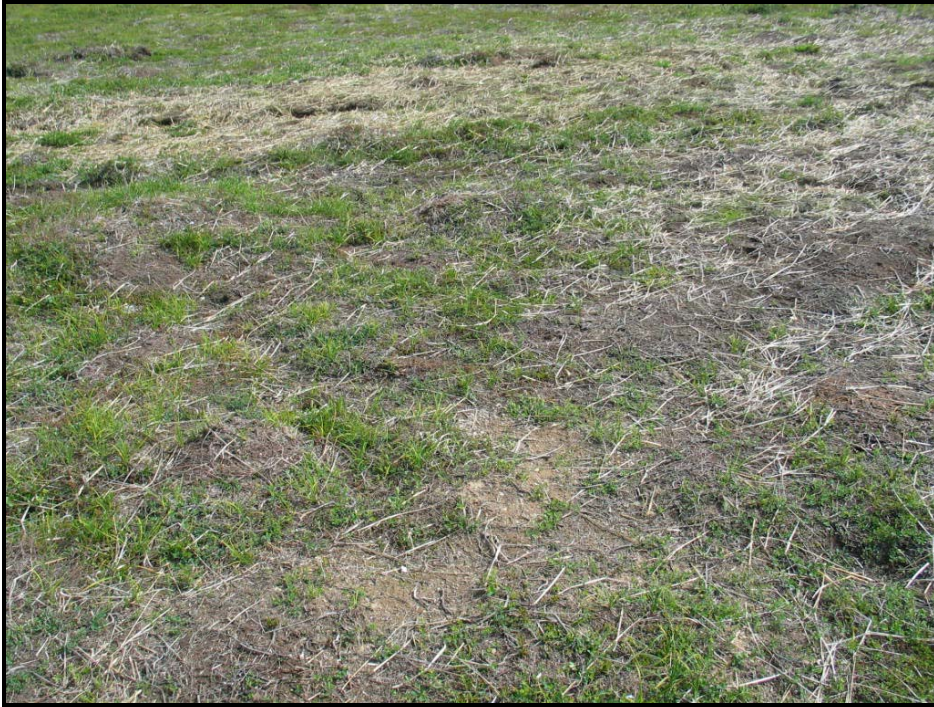
Photo #37. DDH 6350 reclamation

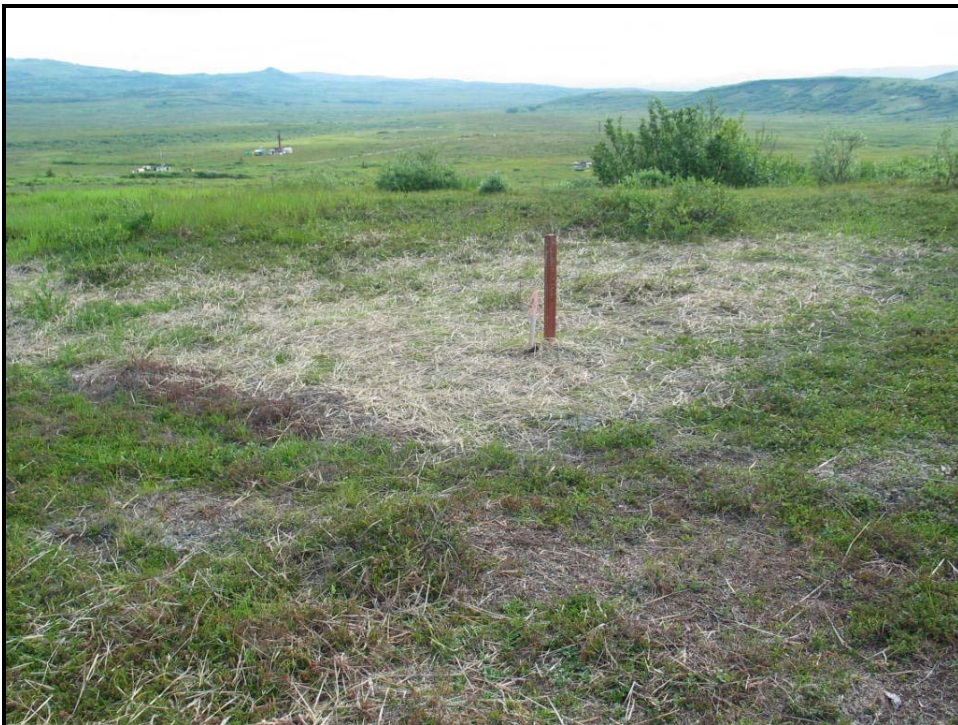
Photo #40. Reclamation at DDH 7362.

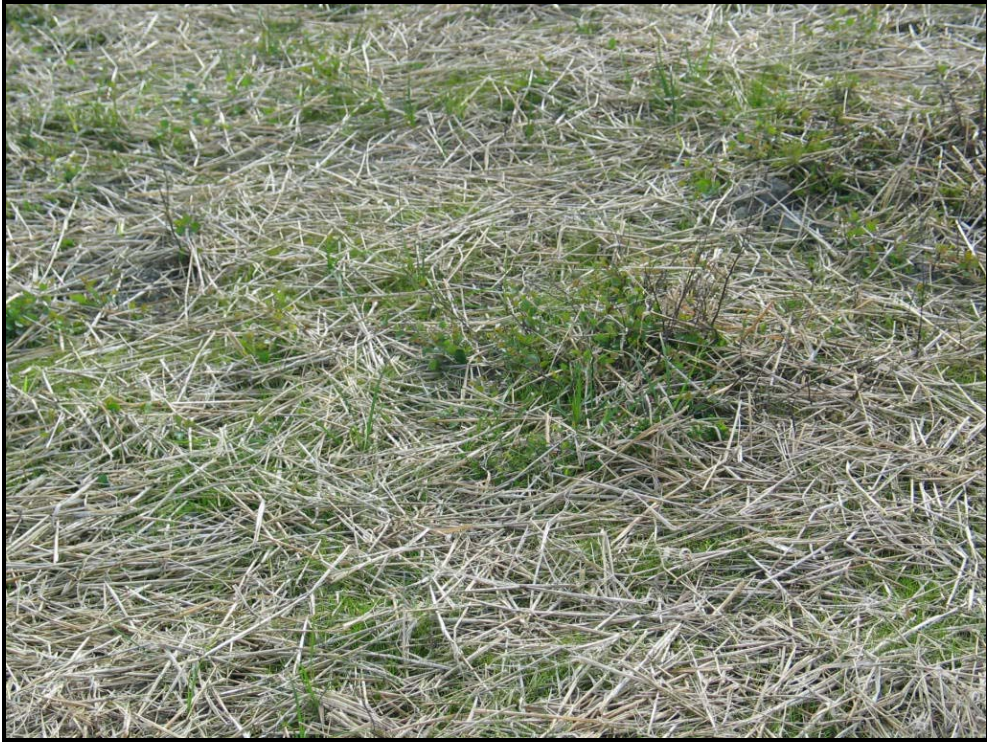
Photo #41. Reclamation at DDH 7362.

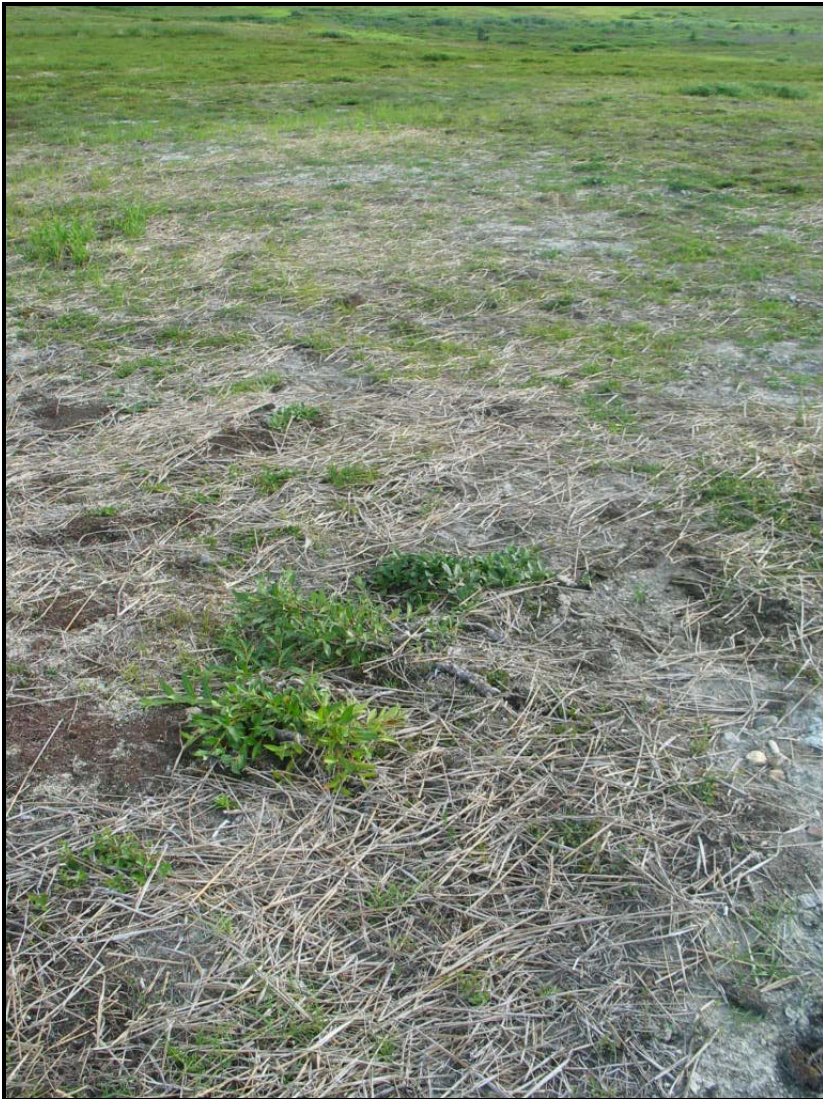
Photo #43. Reclamation at DDH 7361

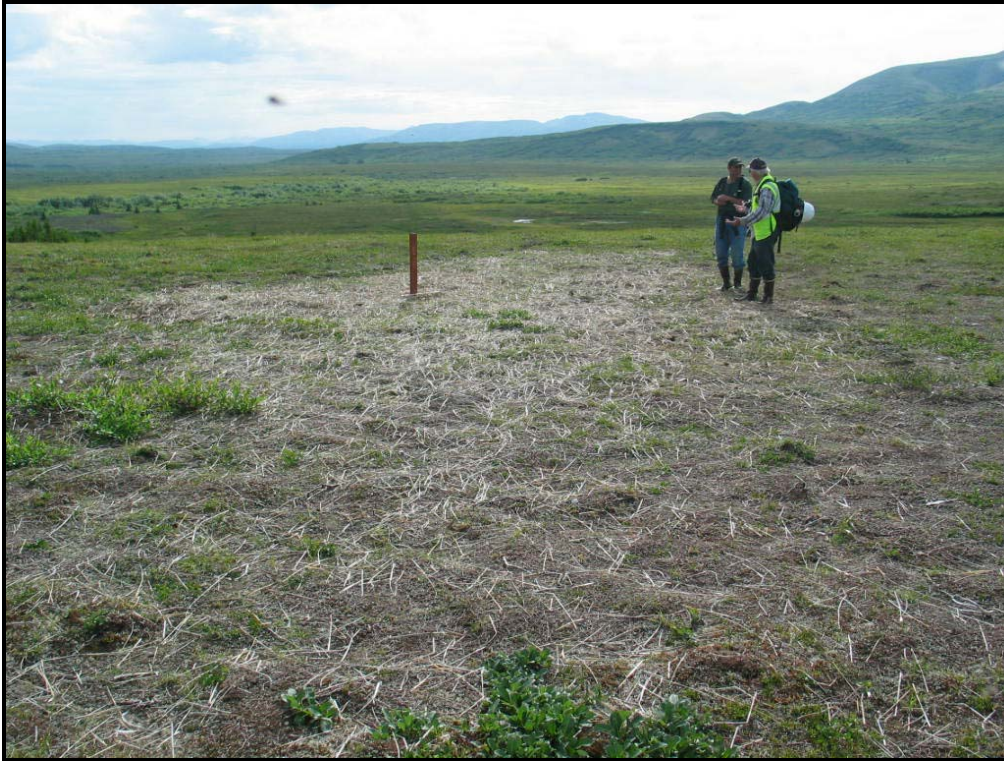
Photo #44. Reclamation at DDH 7367

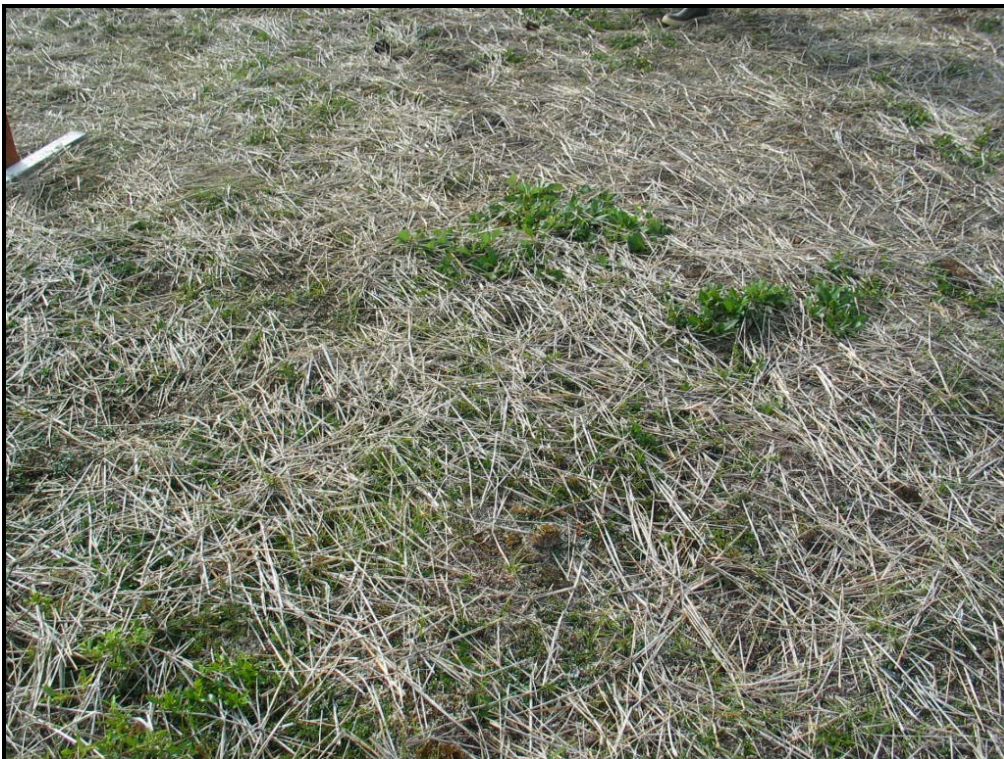
Photo #45. Reclamation at DDH 7367

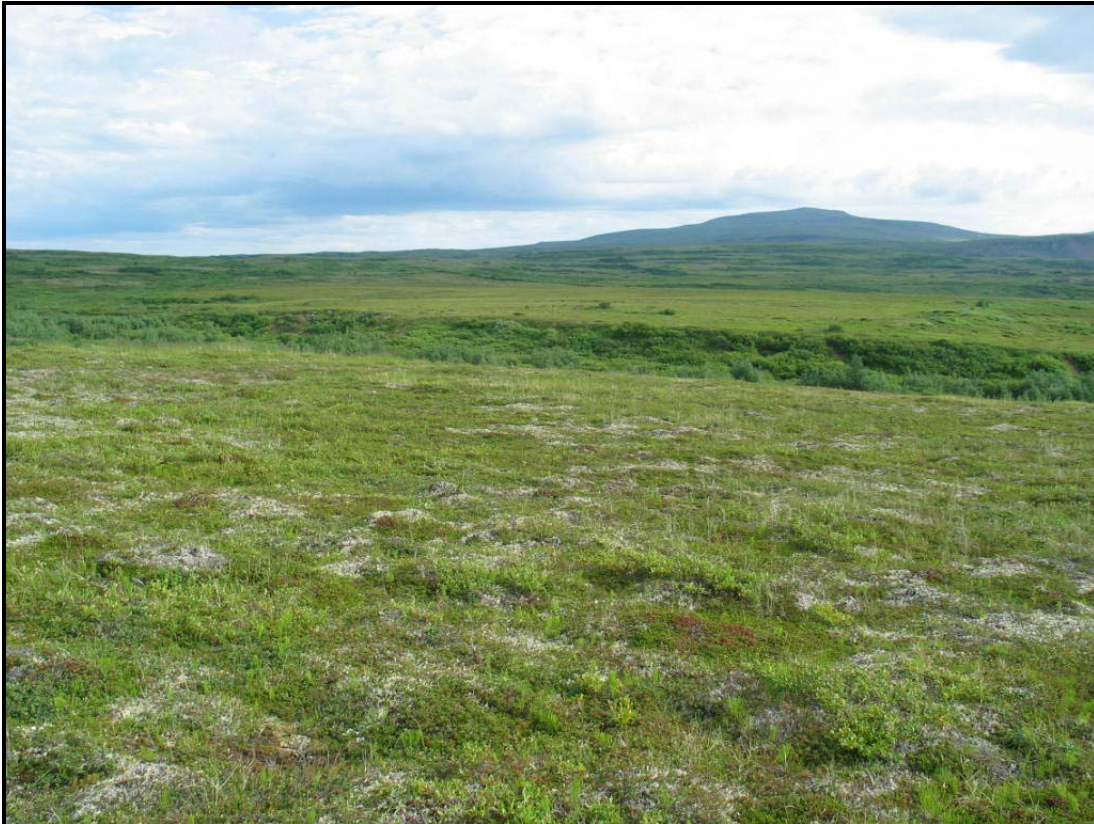
We spent part of the second day walking the Upper Talarik Creek area. We walked down to the creek near where its uppermost tributaries come together. We generally followed the drainage downstream for roughly a half mile, past the area of the May spill. (See photos #59-61.) We saw no inappropriate substances, such as diesel fuel or drilling fluids, in or near the creek. We did not see any fish or large wildlife. There were, however, obvious signs of beaver activity. (See photo #61.)

Photo #59. Uppermost Upper Talarik Creek drainage.

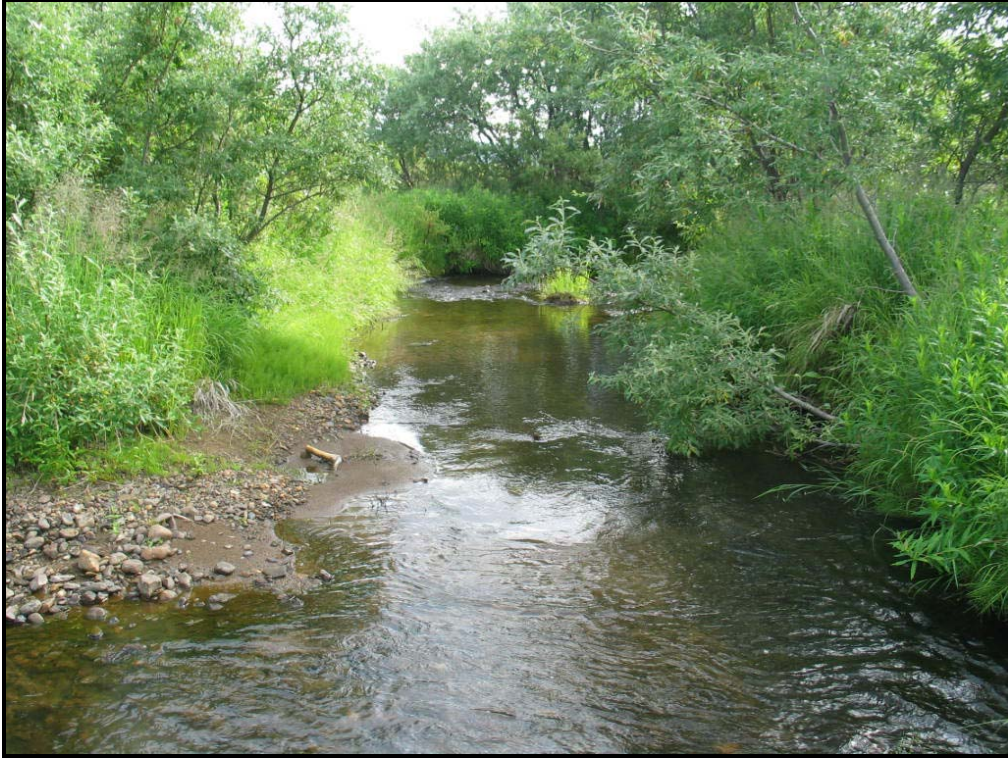
Photo #60. Upper Talarik Creek.

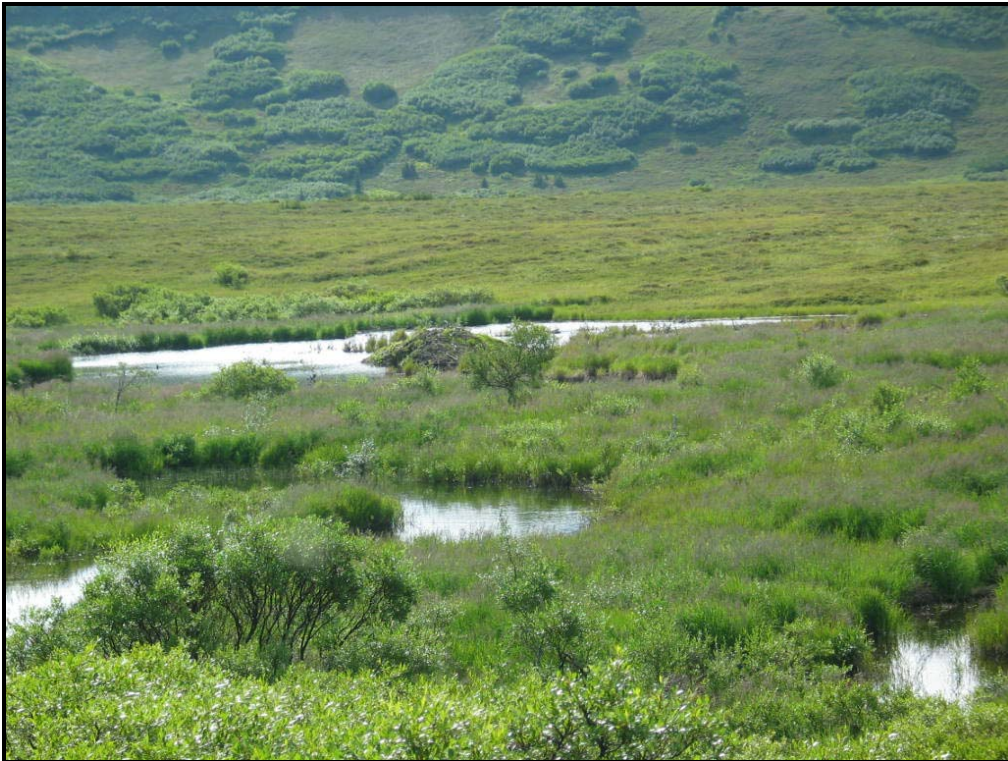
Photo #61. Beaver lodge and dam on Upper Talarik Creek.

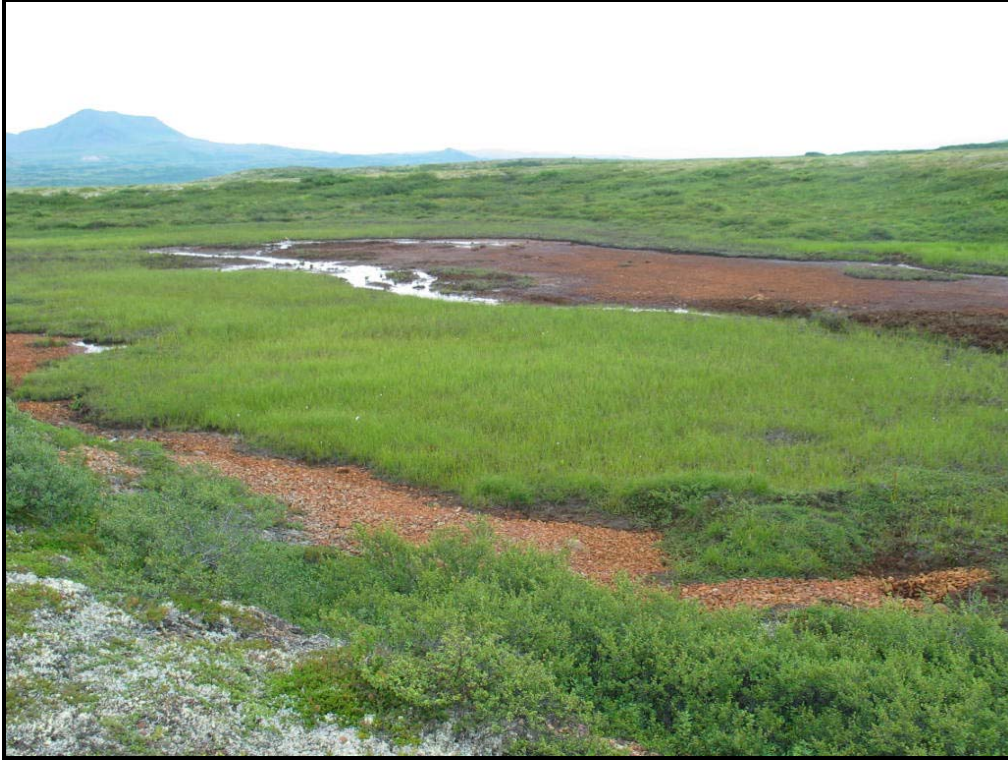
Photo #63. Discovery outcrop and wetland.

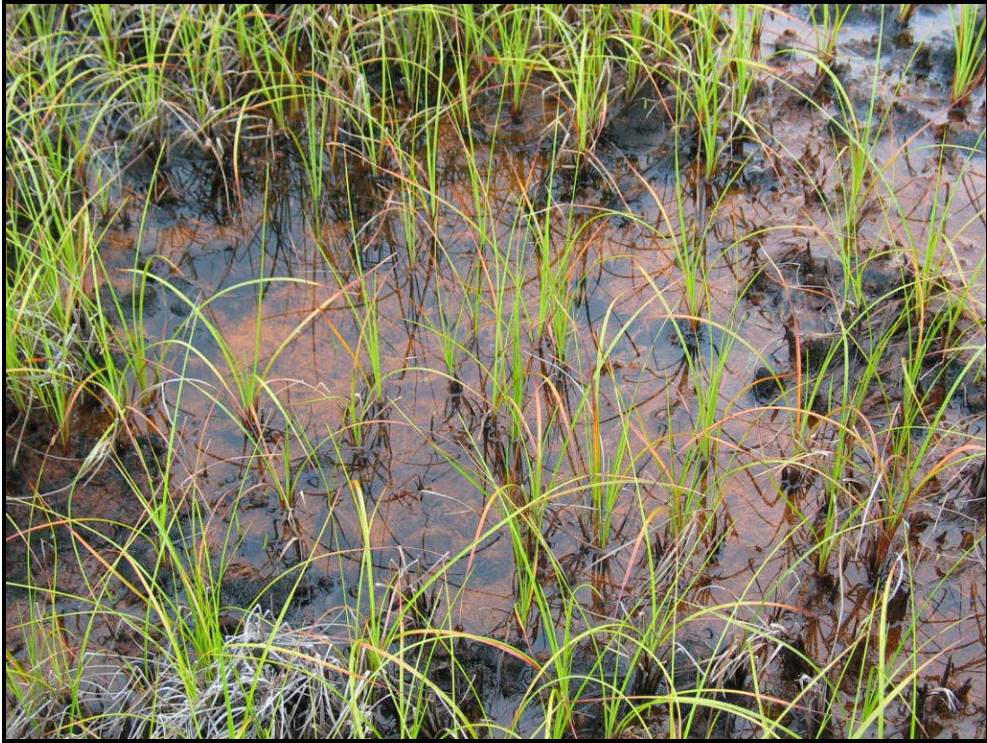
Photo #65. Iron oxide in wetland near discovery outcrop.

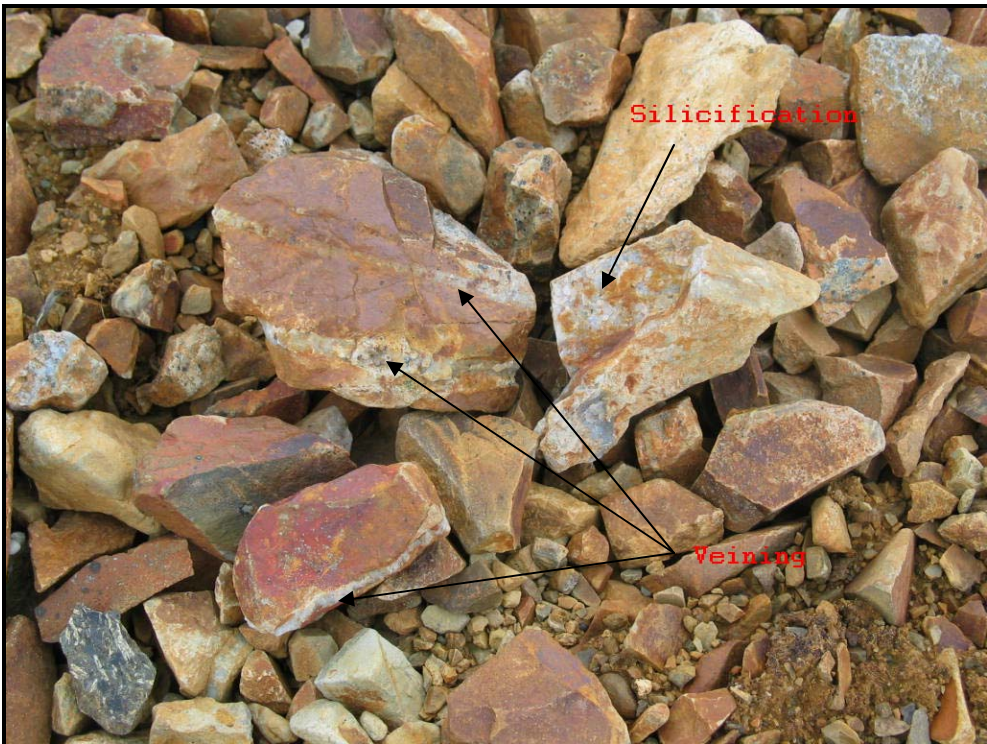
Photo #66. Alteration and veining in outcrop.

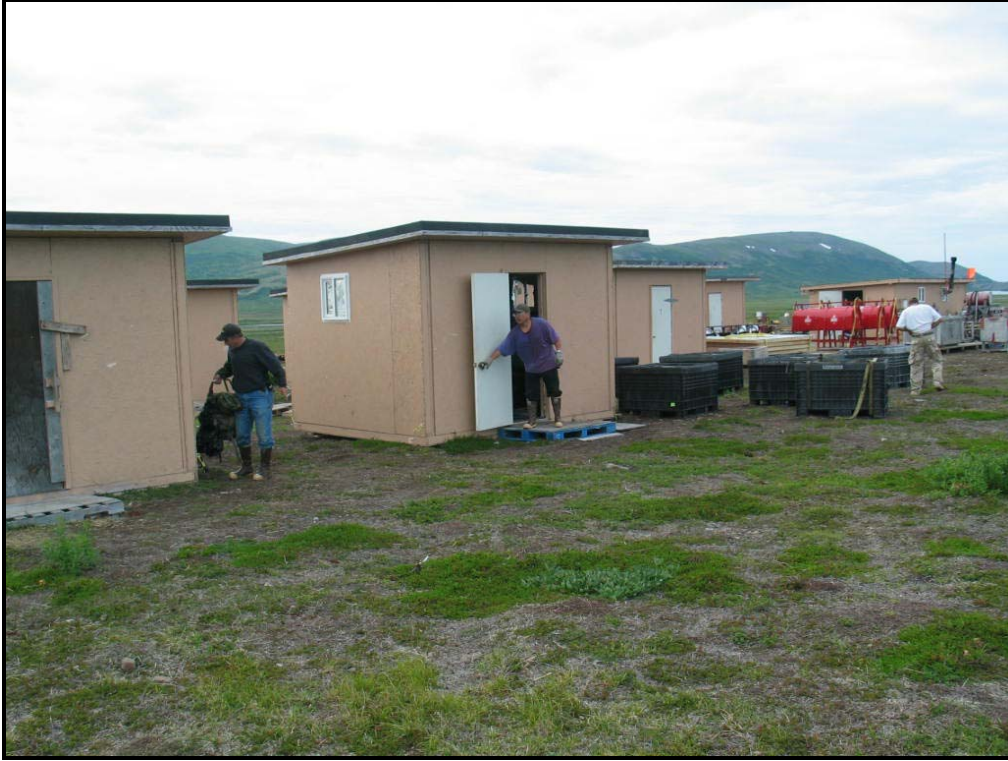
We briefly visited the old exploration camp which is now being used for materials storage and as a possible emergency shelter. Northern Dynasty has a lot of materials stored in the old camp, particularly drill steel. The site is quite active, with helicopters slinging equipment in and out regularly. (See photos #68 and 69.)

Photo #68. Old camp and storage facility over West Orebody.

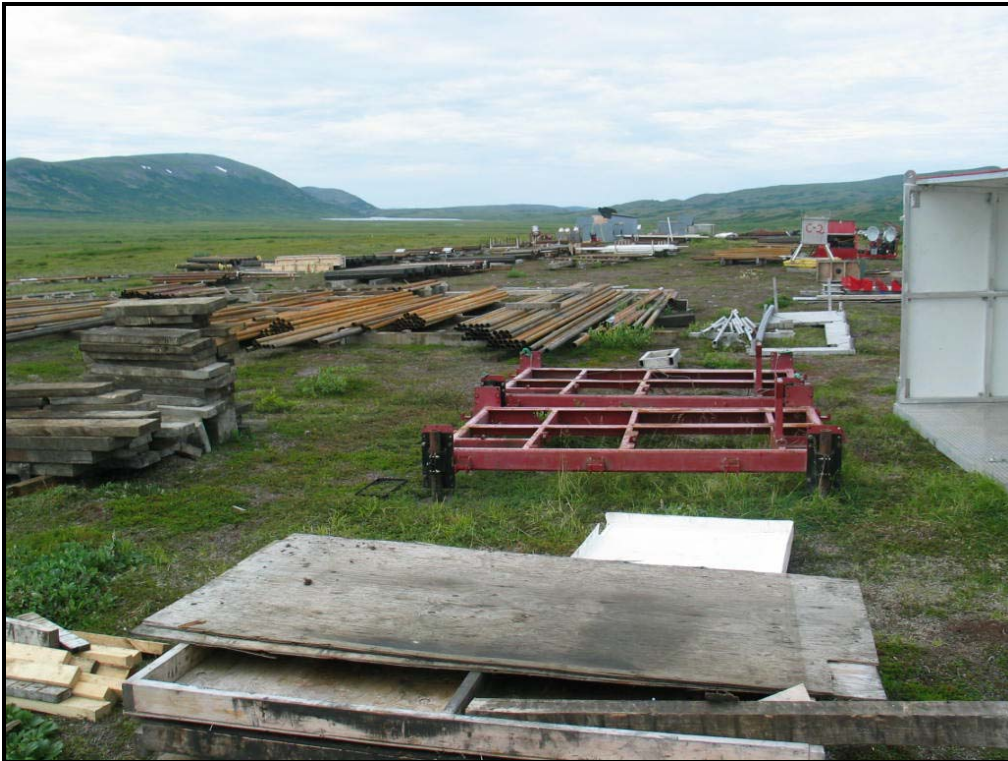
Photo #69. Drill steel stockpiled at old camp.
